# **OLD DONGOLA**

## **DEVELOPMENT, HERITAGE, ARCHAEOLOGY**

FIELDWORK IN 2018–2019. VOL. 1. EXCAVATIONS

EDITED BY Artur Obłuski and Dorota Dzierzbicka

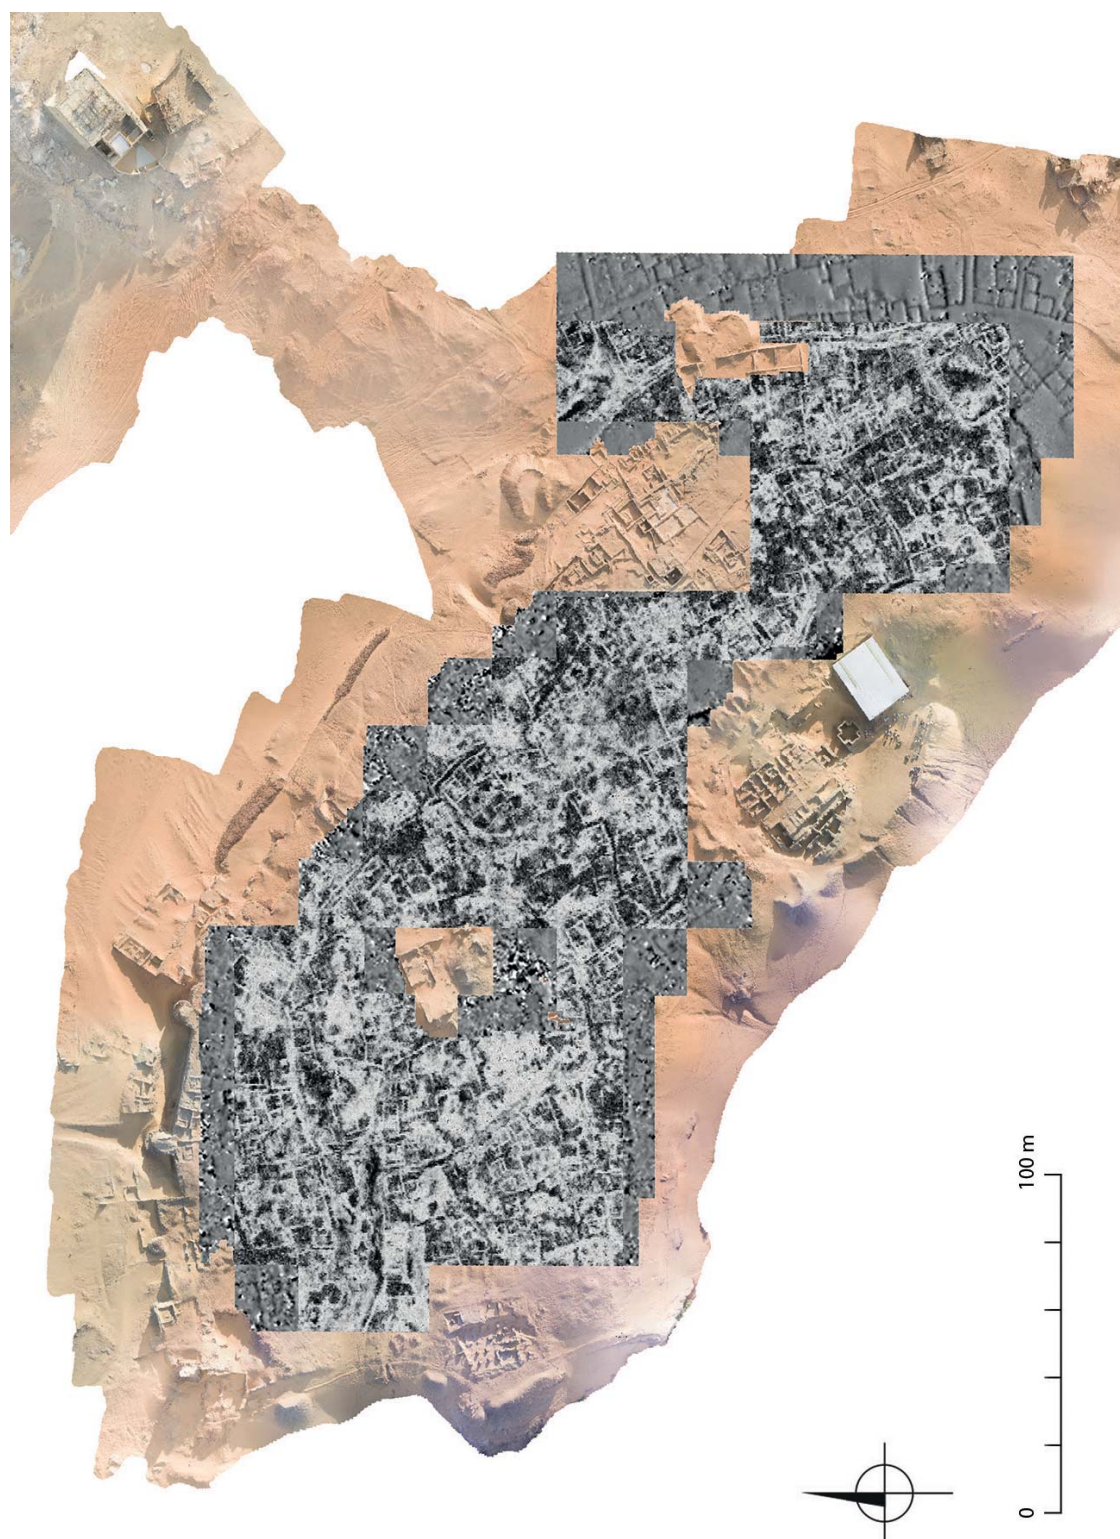
Fig. 3. Results of the ground-penetrating radar and magnetic surveys carried out on the citadel hill

In order to study the urban layout of the site and to plan future fieldwork, magnetic and GPR surveys were conducted by Tomasz Herbich and Robert Ryndziewicz in December 2018 [*Fig. 3*] (Obłuski et al. forthcoming). In order to prepare the site for the GPR survey, all loose fired bricks were removed from the surface of the citadel (over 3.5 ha) and three old dumps from earlier excavations were cleared. The first results of the survey show a dense urban plan with long streets running parallel to the citadel wall. Also visible on the magnetic map is an outline of the wall in the southeastern part of the citadel.

The magnetic survey showed a large anomaly in square 10Y45. Excavations undertaken to identify its cause unearthed walls of fired and sun-dried brick (F965–F968) forming an outline of a structure. A test trench of 2 m by 2 m uncovered a thick dump deposit (arbitrarily divided into contexts 459 and 464). A sample was taken for magnetic analysis.

Fig. 3. Results of the ground-penetrating radar and magnetic surveys carried out on the citadel hill (Processing T. Herbich, R. Ryndziewicz)

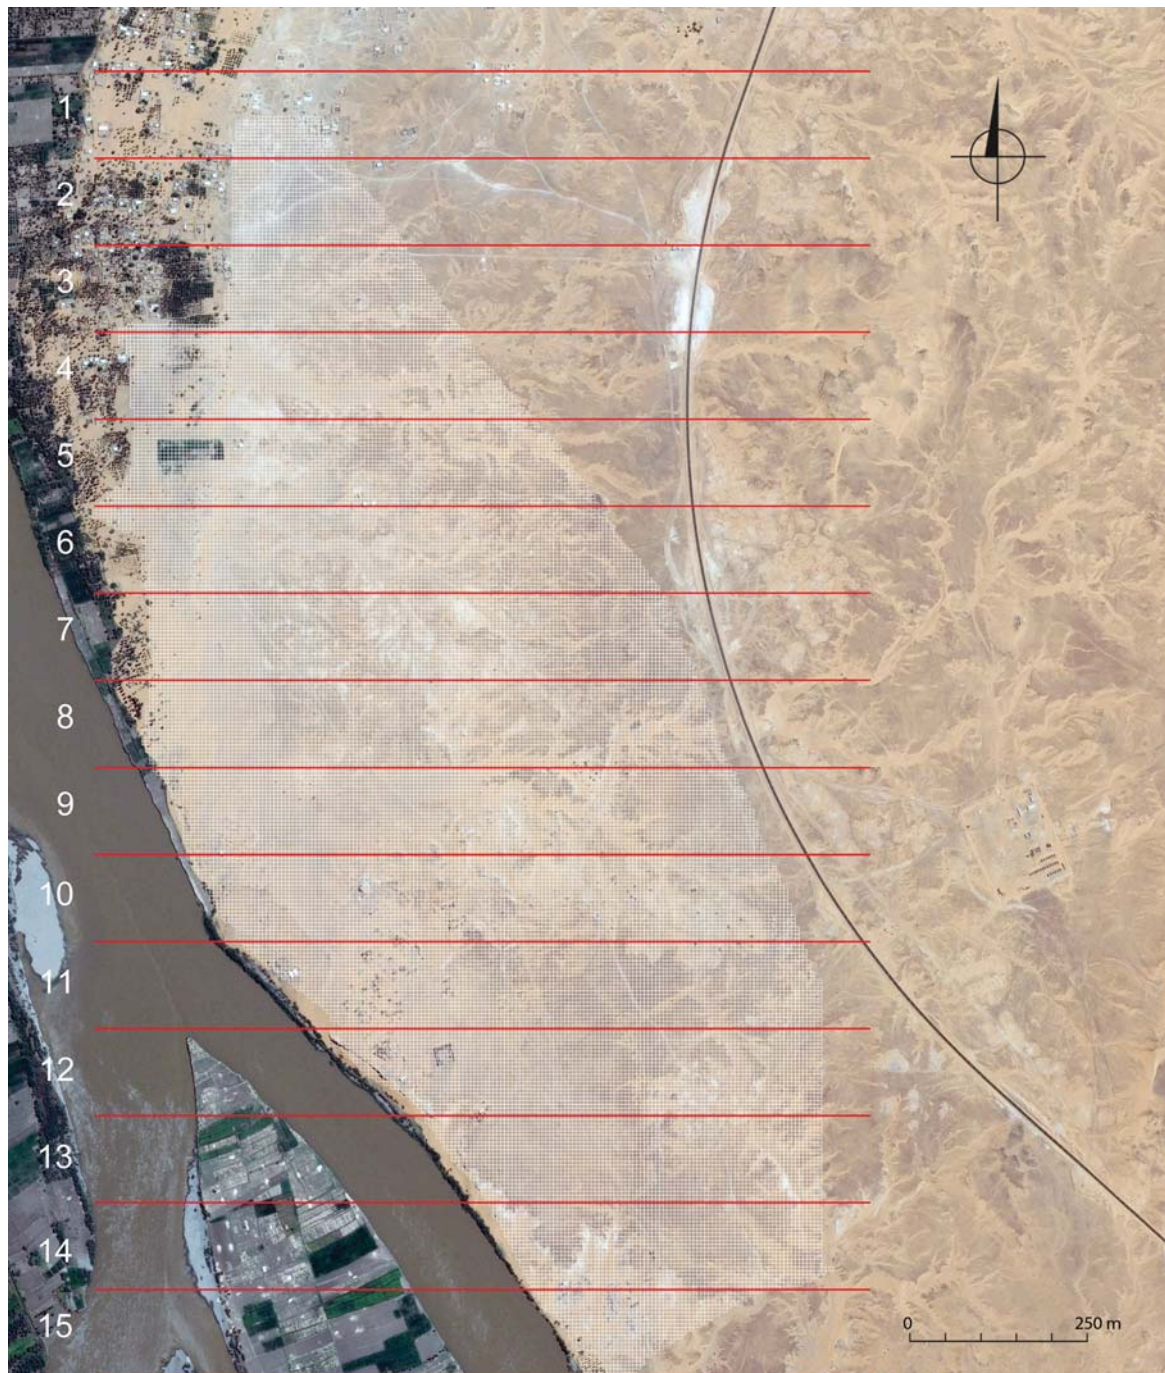
Fig. 4. General view of the site showing the grid of 10 m by 10 m squares in white and the linear division in red

The site of Old Dongola was divided into contiguous sectors. The citadel, the focus of work in the UMMA project, is located in Sector 1, which occupies columns 22–75 of rows 10 and 11 of the newly established grid [*Figs 4–5*].

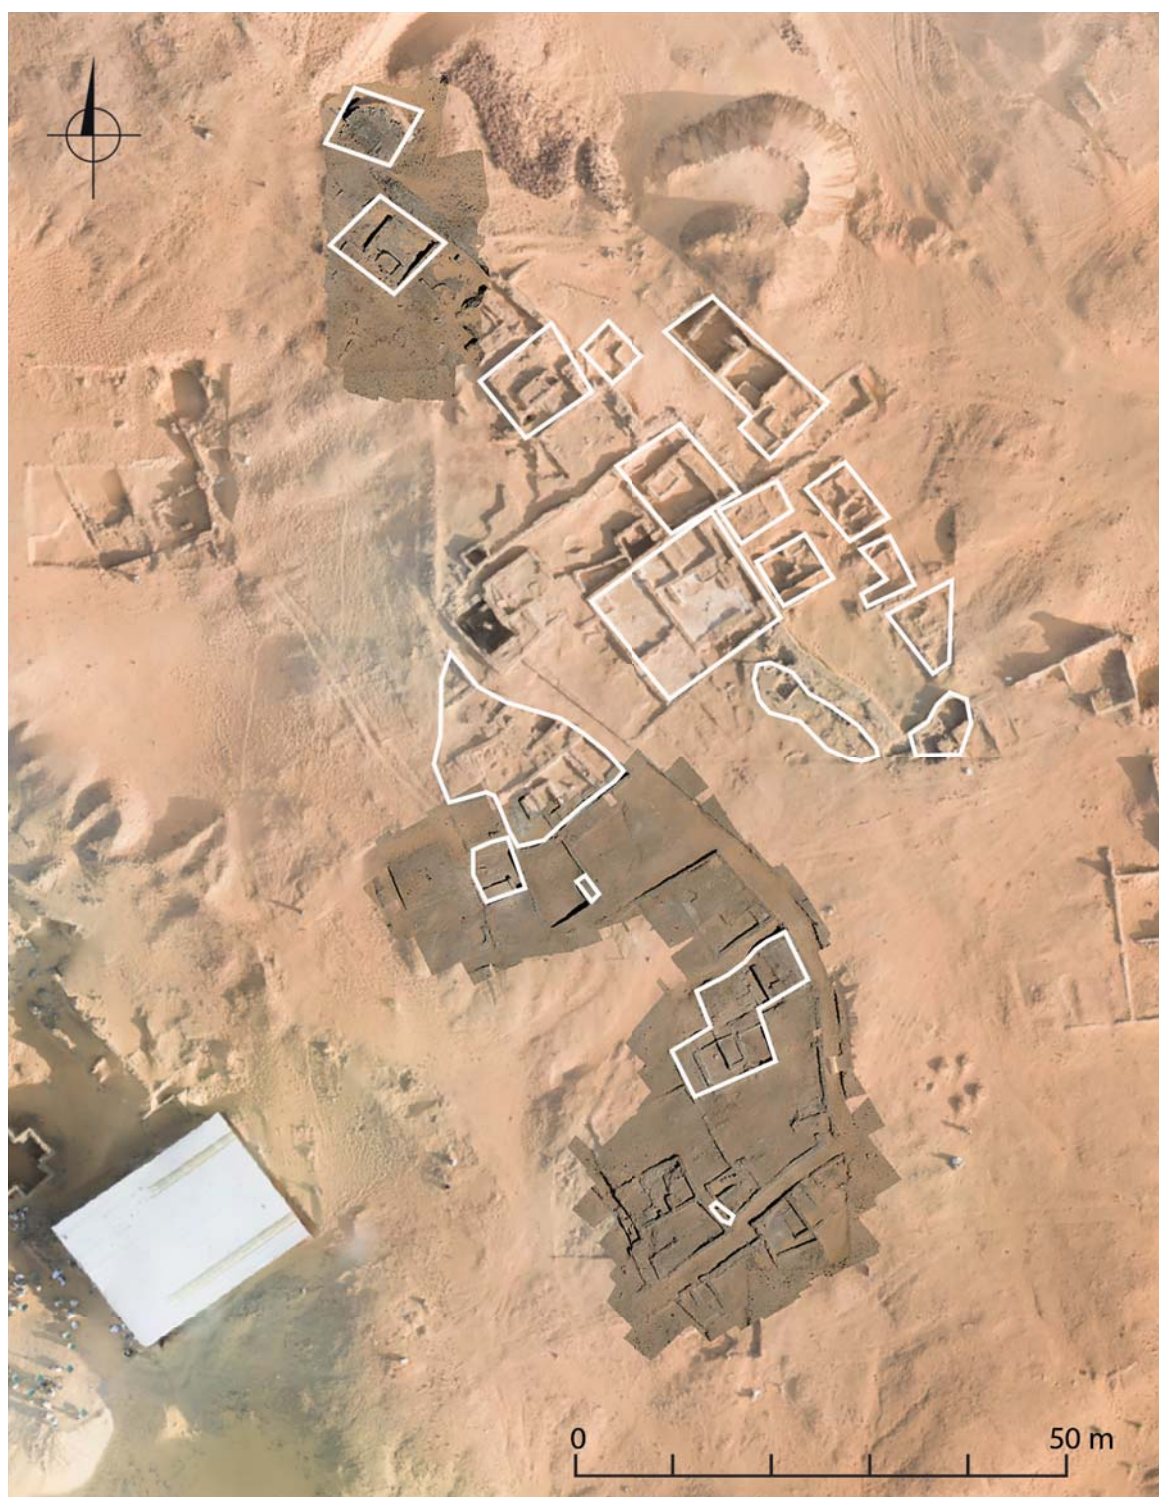
Fig. 7. Orthophoto map of the excavation area combining photographs taken from a drone and from a pole. Architecture documented in detail using photogrammetry is enclosed within white boxes

All photos required for the creation of such documentation were taken with a Nikon D3300 camera and saved in RAW format. Further work required the photos to be processed in Agisoft Metashape software to create a dense point cloud and then a mesh, subsequently adding texture, coordinates, and exporting ready orthophotos/models in desired formats. Twenty-five 3D models were made of structures and architectural complexes selected for this form of documentation [Fig. 7]. Models were also created of several small finds recovered during excavations, as well as of claystone formations selected by the geologist. Selected soil sections were also documented with orthophotos.

The fieldwork progress was documented with aerial photographs taken from a drone. The equipment used for this purpose was the DJI 3 Professional. The images were recorded and saved in RAW format. The use of a drone for aerial photography allowed for full control of the shot and the scale of the photographed area. In 2019, a model of the excavation site was created and an orthophotomap of the whole citadel was made with the use of drone imagery [Fig. 6]. It will constitute a dedicated raster layer serving as a base for further measurements and documentation projects. The drone was also used for smaller photo sessions documenting the progress of excavation works.

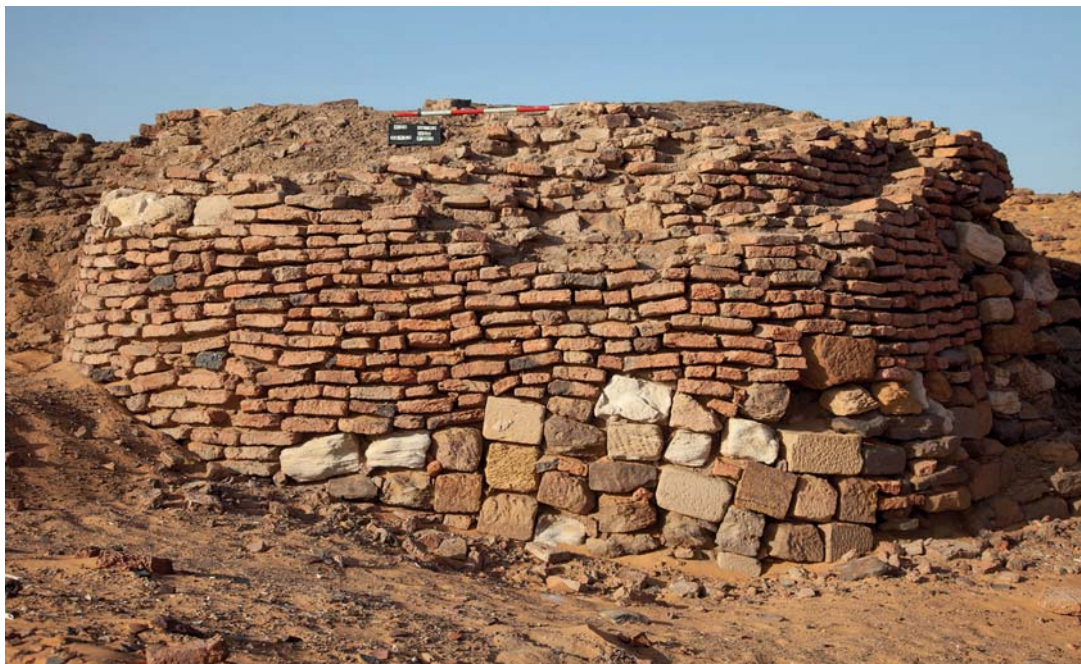
Fig. 10. Tower U66, view looking southwest

U66 is a semicircular tower forming part of the fortifications of the city [*Figs 10–12*]. It consists of a C-shaped fired-brick and stone wall (F963 = F830) abutting the perimeter wall (F79, F964). In the investigated occupational phase, the area within the tower was separated from the area to the southwest by wall F828 and surfaced with a contemporaneous mud floor F831. South of the tower, floor F814 was laid in U78, presumably a courtyard located between the city wall, U58, and wall F654 in the southwest. At the same time, enclosures or benches consisting of walls F657–F658 and F812–F813 were constructed in the courtyard. Subsequently, the space of the tower was used as a rubbish dump (deposit 455).

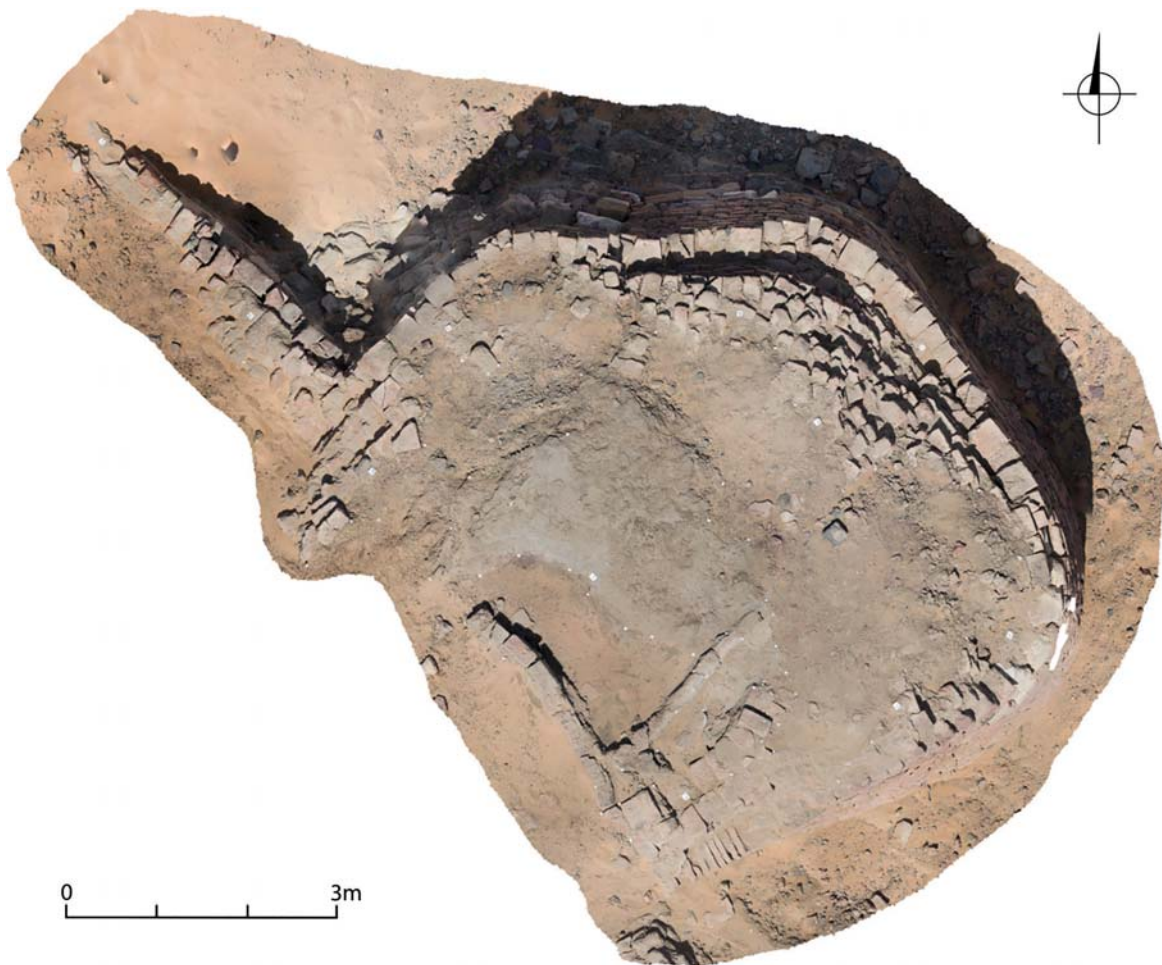
Fig. 12. Tower U66, aerial view

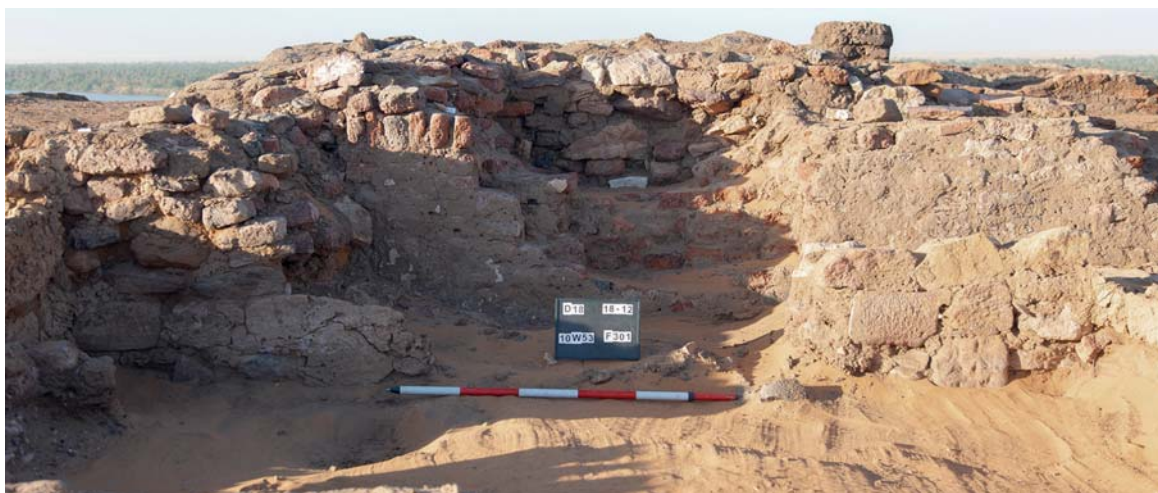
Fig. 13A. City wall between spaces U20 and U74, view looking southwest

In the northernmost section of the excavated area, the earliest part of the uncovered perimeter wall was most probably wall F301, made of stone blocks, and wall F79, built of sun-dried brick partially on top of wall F301 [Fig. 13A–B]. Wall F79, possibly equal or contemporary with wall F233, ran parallel to wall F585, which was later dismantled in squares 10U51 and 10W51–52. The chronological relationship of these two walls remains unclear.

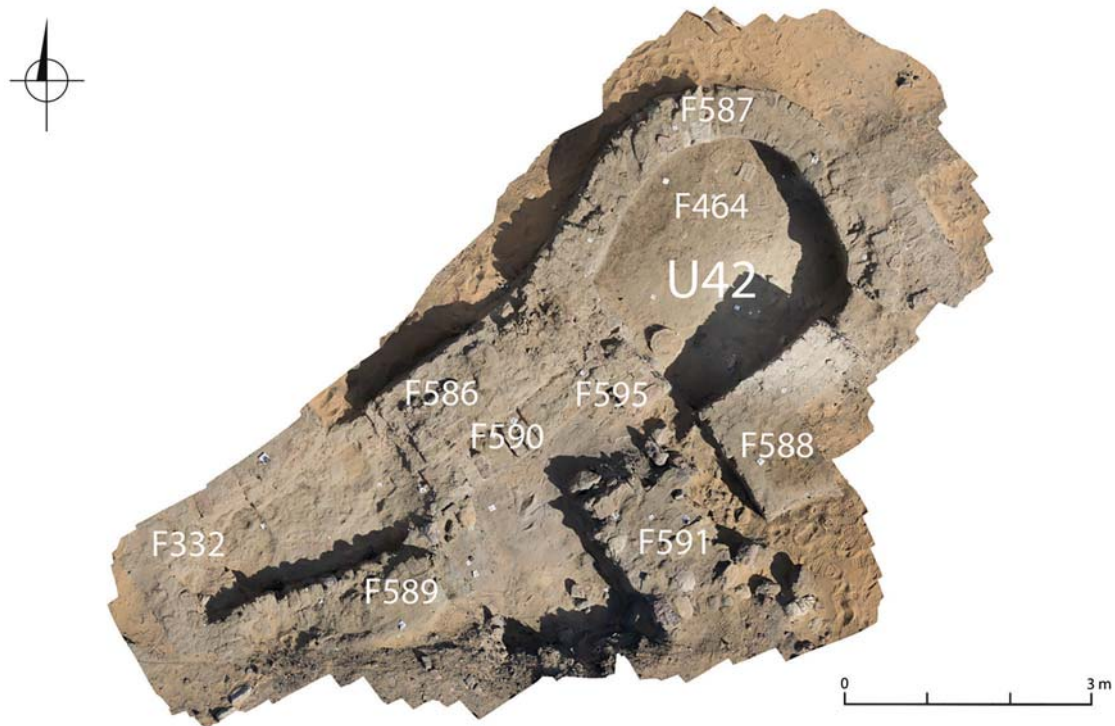
Fig. 16. Tower U42, orthophoto with overlaid feature numbers

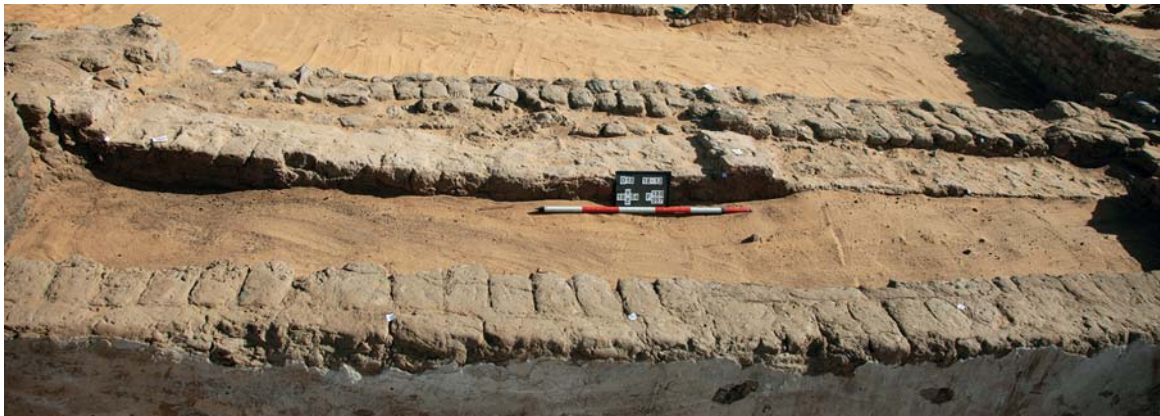
**Fig. 18.** Series of abutting walls forming part of the perimeter wall; the trench after the dismantling of one of the walls is filled with sand

recent walls. The latest addition was the 1.4 m wide wall made of large stone slabs bonded with poor-quality mud mortar (F591 and F589, foundation level 19.92 m). Similar sequences of walls can also be found in other areas under investigation, for example walls F301, F79, F585 and F225 (see below). From the period when the tower was out of use, it suffered progressive damage, as the walls were dismantled in order to source building material.

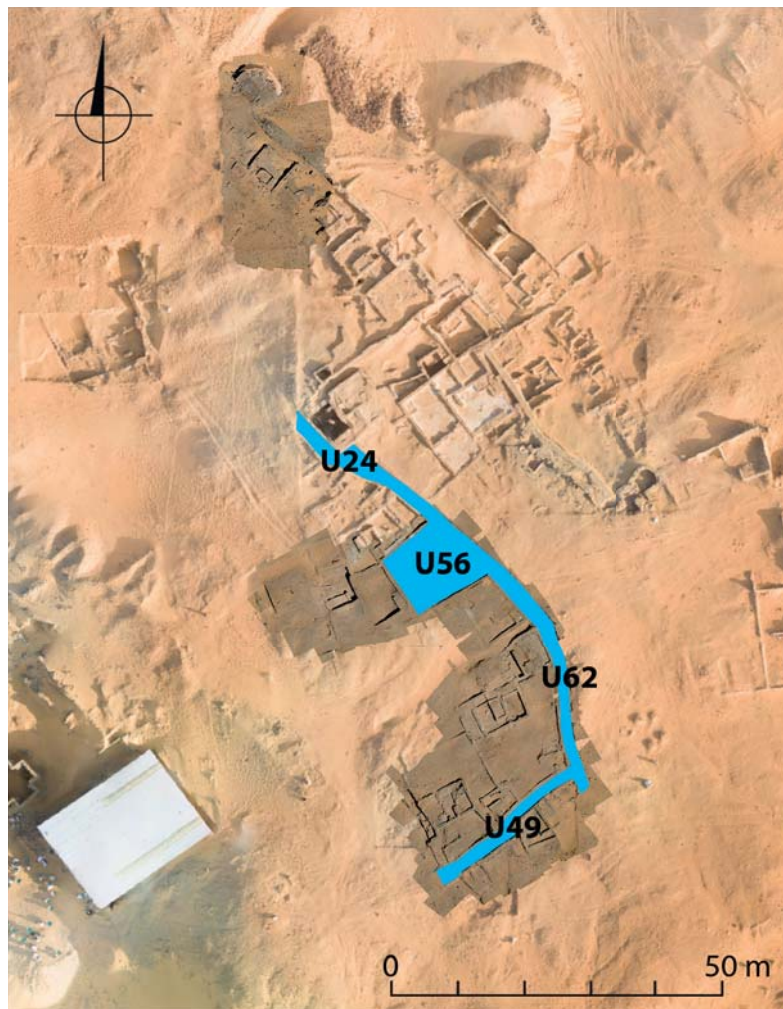
Fig. 19. Orthophoto of the excavated area with elements of the street grid marked in blue

During the area excavations conducted this season, three streets and a courtyard were investigated [Fig. 19]. They divided the urban district within the perimeter walls of the citadel into four zones discussed separately below. GPR results have shown that the streets remain consistent in outline also in deeper strata (see Figs 3, 229). This was archaeologically verified for street U24, whose northern wall, F123, descends over 1.5 m lower than the exposed walking surface. It therefore seems that the street grid is earlier than its uncovered 17th- and 18th-century walking levels.

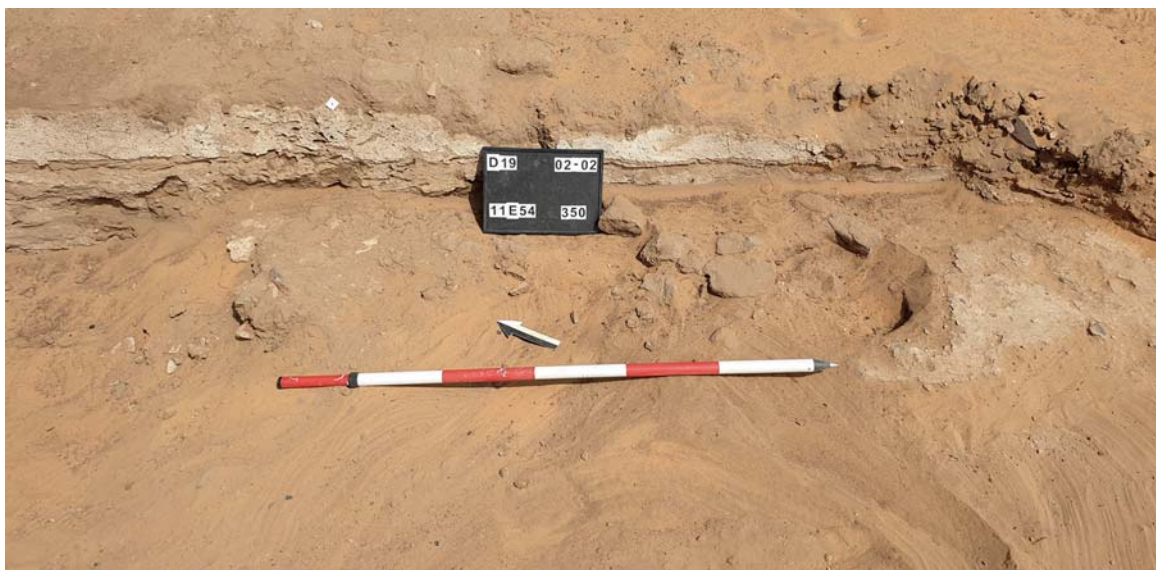
Fig. 21. Courtyard U56, rubble layer 350, view looking northeast

Inside the area delimited by walls F685 and F662 there are various traces of floor levels pertaining to different phases. Floor levels F565 and F566 represent probably the latest phase (period II.C) in the life of the courtyard, together with F569. F565, the remains of a floor level made of a thin layer of mud mortar, is associated with street U24 coming down from the northern part of the citadel. It is likely the latest walking level, as it lies above an earlier floor, F567, from which it is separated by layer 350 [*Fig. 21*] composed of sand mixed with rubble and sun-dried and fired brick fragments. This layer could be the result of a phase of abandonment represented by the rubble and sand on which a new floor was laid in street U62 departing toward the southeast. Another, more extensive remnant of a mud-mortar floor was F568, followed by F570 on its northeastern edge. This last floor level was covered with a thick layer of tamped rubble and sun-dried-brick fragments, lumps of *qurba* and traces of organic matter (300) probably originating

from the destruction of nearby buildings. After their collapse, layer 300 served as a temporary walking surface, attesting to the long-lived usage of the space even after the collapse of some of the buildings flanking it.

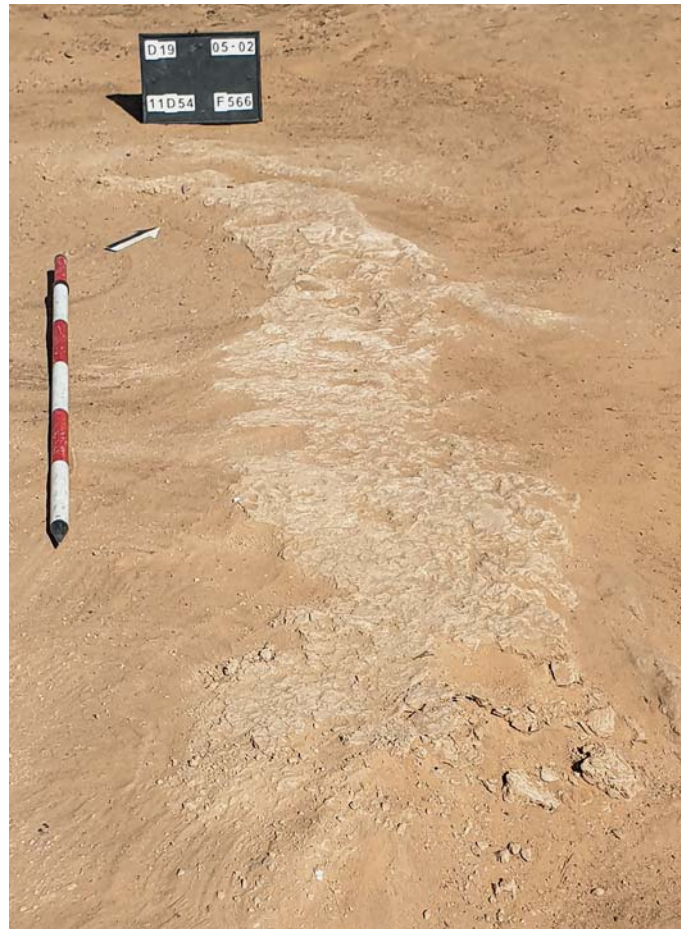
Fig. 22. Courtyard U56, floor level F566, view looking northwest

In the inner part of the courtyard, to the southwest, there were two distinct floors of mud mortar with traces of yellow *qurba*, F566 and F569 [Figs 22–23]. Because of their irregular surface and lack of whitewashing, those floors corresponded well to the idea that this space was an open area serving as a courtyard linking streets U24 and U62 with the houses further to the southwest.

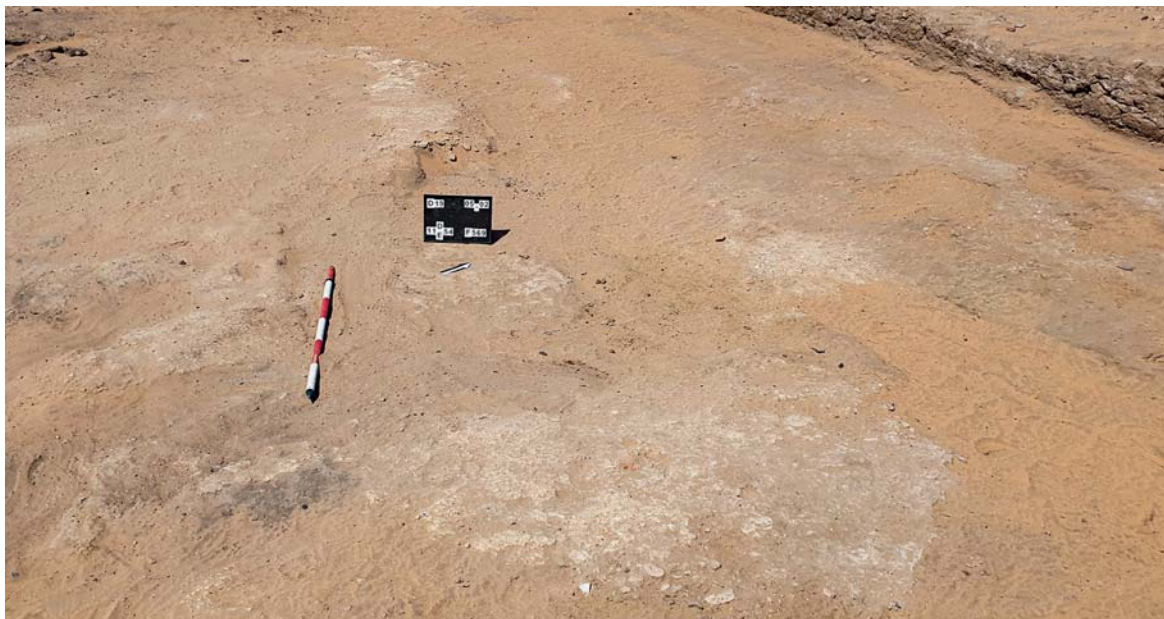
Fig. 23. Courtyard U56, floor level F569, view looking northwest

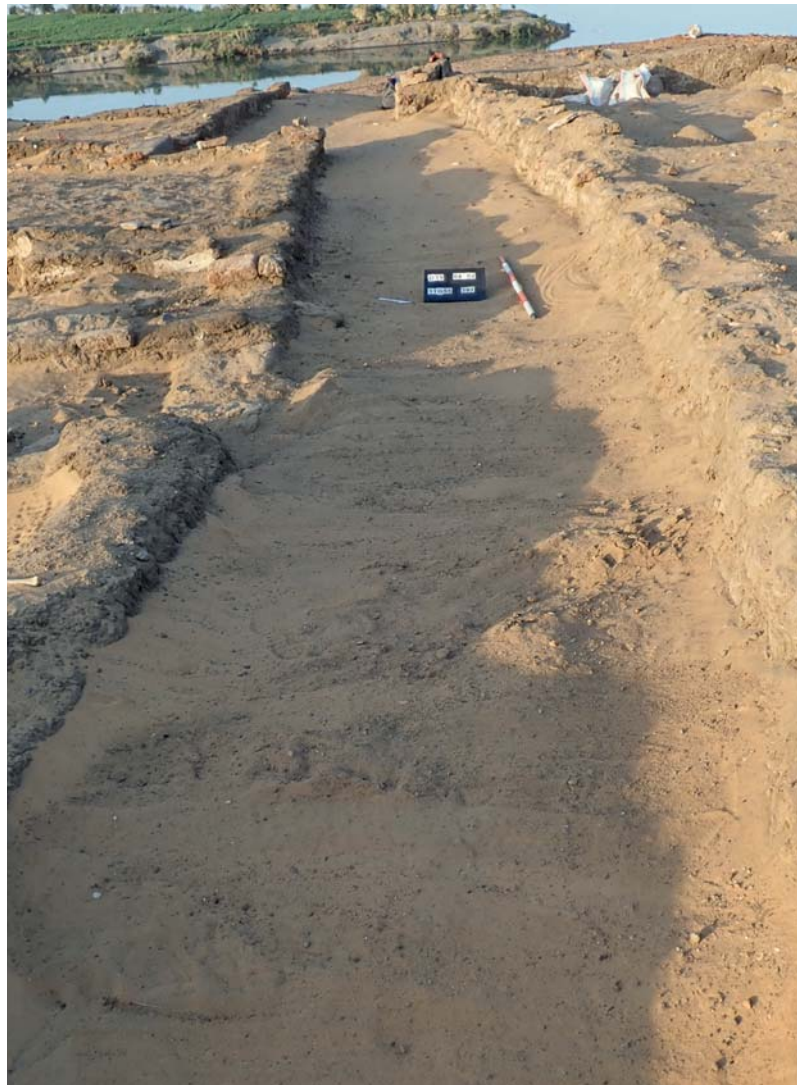
Fig. 24. Street U49, view looking southwest

The southeast area of the city is concentrated along street U49 [Fig. 24]. The street runs north-east–southwest and turns toward the south in the west. It measures 1.46–2.01 m in width. According to the magnetic map, it did not continue toward the east but at its eastern end it stopped at street U62, which also determined the eastern boundary of the excavated zone. The street gave access to several compounds: U43/46/51, U44/45/48/55/59/60/71, U57/70, and U102 (see below, zones 1.3 and 1.4). Originally the entrance to U50 was also from this street.

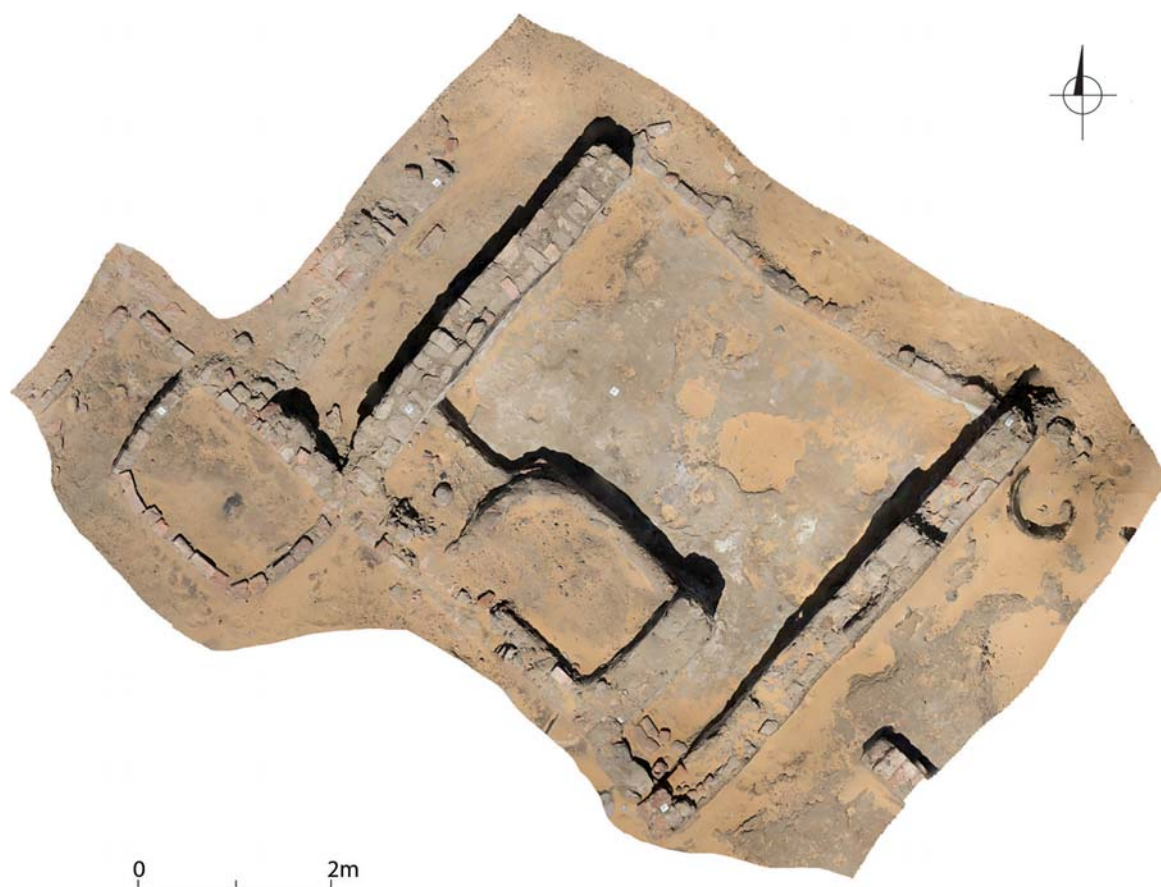
Fig. 27. Building U58a/58b, aerial view

The dwelling has the common form of a square building divided into two unequal parts, U58a and U58b, by partition wall F655 [*Figs 27–28*]. Such a layout is well attested at Old Dongola (Godlewski 2015a; 2015b; 2018), as well as at other sites in the Middle Nile Valley, like Attiri (Adams 1987: 335–336; Osman and Edwards 2012: 192), Gergetti (Vila 1977a: 32–37) and Keyendi (Vila 1978: 81–85). The northwestern part, U58b, is much smaller than the southeastern, U58a. The entrance to the building, located in the southwestern wall of U58a, is screened off by stub wall F651. The main room is equipped with three benches, two of which abut one another and are located behind the stub wall. The third is located opposite the entrance. The building is delimited from the northeast by a negative of a wall (F835) that abutted city wall F79, and from the southeast, southwest and northwest by mud-plastered and whitewashed mud-brick walls F102, F654 and F816 (removed in the northeastern part, leaving the negative F844).

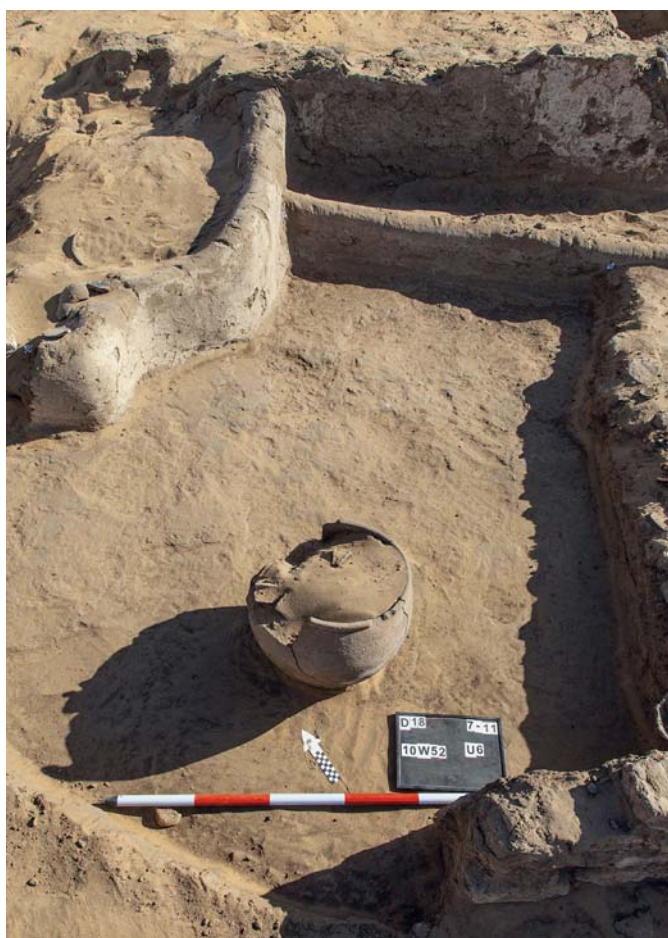
Fig. 31. Central part of room U6, view looking north

U6 was a square, one-room building with a mud floor [Fig. 31]. Of the surrounding walls, three out of four were dismantled. From the northeast, the room was delimited by plastered sun-dried-brick wall F80, from the southeast by a negative of a wall extant only in the northeastern part (F454), and from the northwest by a negative of a wall (F492), which remains only in the southwestern part (F841). The southwestern wall of U6 was also dismantled. The room was furnished with three contiguous benches located in its northern part. One (F84) was equipped with an abutting stove. In the southern part, there were two more benches, F81/F82 and F92/F86. The entrance to the room could not be identified due to the dismantlement of the outer walls, but its only possible location is in the western part of the southwestern wall. The building was associated with courtyard U73 located to the southwest, where its contemporary level was floor F88. The features are preserved to a height of 80 cm.

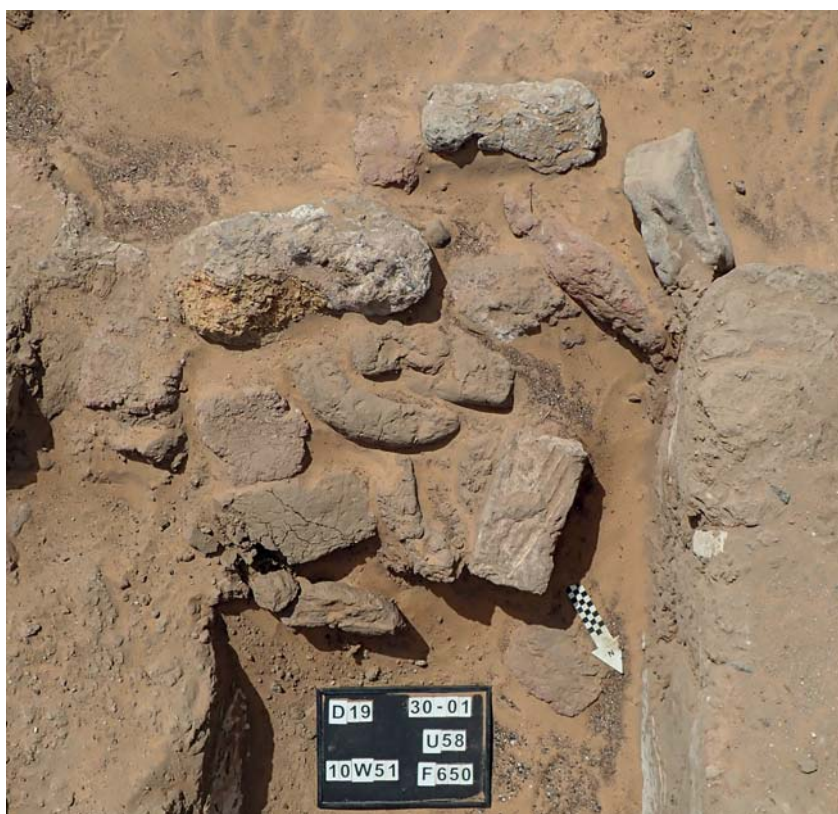
Fig. 32. Threshold F650 in room U58a

The second phase of use of building U58a/58b (periods III.B and III.A) is connected with the accumulation of fill layer 462 in U58b and of layer 460 in U58a (equal to floor F811). In courtyard U73, occupational layer 456 accumulated at this time. As a result of the rise of the occupational level, a carelessly laid threshold (F650) formed of fragments of sun-dried and fired bricks, stones and broken containers of sun-dried clay was added at the entrance to U58a [*Fig. 32*].

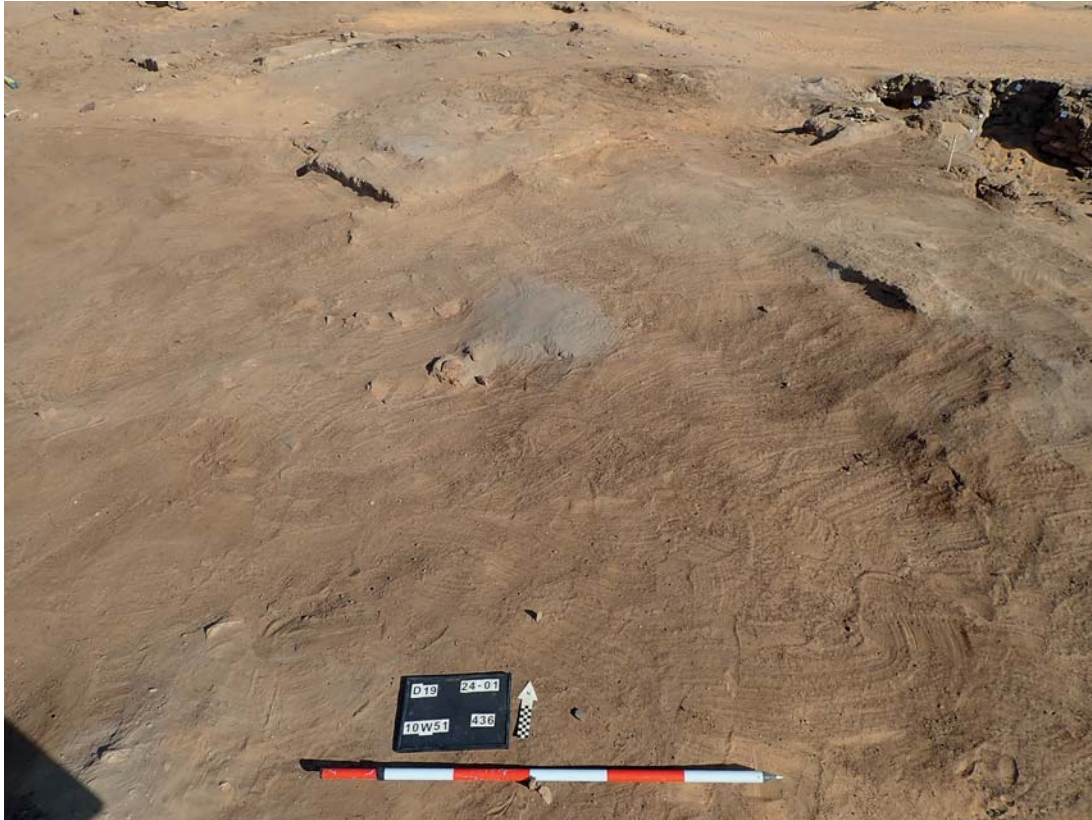
Fig. 33. Accumulation of animal dung (layer 436) in room U8

Following abandonment at the end of period III.A, the building fell into ruin, as attested by deposit 446 from the collapsed roof and by rubble layers 444 and 451 associated with the walls. At the same time, the roof of room U8 collapsed (layer 131). Subsequently, the area of rooms U58a and U58b filled with windblown sand (441) and livestock was kept within the compound, as indicated by concentrations of animal dung (440). In addition, fire-burning took place in U58a (439). It was most probably in this phase that parts of the outer walls were removed (pits F835, F844). In courtyard U73, a layer of animal dung (442) accumulated, and several fire-spots appeared. After abandonment of room U8, the space filled with windblown sand (128) and layers of animal dung (119, 436, 437) accumulated on its surface [*Fig. 33*].

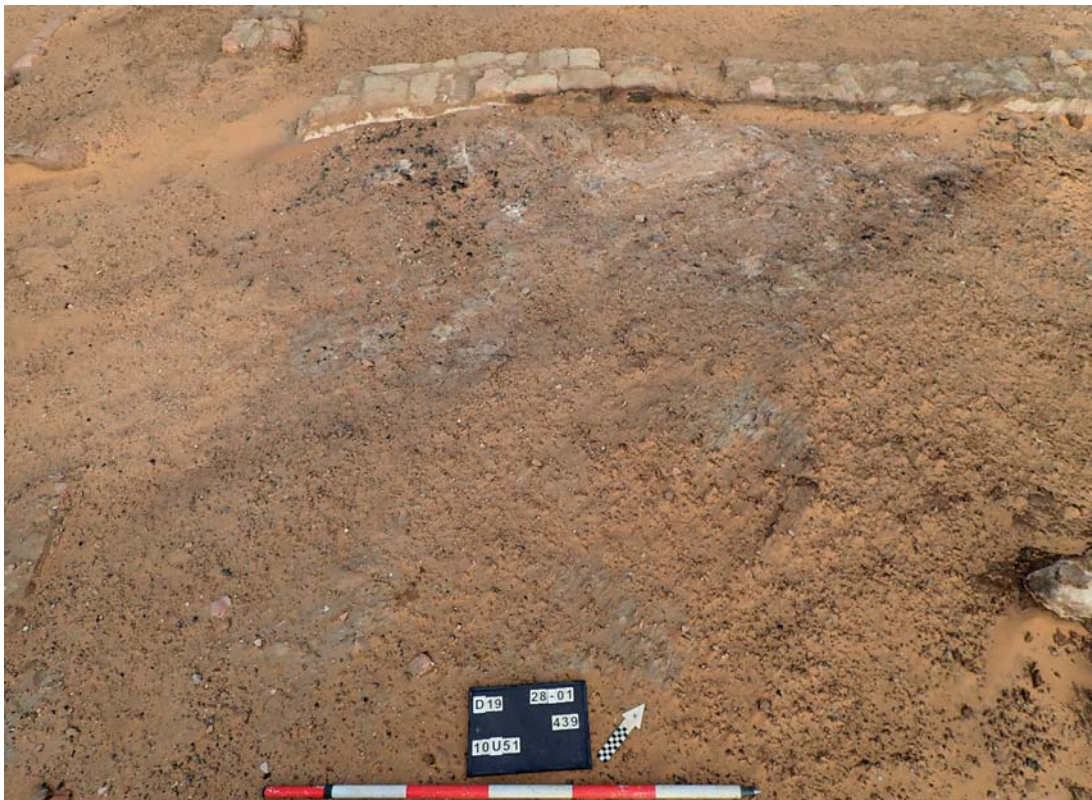
Fig. 34. Ash layer 439 in room U58a

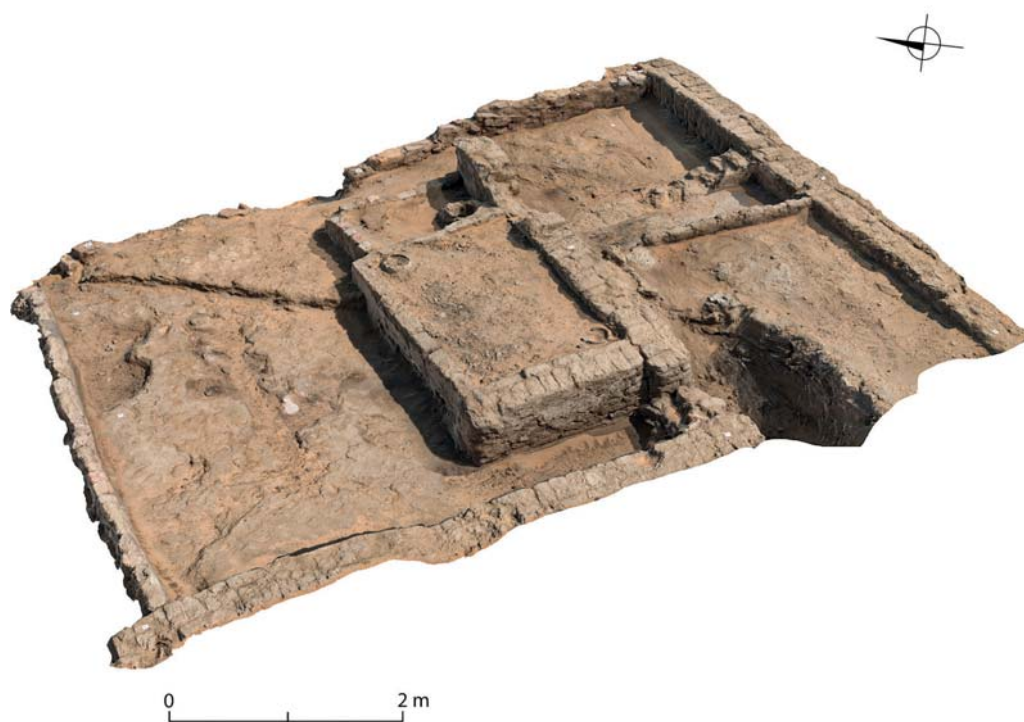
Fig. 36. Building U5/25/72, aerial view looking east

The layout of house U5/25/72 does not differ significantly from other houses in the area under investigation. It was a rectangular building made of sun-dried bricks laid in alternating courses of headers and stretchers, built to abut earlier structures. It was entered from a large, open courtyard shared by several buildings, and it comprised three spaces: semi-open vestibule U72, large, rectangular, multifunctional space U5, and a small, square space most probably used as a kitchen. U5, furnished with three benches of different sizes, must have been the main living space and the place where most of the daily activities were performed. While the smaller benches (F42 and F219) were connected primarily with food processing and storage, the main bench (F48), shielded from the entrance by a stub wall, might have been used for sleeping, as well as for food preparation. The storage function of the space is indicated by the occurrence of a large amount of sorghum grains and spikelets, as well as by the dung of rodents in botanical samples collected from the occupational layer above the floor. Vestibule U72, equipped with a large bench with an abutting stove, also seems to have been multifunctional, whereas U25 may have been used as a kitchen. This is indicated by traces of burning and soot on the walls and a massive accumulation

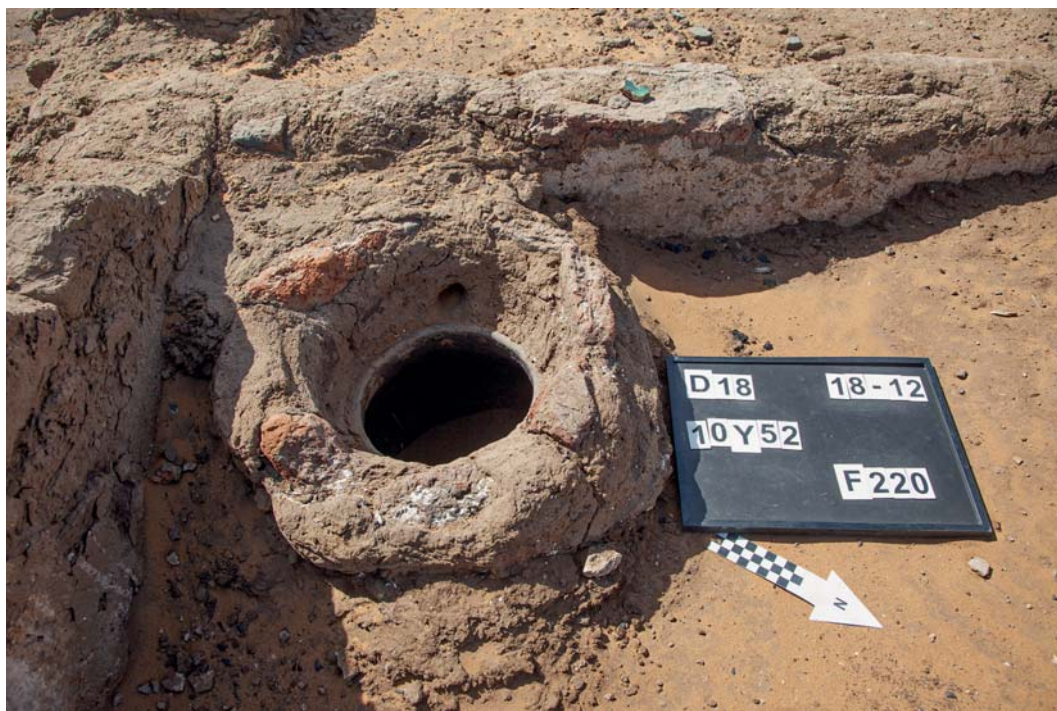
Fig. 37. Pot F220 embedded in bench F219

the first one on the northeast. Its facing was made of fired-brick fragments and the fill was a loose deposit with no trace of surface coating. In the southern corner, a pot (F220) was embedded [Figs 37, 38]. The entire handmade spherical vessel (maximum diameter and height 45 cm) was sunk in the upper surface of the bench. Above its rim was an additional raised edge made of fired-brick fragments covered with smoothed mud mortar. On the inner surface of this feature there are two rounded depressions (diameter 4 cm) located on opposite sides, indicating the existence of an additional, now-lost element. The interior of the pot is covered with soot. Both benches were most probably connected with food processing.

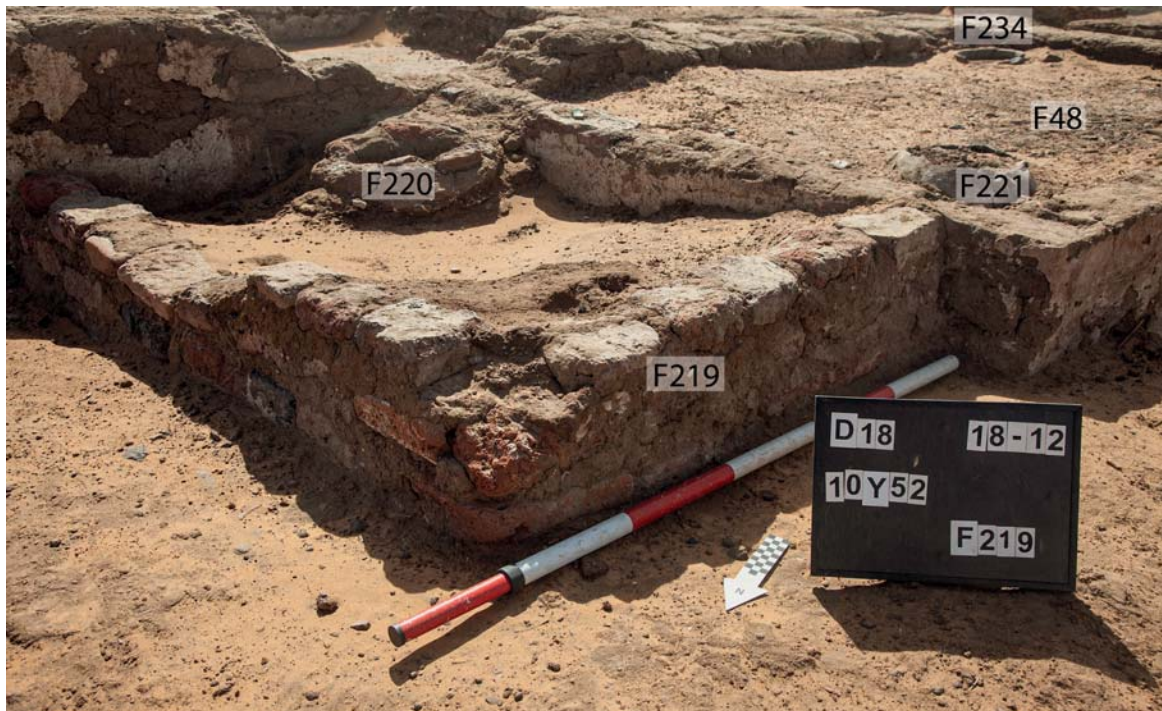
Fig. 38. Benches in room U5
