# **OLD DONGOLA**

## **DEVELOPMENT, HERITAGE, ARCHAEOLOGY**

FIELDWORK IN 2018–2019. VOL. 1. EXCAVATIONS

EDITED BY Artur Obłuski and Dorota Dzierzbicka

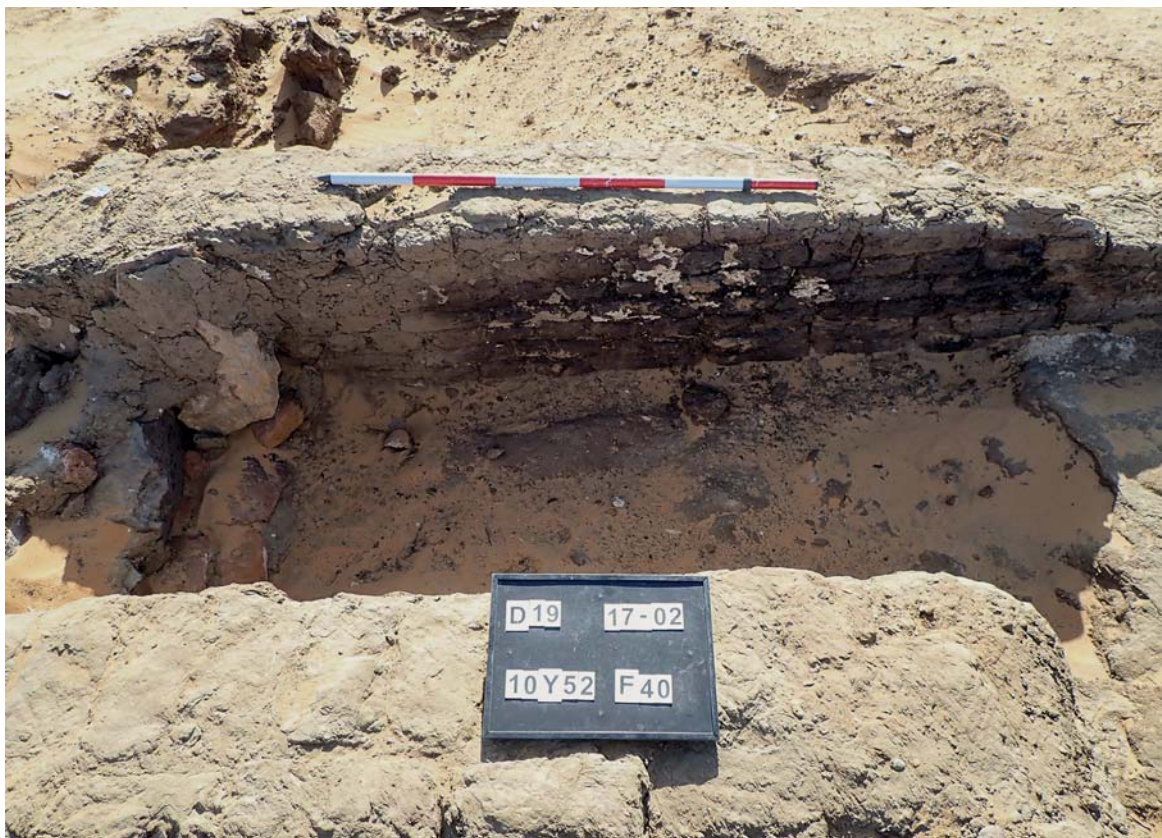
Fig. 39. Traces of burning on the eastern face of wall F40 in room U5

All walls bear traces of the same layer of plaster, 0.6–1.00 cm thick, consisting of a layer of mud covered with desert-clay mortar and whitewashed. On the eastern face of wall F40, in its southern part, below the plaster, there are traces of burning (140 cm long), covering the whole visible height of the wall [Fig. 39]. Since they are not preserved on any other surface in the unit, they must be connected with an earlier occupational phase that has not been reached yet.

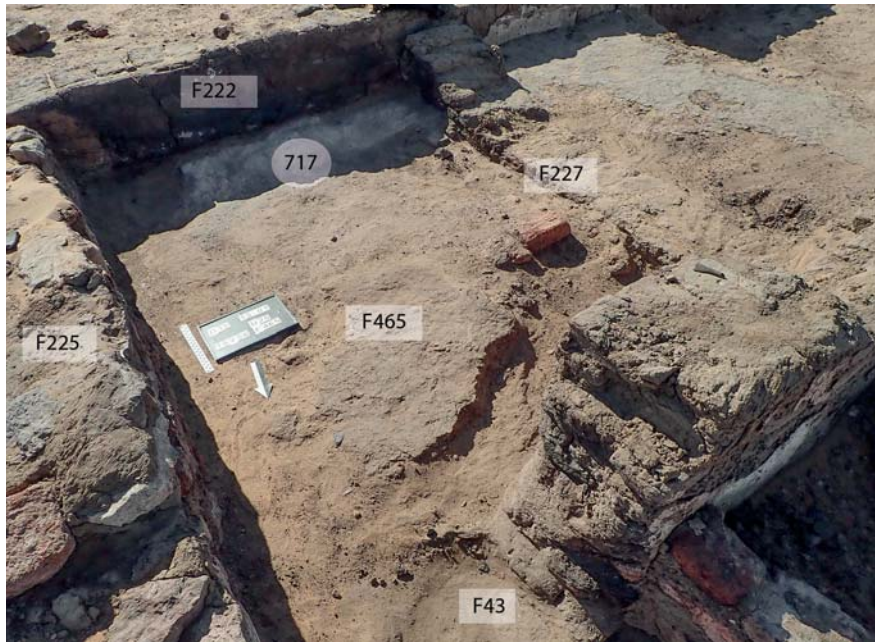
Fig. 40. Space U25, view from the entrance in the northwestern corner

The entrance from U5 led to a much smaller, rectangular space (U25), delimited by walls F43 in the northwest, F225 in the northeast, F222 in the southeast, and F227 in the southwest [Fig. 40]. The latter wall was dismantled in its northwestern part. The unit measured about 2.35 m by 1.80 m. The upper part was filled with rubble (layer 687, lower elevation 20.80 m) overlying a thick and compact layer of organic matter (715) and ashes (217) accumulated in the southern part, along

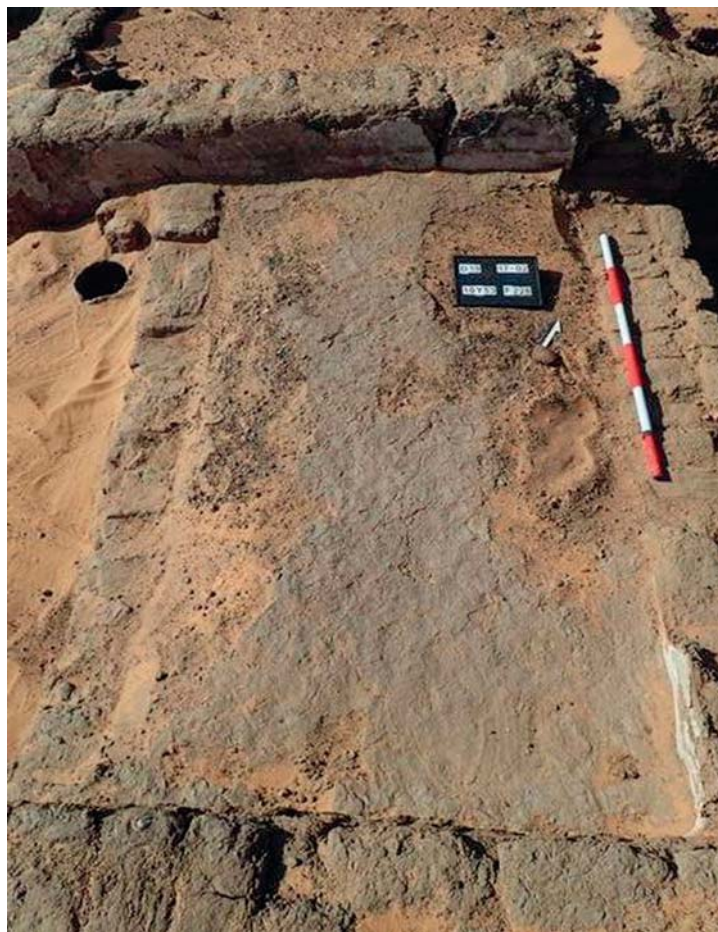
Fig. 41. Bench F228 in vestibule U72

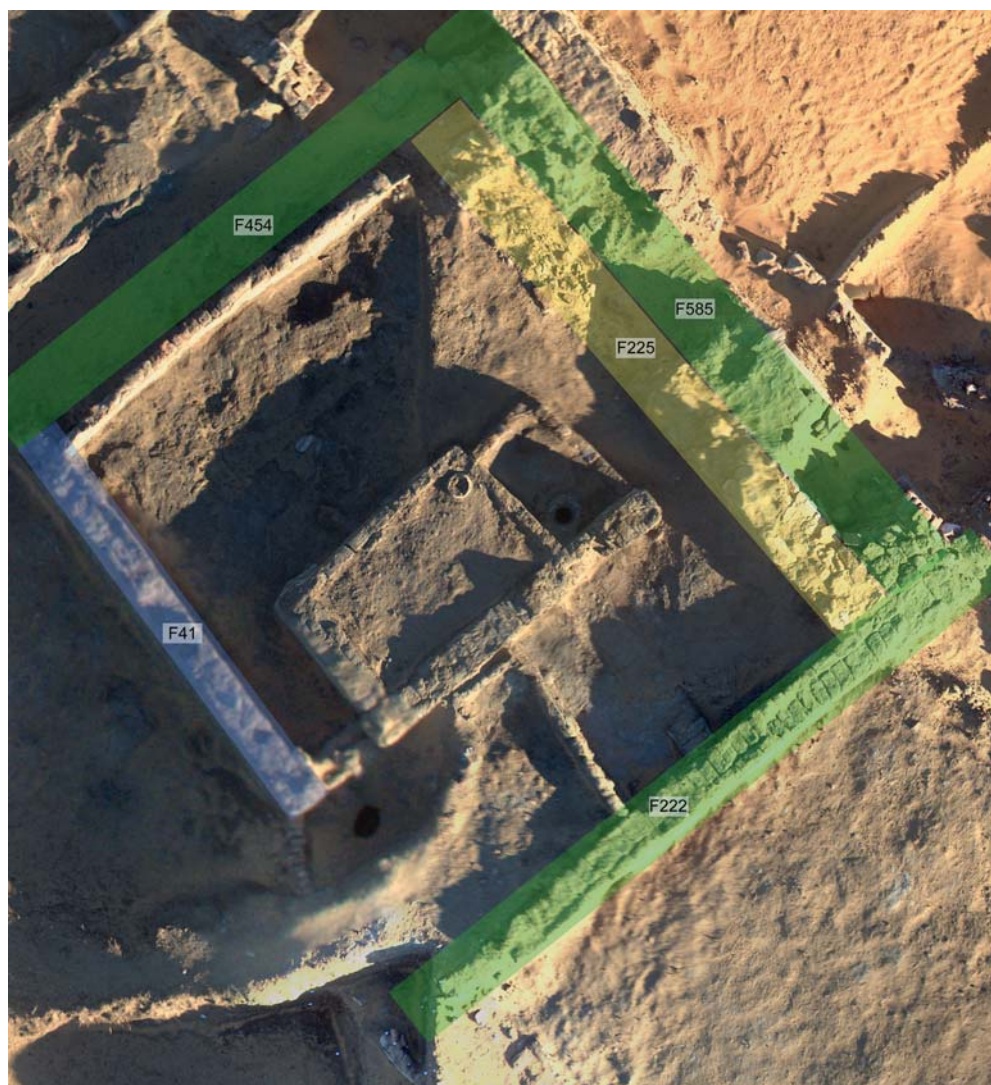
Fig. 42. Building U5/25/72 and phasing of walls marked in color

In the development of building U5/25/72 several phases can be distinguished, but only two of them have been examined so far. Walls F454, F585 and F222 delimiting the house from the northwest, northeast and southeast, respectively, surely belonged to an earlier building, and a new house was added to them. Determining the exact sequences of those walls is difficult, since their foundation levels have not been reached. Furthermore, F454 was dismantled by looters following abandonment in period II, and only a negative filled with windblown sand remains. From the southwest, the house was delimited by wall F40, which belonged to the original phase (period III.D) [Fig. 42]. A subsequent addition in period III.B was a wall of stone (F225, foundation level 20.30 m) built along the inner face of the city wall. A similar sequence of remodeling of the curtain wall can be observed in square 11A56 (see above, Fig. 18).

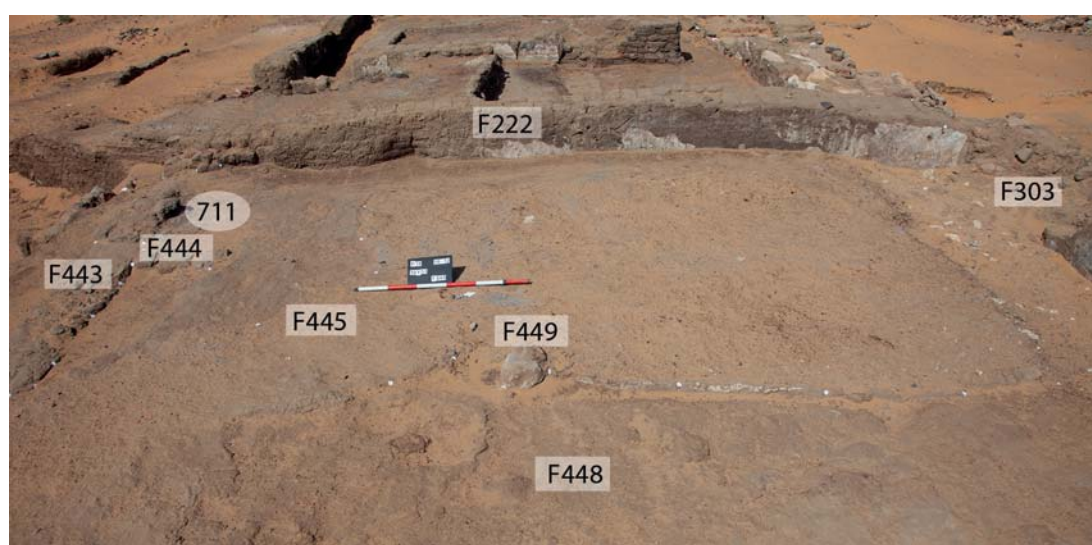
Fig. 46. Space U74, view looking northwest with indicated feature numbers

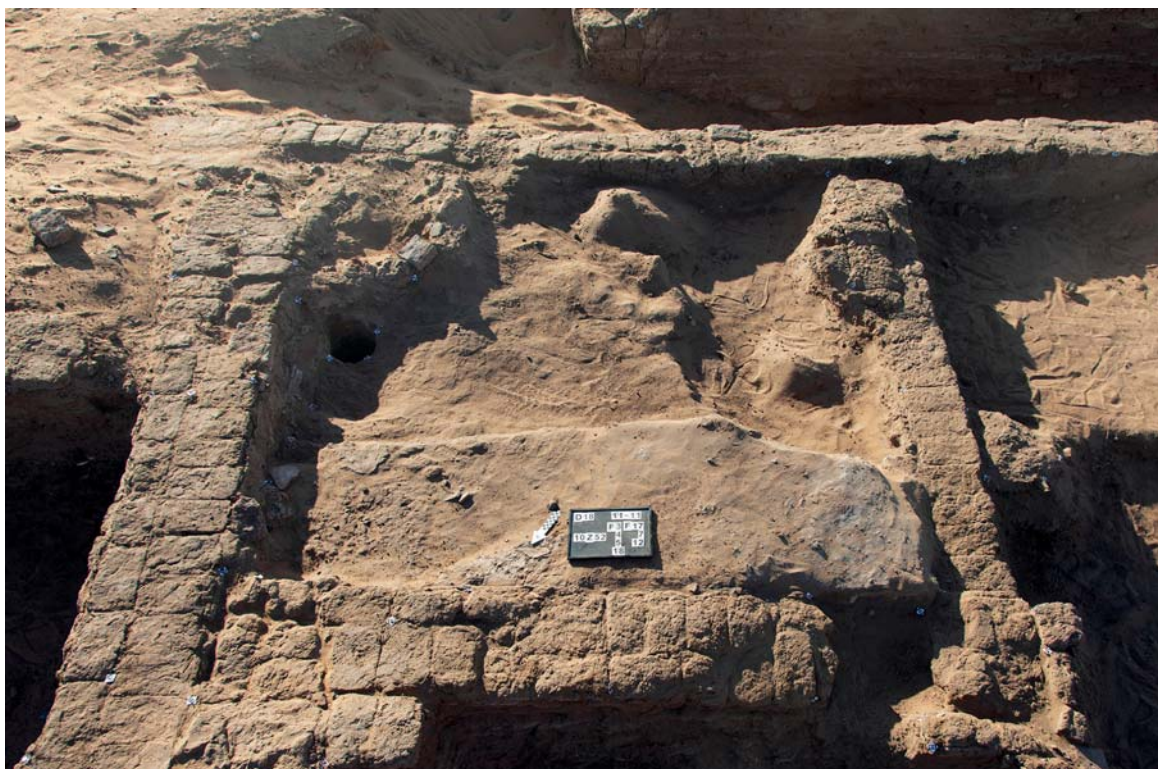
Fig. 47. Room U7

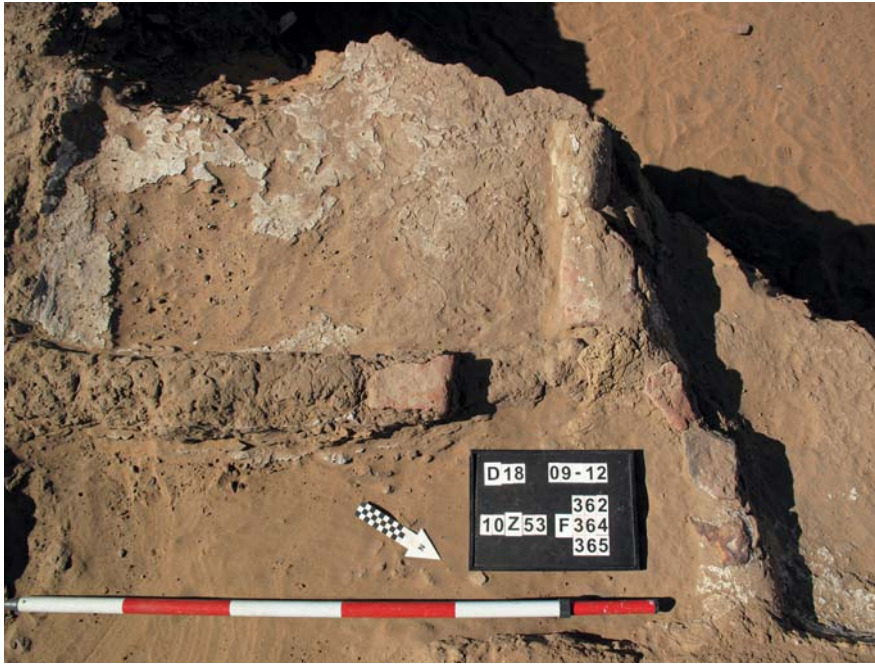
Fig. 48. Relics of benches F362, F364 and F365 in building U76/77

preserved part of U77, a set of typical benches and a floor coated with *gir* were exposed (F361, F362, F364, F365, F366) [Fig. 48]. The building seems to have a typical layout comprising a larger room furnished with benches and a narrow storeroom in the rear part.

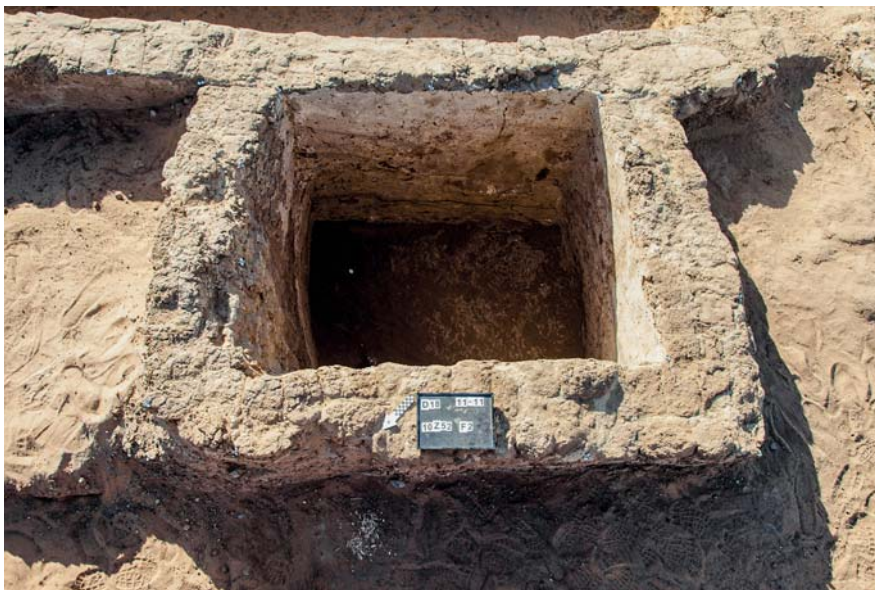
Fig. 49. Silo U3, view looking southeast

At an undetermined date (most likely also in period II), a silo (U3) measuring 1.5 m by 1.7 m and over 1.5 m deep was dug into the deposits against the southwest–northeast-oriented wall (F118) [Fig. 49].

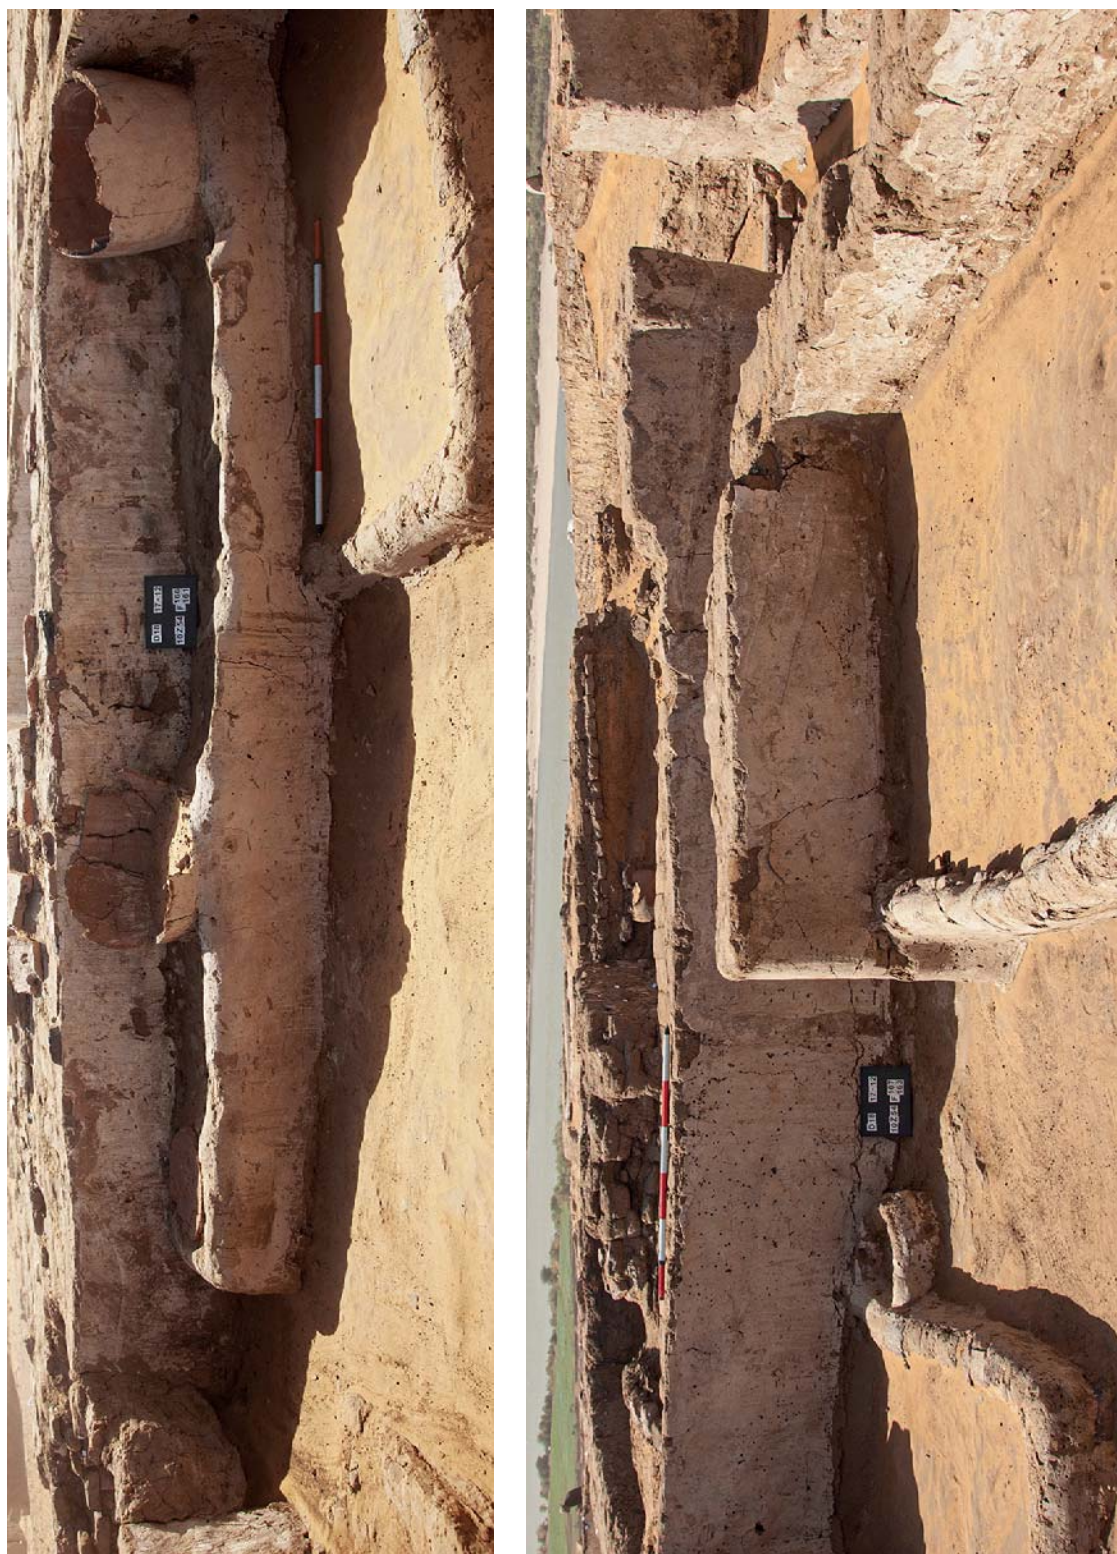
Fig. 53A–B. Room U16, views looking southeast (top) and southwest (bottom)

Building U16/30/35 [Figs 52–53A–B], measuring 8.9 m by 8 m, used the outer wall of the settlement (F108, F187, F524, F357 and F528) as its rear wall. Based on pottery finds, occupation of this compound may be dated from period III.C into II.C at least. It was entered from the west (from courtyard U18) through a 70 cm wide door, which opened into an elongated room, U30 (2.3–2.8 m by 7.10 m), originally equipped with two benches, F379 to the left of the entrance (1.4 m by 2.6 m) and F385 at the northeastern end of the room (2.35 m by 1.35 m) [Figs 54–55].

From room U30 one entered U16, the main room of the house, by passing through a door in the southern corner of U30, followed by a short corridor (2.40 m by 0.85 m). The relatively small area of the room (5.30 m by 5.60 m) was almost completely filled with five benches (F181, F166, F179, F355 and F356), which were certainly not contemporaneous with one another. The two oldest benches were, as it seems, located against the southeastern wall of the room and in its northern corner. The bench against the southeastern wall (F166) measured 0.75–0.9 m by 4.95 m. It served as a stand for seven large storage vessels, which were integral parts of the structure [Fig. 56].

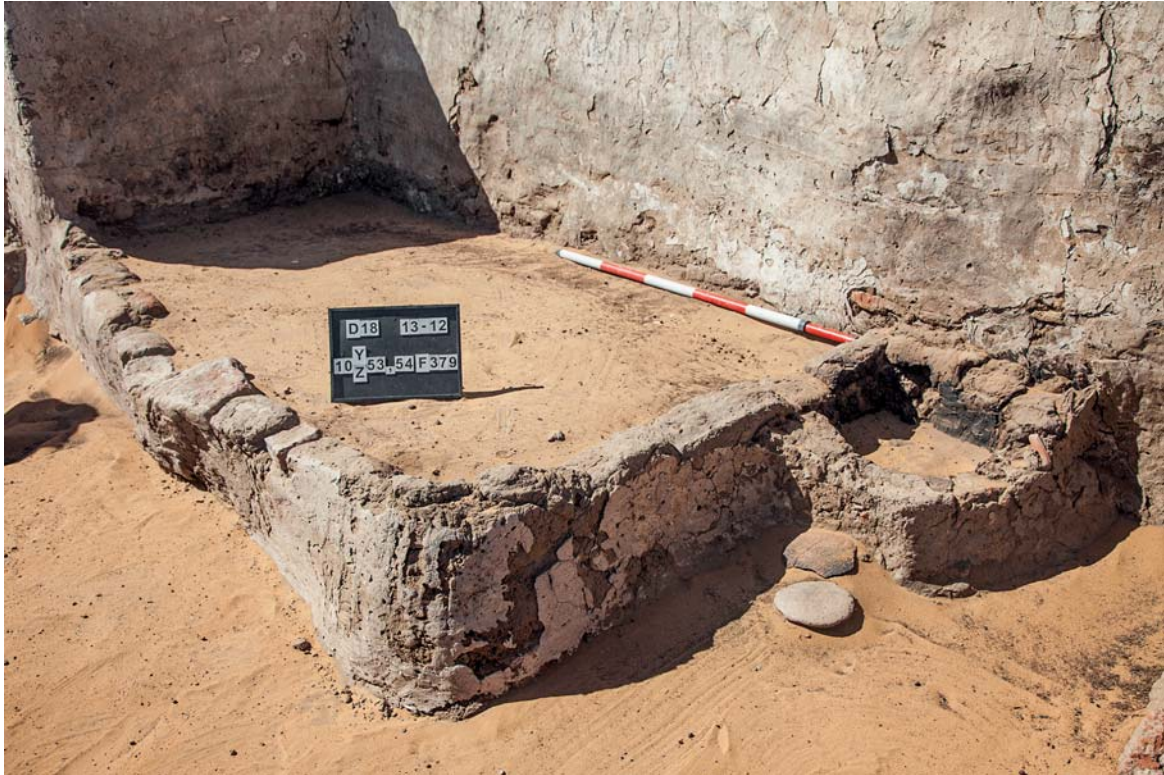
Fig. 54. Room U30, bench F379, view looking west

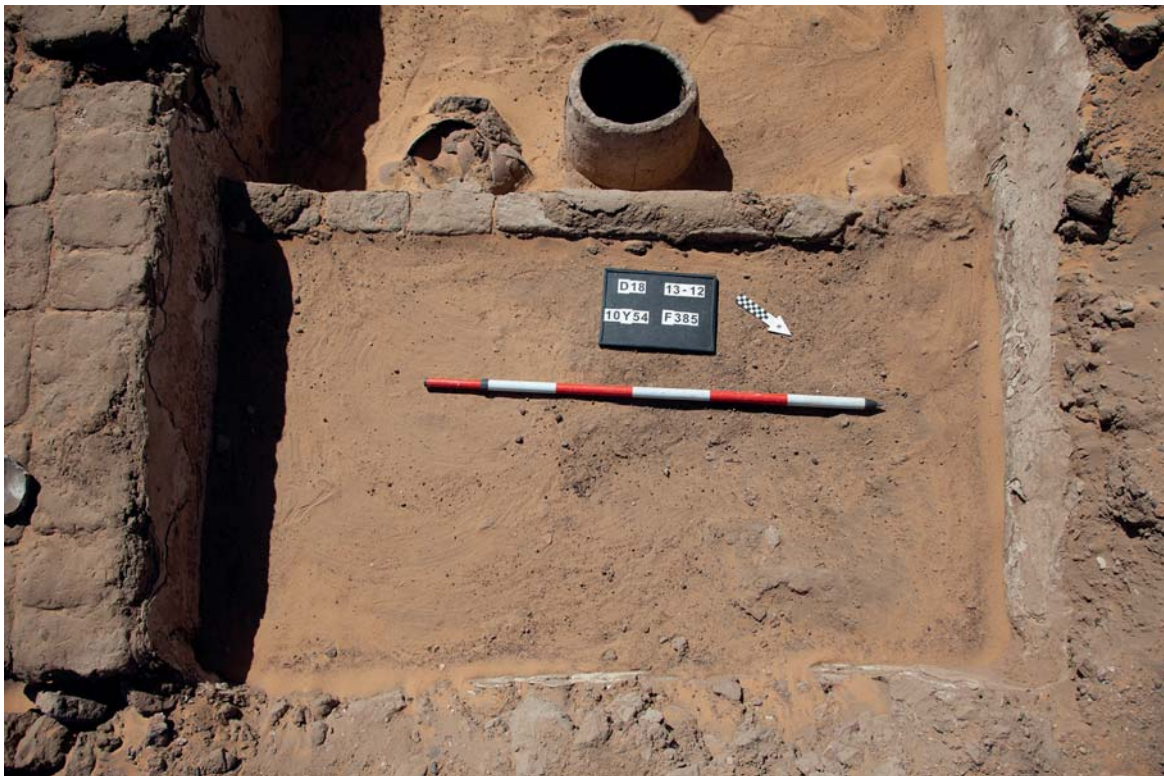
Fig. 55. Room U30, bench F385 aerial view

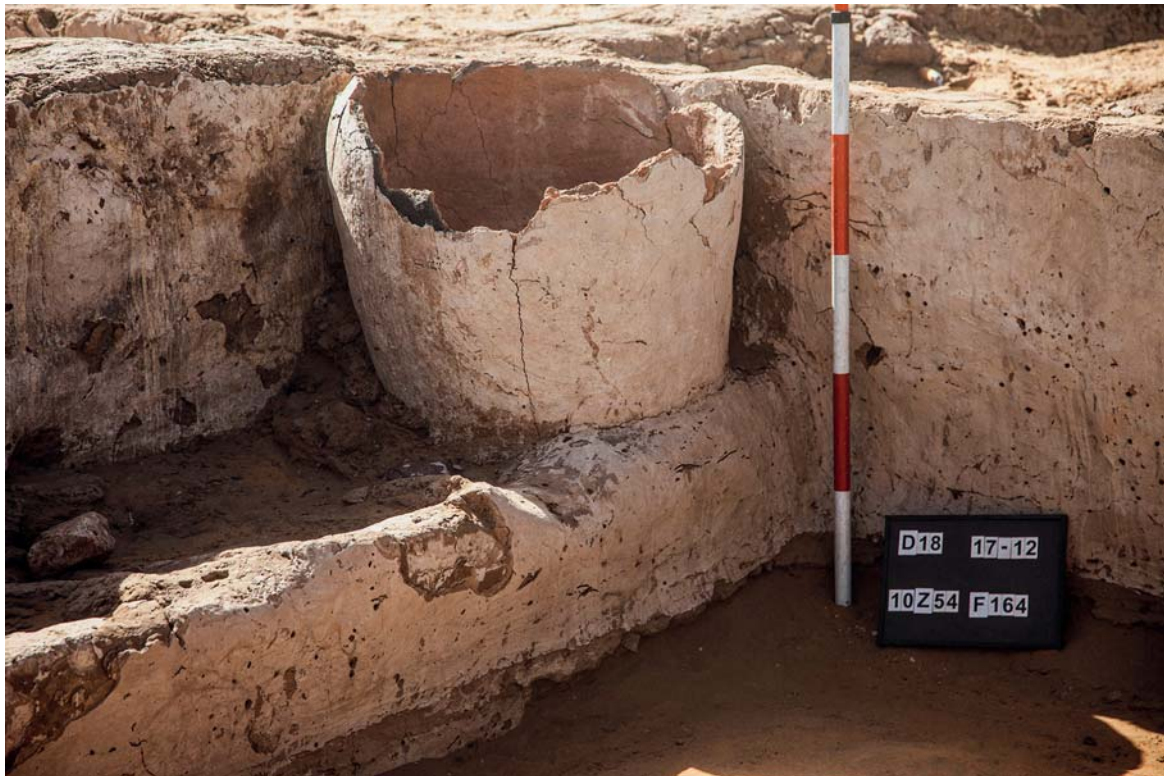
Fig. 56. Vessel F164 on bench F166 in room U16

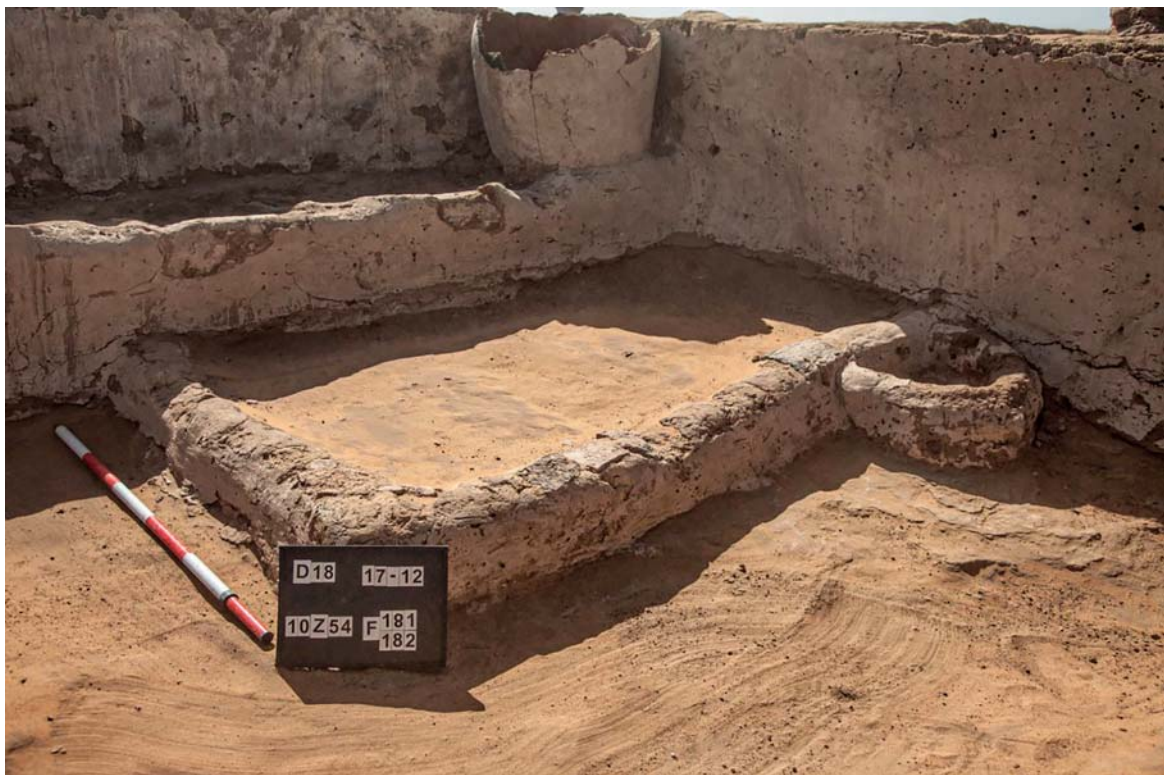
Fig. 57. Room U16, bench F181 with stove F182

the room (F181). This one, as with the benches in the elongated room, U30, was equipped with a small abutting stove (F182) [Fig. 57]. The last bench, F356 (3 m by 0.75 m), was added along the northeastern wall of the room just after the last plastering (F354) of the whole interior (phase U16.3). In the eastern corner of the room there was a passage (with no threshold) to the rear room of the house (U35), which was long and narrow (6 m by 1.9 m).

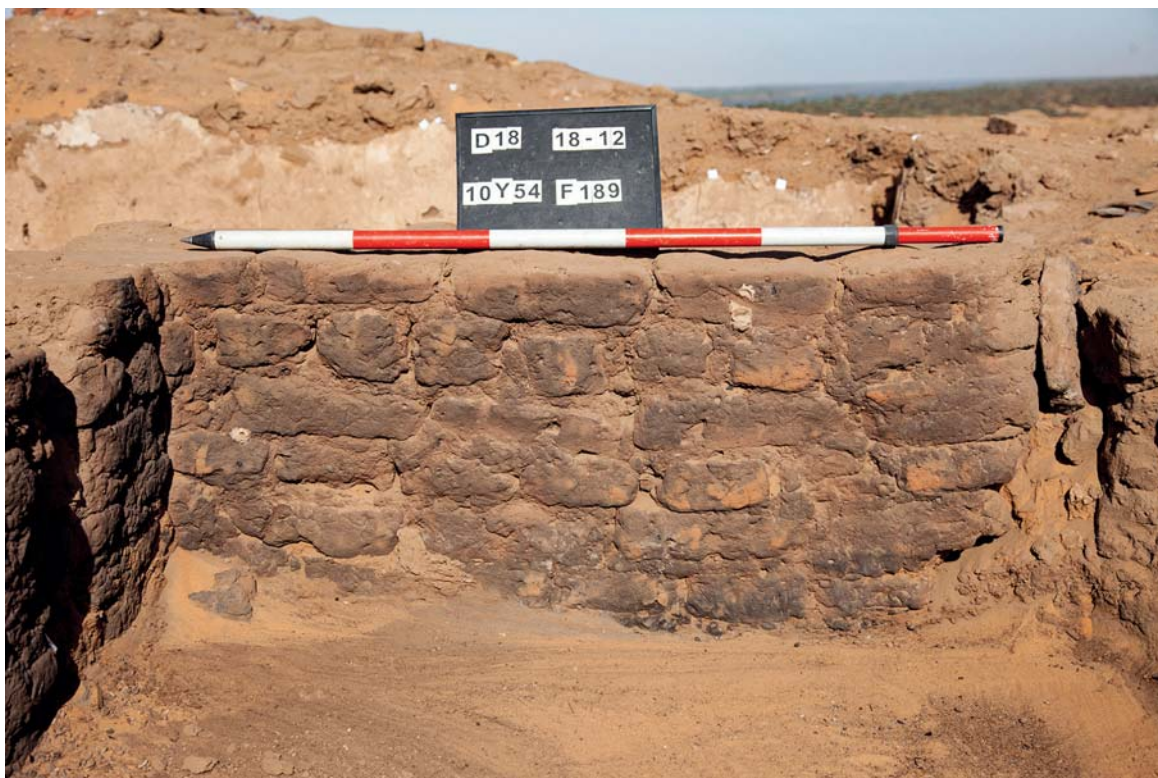
Fig. 58. Burnt southern face of wall F189 in room U35

In the original occupational phase (from period III to early period II, phases U16.4, U17.2, U30.3, U35.4), the dwelling featured numerous benches clustered in a relatively confined area. The house was gradually abandoned. After a fire, which burned all wall faces [Fig. 58], as well as the floor of the room at the rear of the house (U35), the entrance leading to it from the main room (U16) was blocked (F180) (phases U16.1, U35.2). The fact that the blocking wall was not built on the level of the original floor (F353, elevation 19.86 m), but on top of sand accumulated inside the room (deposit 27, elevation 20.04 m) may suggest that room U16 had already been deprived of a roof [Fig. 59]. Later on (still in phase U16.1), U16 also went out of use, and the entrance to it from the elongated room (U30) was blocked by heaps of sun-dried-brick rubble (context 199).

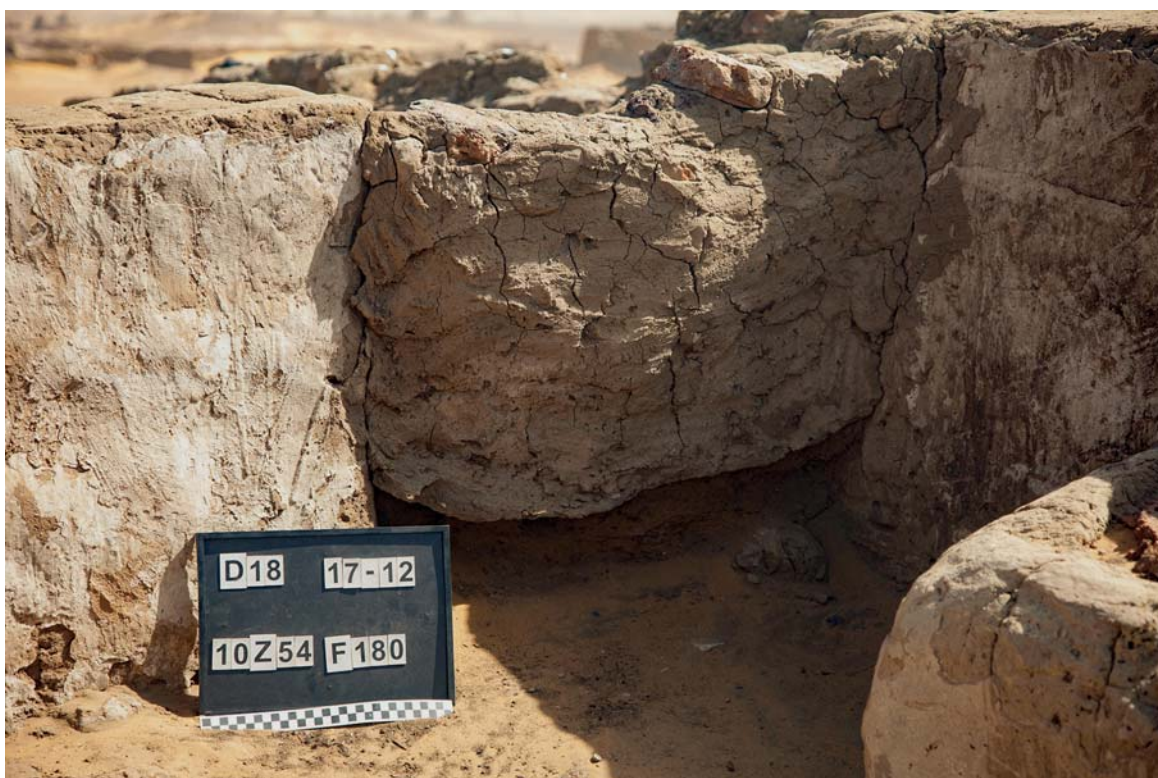
Fig. 59. Blocking wall in the doorway between rooms U16 and U35

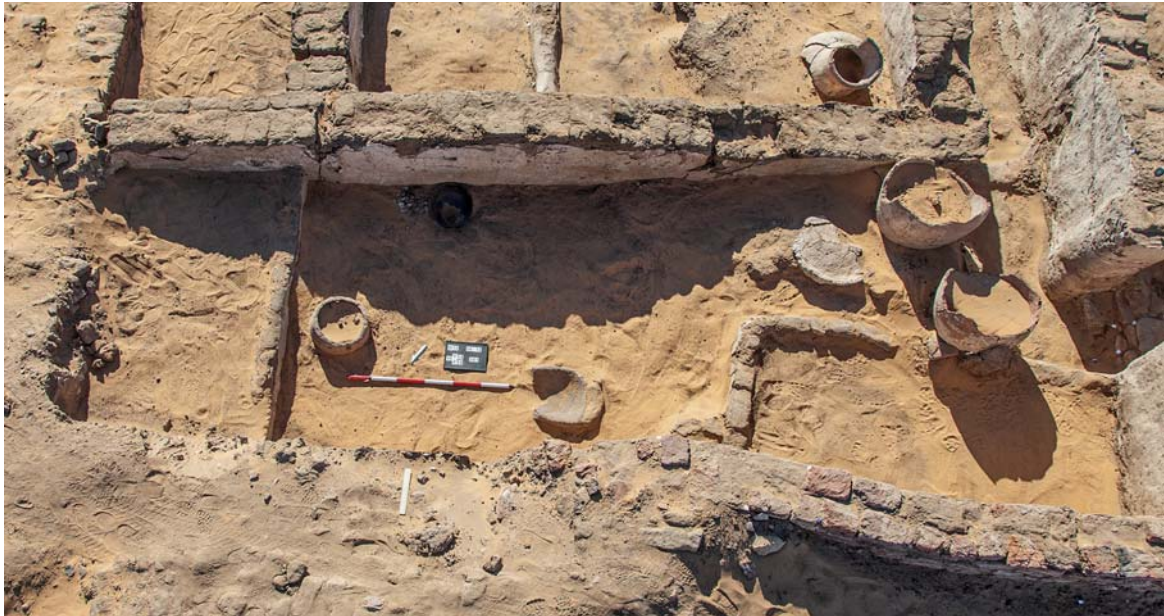
Fig. 62. U30 in the late phase of use, aerial view

U30, an elongated room to the northwest (previously part of building U16/30/35; see above), remained in use in period II, although the original floor was covered with a thick layer of blown-in sand (phase U30.2) [Figs 62–64]. Both benches still protruded above the sand, and to the eastern one a roughly made stove was added (F387). A find indicating the household function of this room was a quern (F384) with a ceramic bowl set directly on top of a layer of windblown sand that covered the floor after the room had been deprived of a roof [Fig. 65A–B]. The top of this sand deposit became the new walking level of this space.

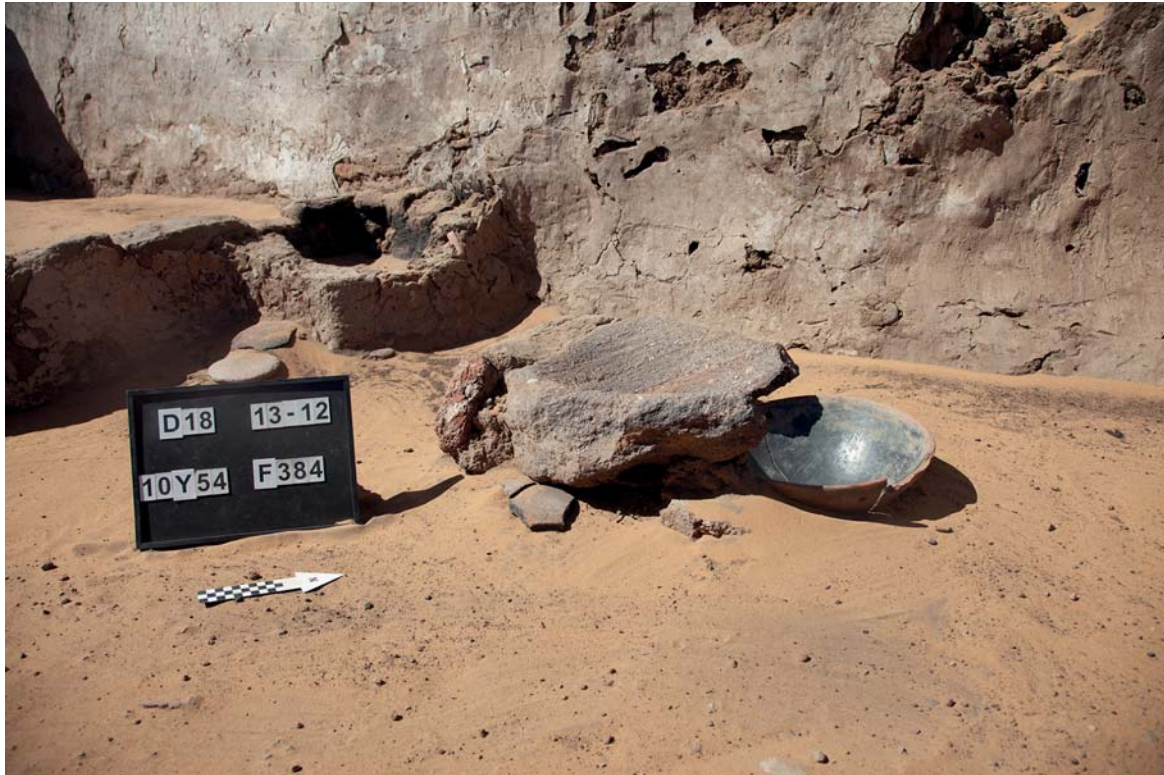
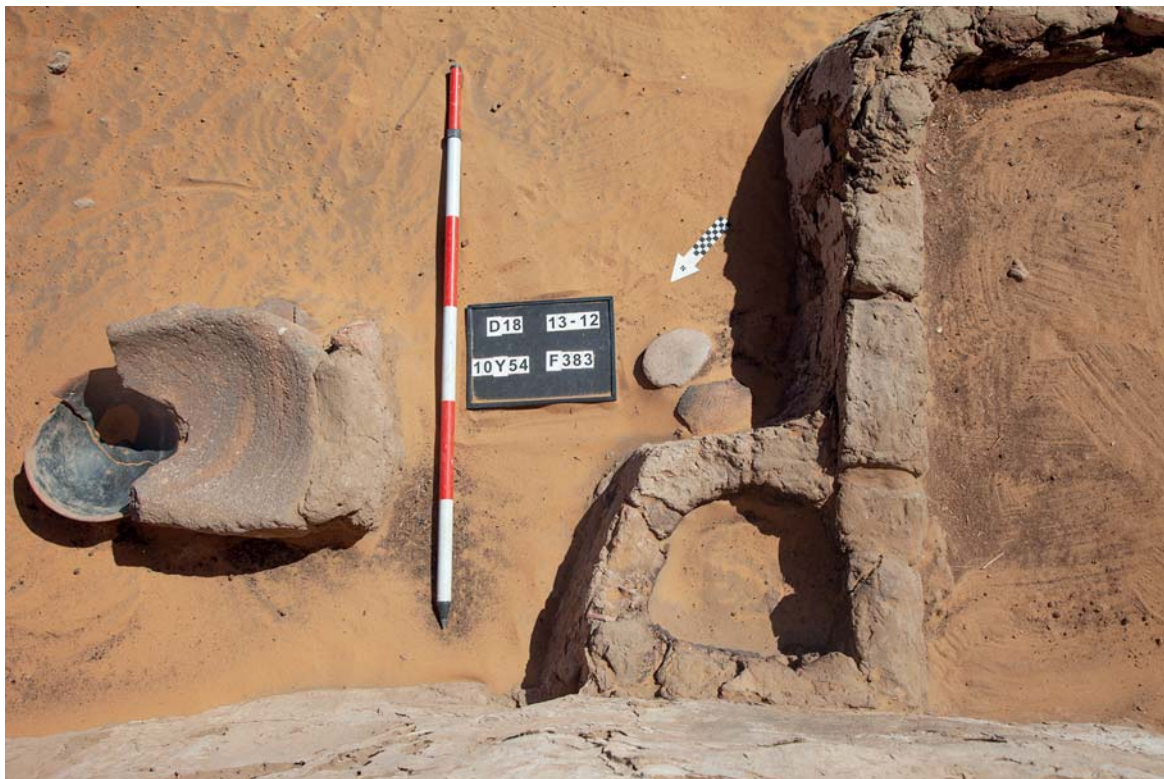
Fig. 65A–B. Quern F384 in context, view looking west (top) and aerial view (bottom)

After the features in the courtyard were established, the level of floor F326 gradually rose, with accumulation of several superimposed thin layers of mud abutting the bins and walls. Somewhat later than the other features, F114 was built on top of the floor [Fig. 92]. This structure can be interpreted as a quern emplacement with a fair degree of certainty despite the lack of a quern and bowl. In other excavated areas (e.g., U15 and U36) such mud bases with circular depressions also co-occur with concentrations of grains in botanical samples, storage vessels, and discarded grinding and pounding stones. A similar quern emplacement with a quern *in situ* is also preserved in U30, embedded in mud with an attached bowl [see Fig. 65].

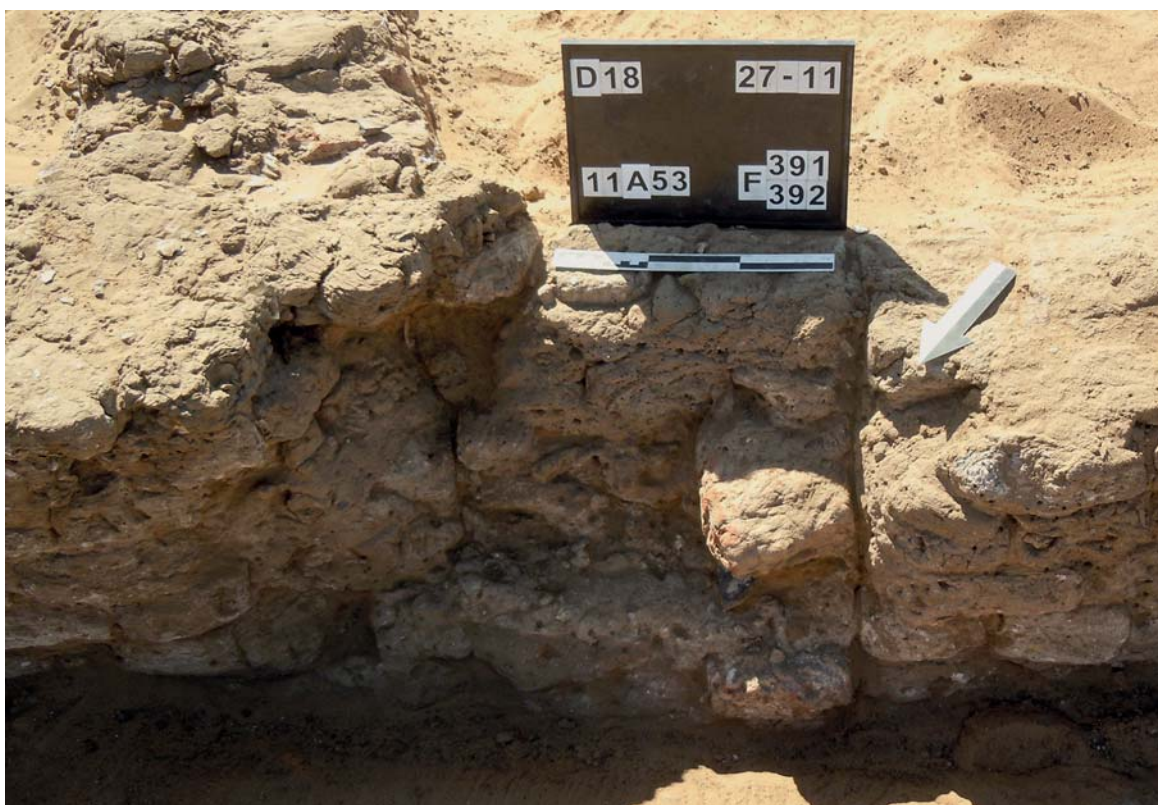
Fig. 69. Threshold and blocking wall F391 and F392

The courtyard was also accessed from a house located to the south (in square 11A53; see below and *Fig. 69*) through a doorway with threshold F391 (lower elevation 19.58 m), and probably from the northwest through an opening between walls F118 and F242, later closed with blocking wall F558. This passage, however, had already been blocked in the excavated phase of the courtyard; the lower elevation of this blocking wall was not reached during the excavation of the courtyard, where the lowest elevation of floor level F248 is at 19.72 m [*Fig. 51*].

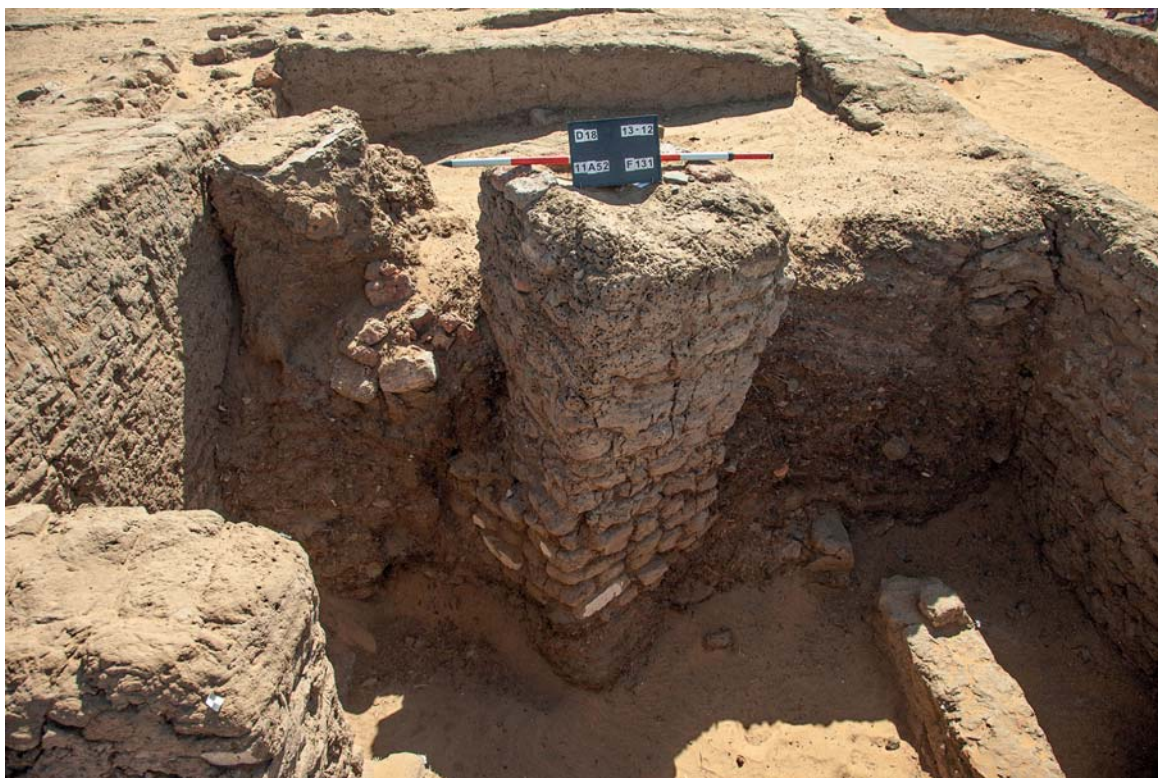
Fig. 73. Section cut across room U2 showing stratigraphy and successive additions to structure F131

The structure F131 was initially thought to be a pillar, but proved to be much too big and massive in relation to the dimensions of room U2 to be interpreted as a support for a roof. It also leaned heavily toward the west. Once completely freed from deposits 81 and 84, it partially collapsed, confirming that it was not self-standing and hence could never have supported the weight of a roof. The faces of F131 are rough and unplastered. The feature appears to have served as a sort of base or support. It was raised at least three times, each time with a slightly different orientation. Even

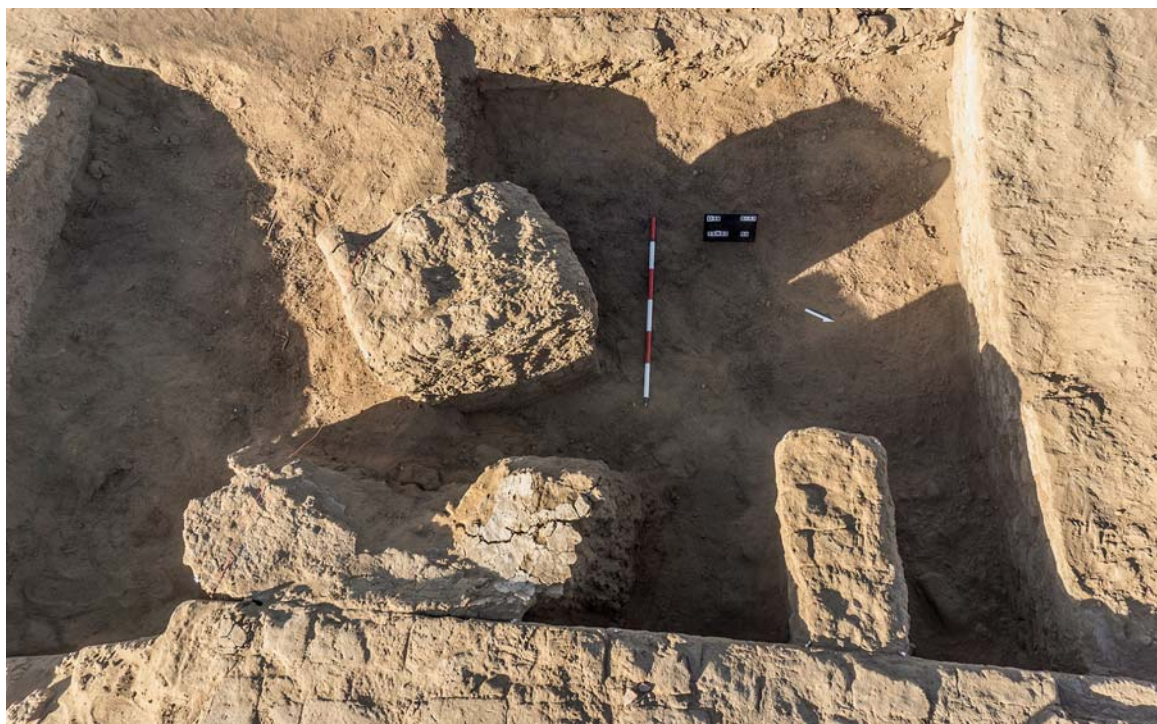
Fig. 74. Deposit 84 in room U2

Deposit 84 (elevation about 18.70 m), a sandy and organic layer with a small lens of burnt matter (83), seems to represent a hiatus in occupation, followed by a refurbishment of the space, marking a new occupational phase (U2.2, period IV–III.B) [Fig. 74]. It consisted in the construction of walls F944, F120 and F121, and in the raising of base F131. Wall F121 has a single foundation course of sun-dried bricks slightly protruding from its short side, standing directly on top of deposit 84. The original purpose of the wall has yet to be established. Sun-dried-brick wall F120 was built on top of the old fired-brick wall F148. Its first course also starts approximately at the level of the upper surface of deposit 84. Sun-dried-brick wall F944, in turn, was built partially on top of the older wall F123 of the same material. The imperfect alignment of the two walls left a sort of ledge on the external side, while inside the unit the new wall partially rested on the fill (84). This occupational phase of U2 was again followed by substantial accumulation of refuse (period III.C–III.B) consisting primarily of sand mixed with animal dung and organic particles (81), indicating that its function remained unchanged. Lastly, in phase U2.1 during period III.A–II.C, the later floor levels were laid on a thick sand layer (299).

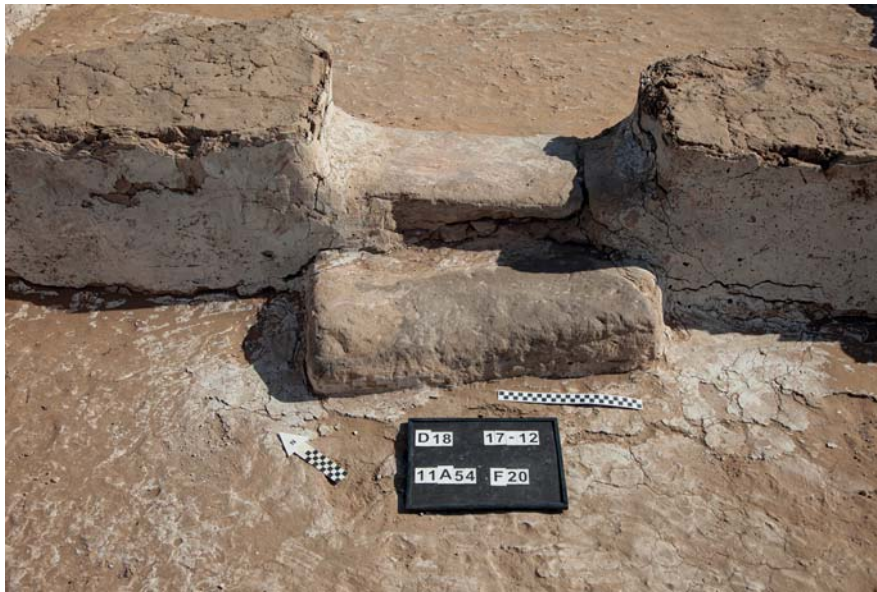
Fig. 77. Threshold F20

of the entrance to facilitate access (F20) [Fig. 77]. The main entrance was placed in the middle of the southwestern wall of room U13. The room, which measured 3.10 m by 2.65–2.75 m, lacked furnishings. Two doorways, both with relatively high thresholds (F35 and F37), led from this space to the adjacent rooms. The door in the east corner of U13 opened into a narrow corridor (0.65–0.8 m wide), which gave access to a larger room, U14 (4.00 m by 3.90 m), equipped with a bench (F162) placed directly behind the northern stub wall of the corridor (F39).

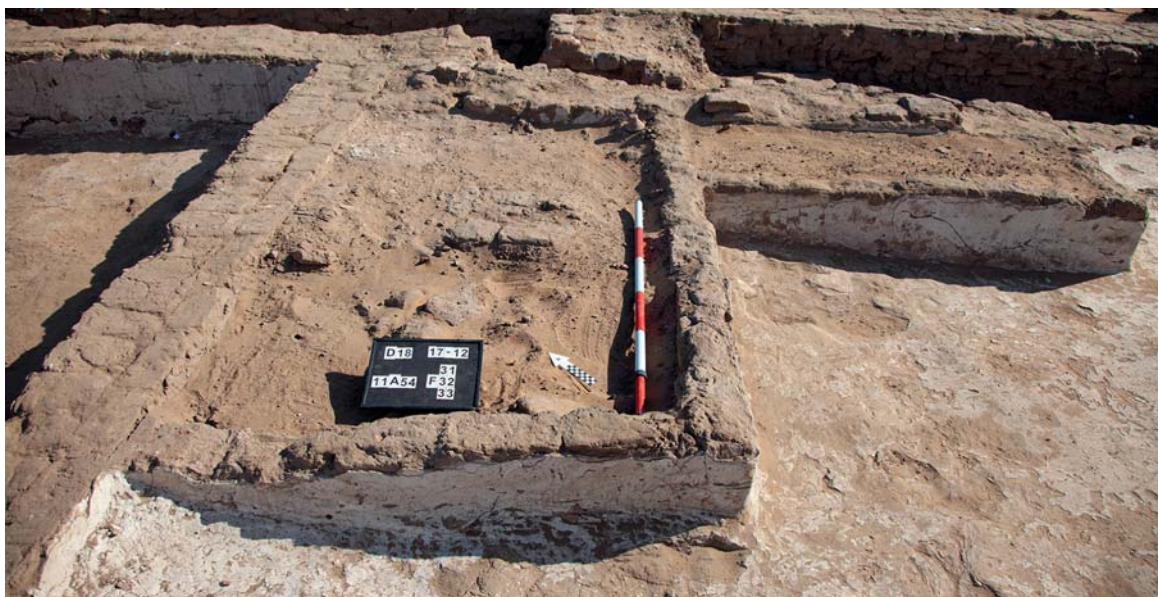
Fig. 79. Benches F32 and F33

Subsequently, two new benches (F32 and F33), the larger measuring 155 cm by 210 cm, and the smaller 175 cm by 65 cm, were constructed in the northern corner of the room abutting the older one [Figs 79–80]. A small vessel with a lid was sunk into the surface of bench F33 in its east corner. It was found empty, but it may have been intended for storage of small personal objects. Vessels embedded in benches are common on site, but they are usually reused *saqiya* pots (*qawwadis*) and cooking pots. The small size and elaborate decoration of this vessel make it a unique find.
