# **OLD DONGOLA**

## **DEVELOPMENT, HERITAGE, ARCHAEOLOGY**

FIELDWORK IN 2018–2019. VOL. 1. EXCAVATIONS

EDITED BY Artur Obłuski and Dorota Dzierzbicka

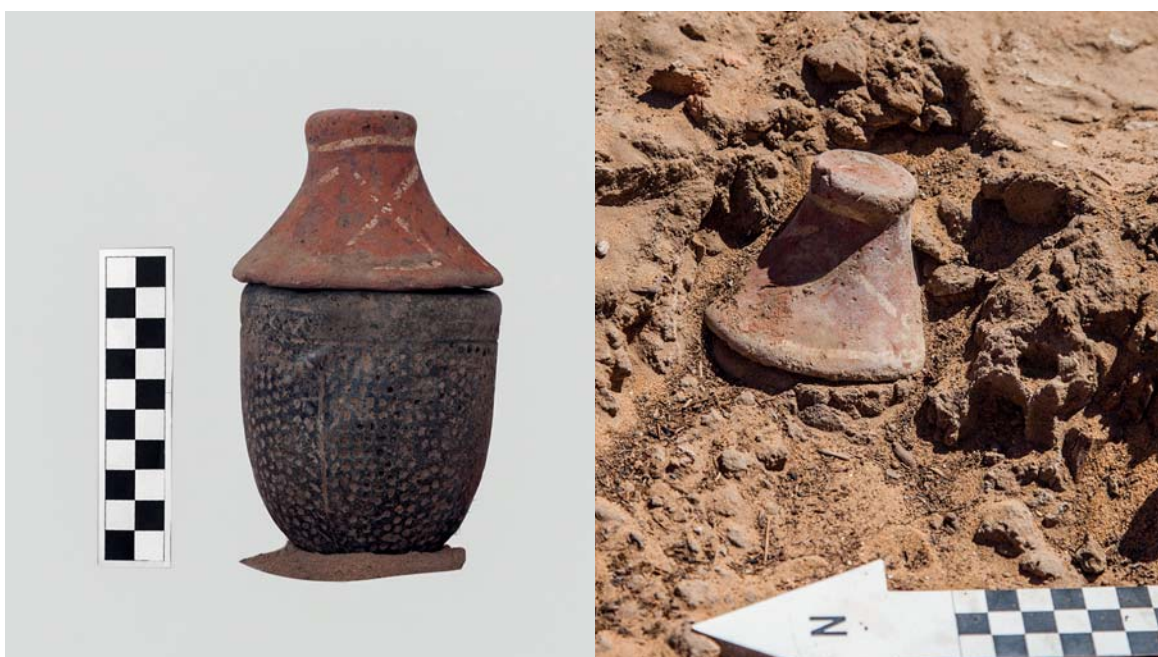
Fig. 80. Vessel with lid, sunk into the east corner of bench F33

Subsequently, two new benches (F32 and F33), the larger measuring 155 cm by 210 cm, and the smaller 175 cm by 65 cm, were constructed in the northern corner of the room abutting the older one [Figs 79–80]. A small vessel with a lid was sunk into the surface of bench F33 in its east corner. It was found empty, but it may have been intended for storage of small personal objects. Vessels embedded in benches are common on site, but they are usually reused *saqiya* pots (*qawwadis*) and cooking pots. The small size and elaborate decoration of this vessel make it a unique find.

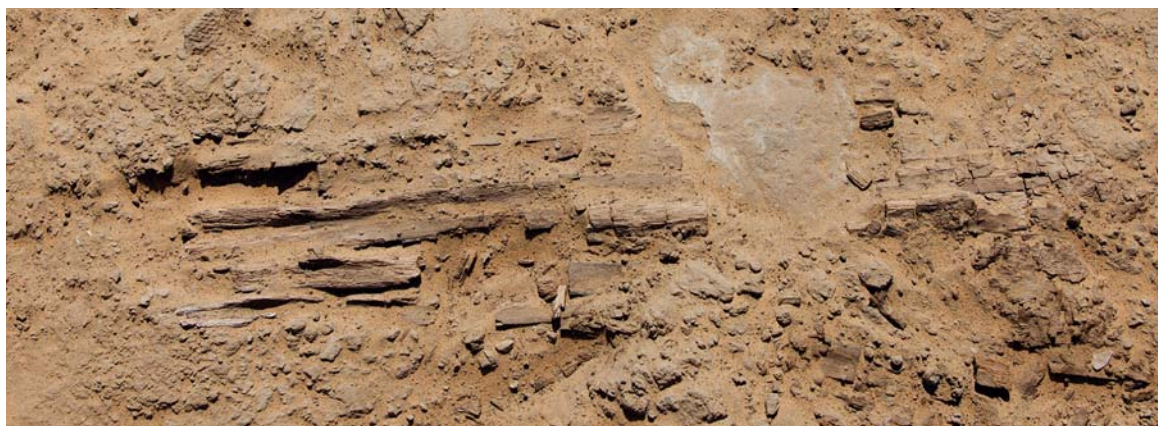
Fig. 81. Relics of a collapsed flat ceiling on the floor of room U14

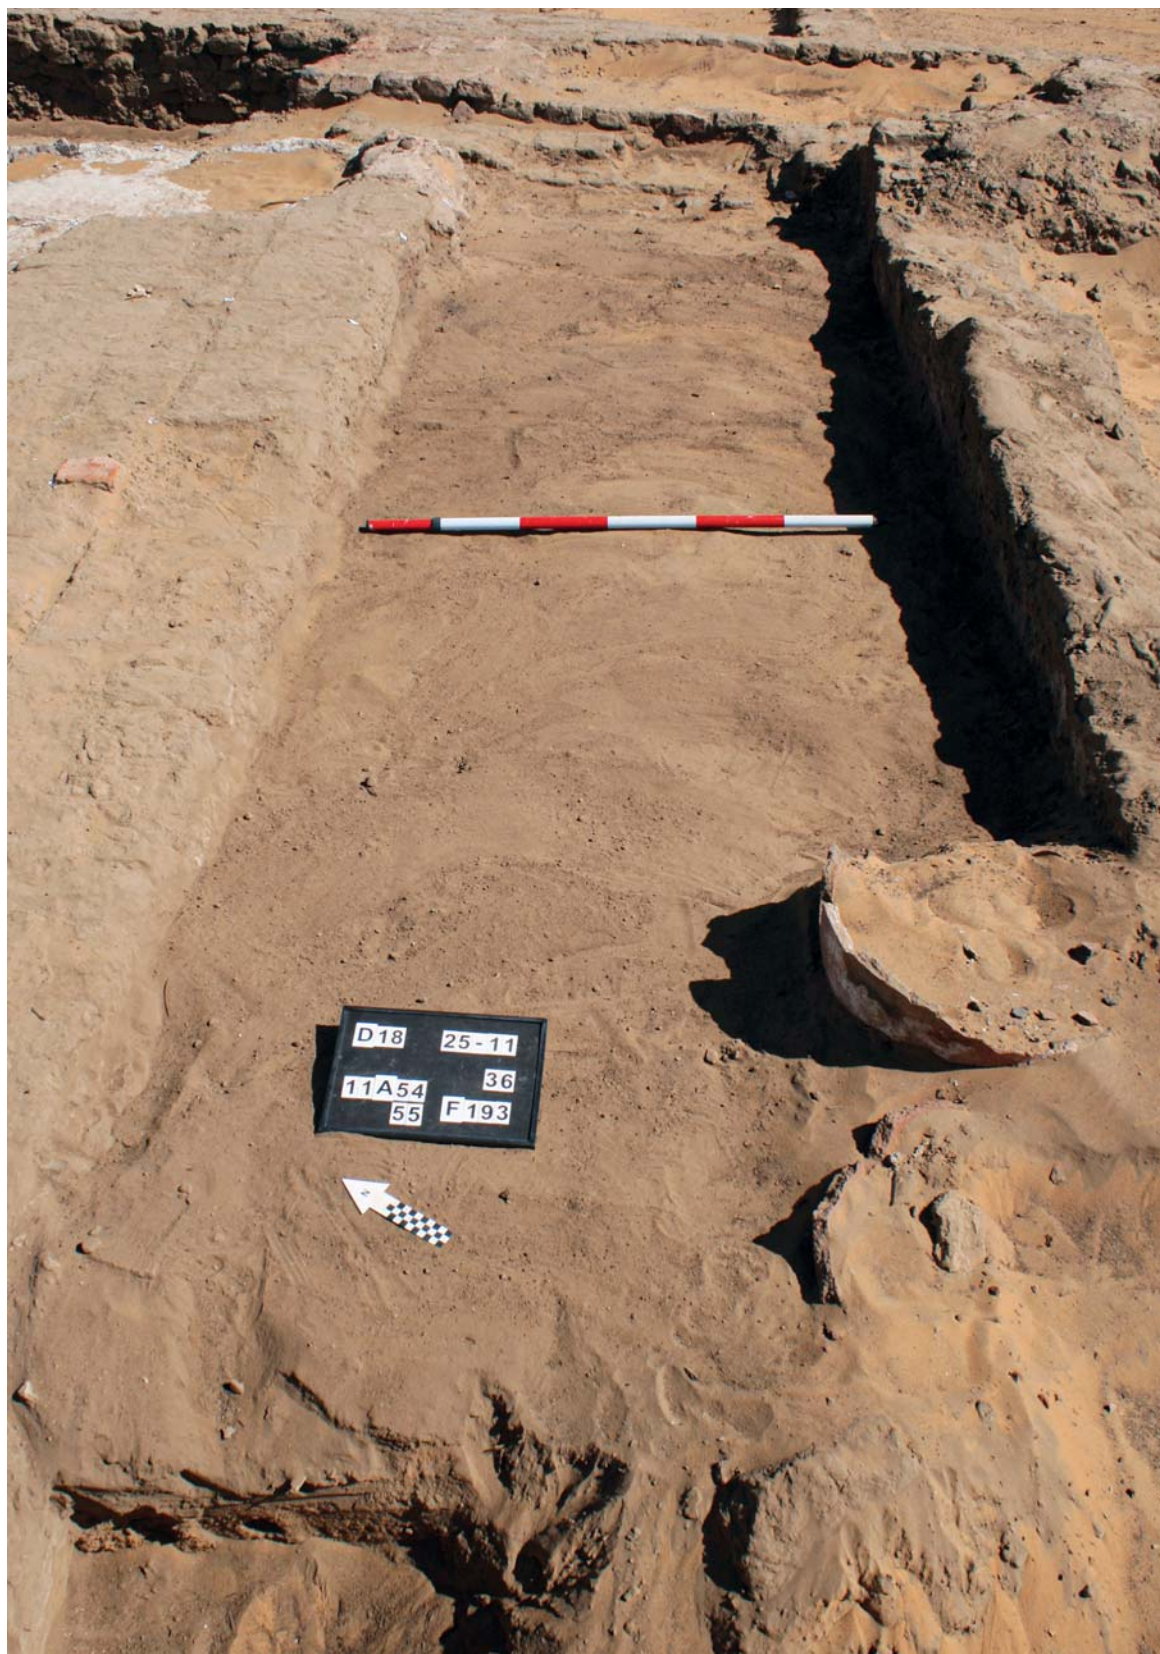
Fig. 82. Room U33, view looking northeast

As the new benches were built, changes were made to the older ones. The southern end of the eastern one (F31) and the eastern end of the southern one (F26) were cut, clearing the passage to room U33 in the eastern corner. The room was narrow but long (1.5 m by 6.5 m) [Fig. 82]. As evidenced by remains of two storage vessels and at least two floors (F192 and F193) of tamped earth with plant remains and by a layer of animal dung and household waste (contexts 35 and 36) separating the floors, this space was used as a storeroom (see similar long, apparently unswept spaces in other buildings, such as U26a, U58b).

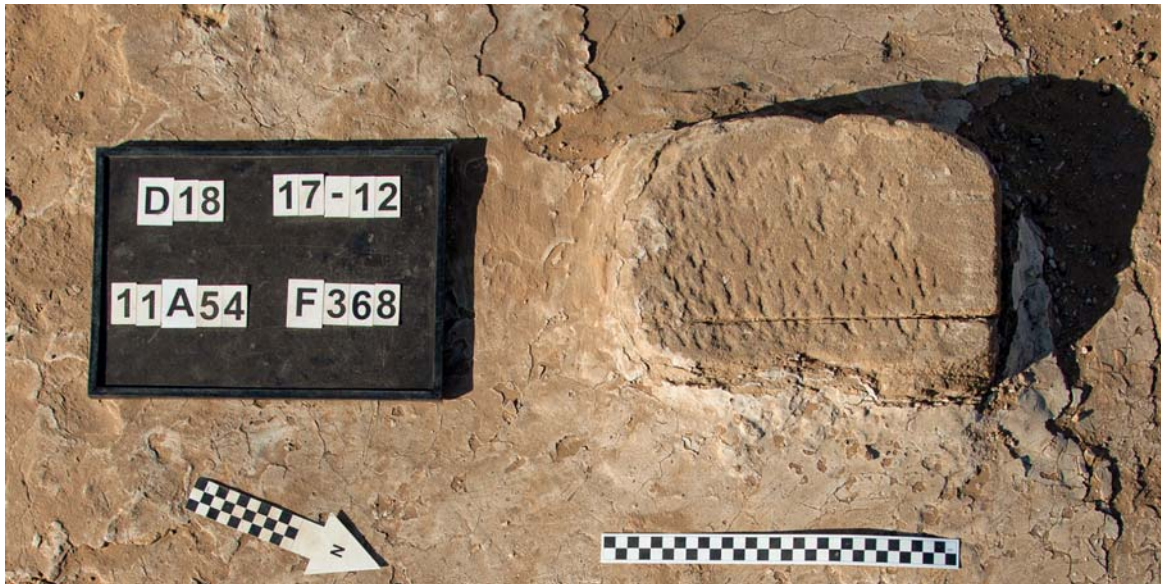
Fig. 83. Pillar base in room U11

In room U11, a central post standing on a sandstone ashlar (F368) was placed, apparently to support the roof [Fig. 83]. The distance from the room walls to the post measured 3.45 m at most, and it is obvious that there was no need for beams of substantial length. The walls of the house were built of brownish-grey sun-dried bricks mortared with Nile alluvium. Fired bricks, mostly fragmented, appeared only in minor structures, such as benches and thresholds. Wall faces inside the house were coated with brownish-grey plaster, and after that many times with yellowish and/or pinkish *qurba*, each time whitewashed with *gir*.

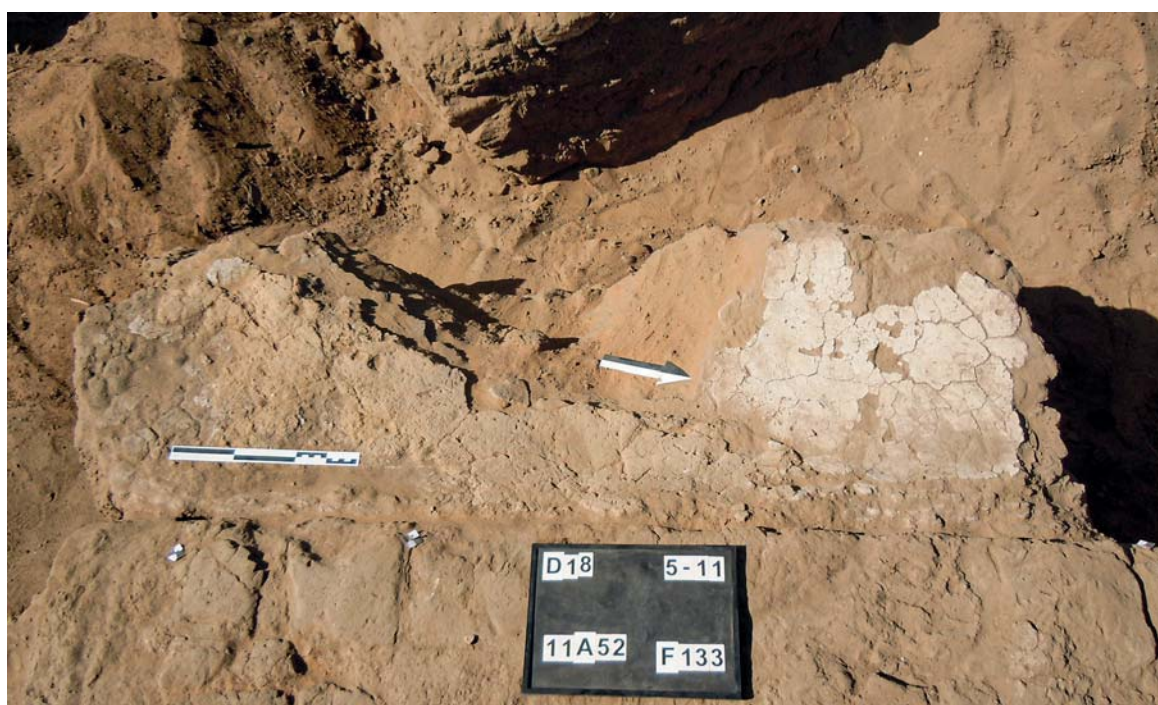
Fig. 87. Room U2. Floor level F133 and below it F141 and F142

One room (U82), located in the north corner, was delimited by walls F119, F120, F550, F240 and F135, and paved with floor F134 overlying deposit 85. Due to the presence of the floor level, the layer has not been excavated. To the southeast of it, a second room (U84) was delimited by walls F122, F128, F135 and floor level F132, characterized by the presence of a rounded curb along its southwest side. A third, smaller space (U83) was formed by an L-shaped corridor located between F128, F122, F123, F124, F150, F127, and F135, and probably having F140 as its floor level. Inside these spaces, other walls and structures have been identified (F136, F137, F138, F139, F127, F133), but they seem to belong to earlier phases and their relative sequence and function are impossible to determine without further excavation. Room U2 in its latest phase (U2.1, periods III.A–II.C; for earlier phases, see above) was formed by walls F120, F135, F150, F124, F123 and F125 enclosing an internal space furnished with a floor level (F133) made of mud plaster whitewashed with *gir*. This floor—preserved only in a small portion along the northeastern part of the room—had two other precedent floor levels below it (F141, F142), denoting an extended occupation of the room at least into period II.B [Fig. 87].

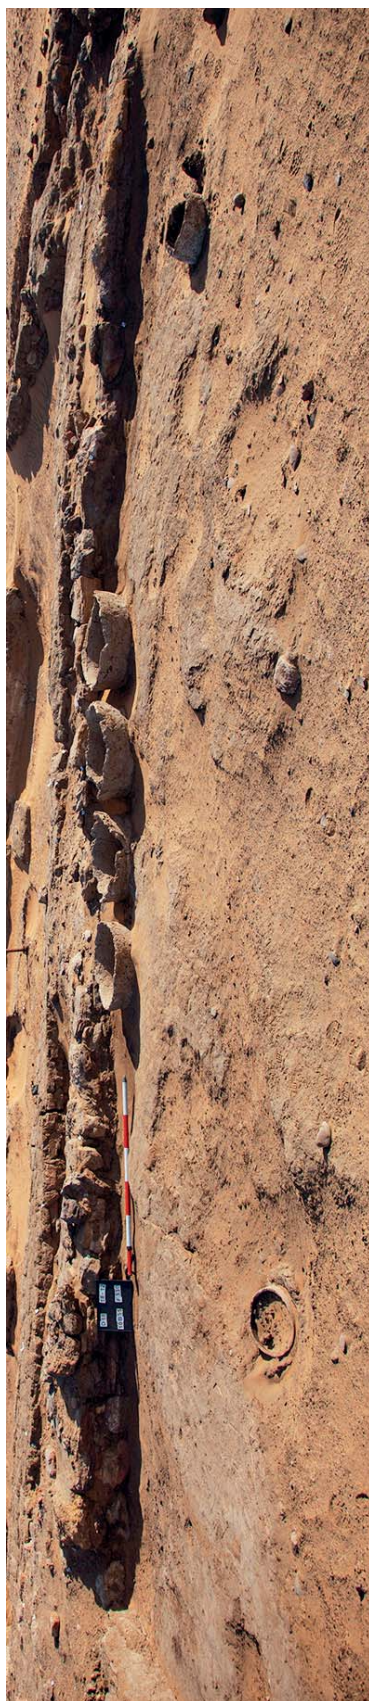
Fig. 89. Courtyard U86

A large courtyard, U86, is located along the inner face of the city wall. It is an open area with four storage bins located by the wall, a hearth, and a quern emplacement [Figs 88–89]. An enclosed space with two storage vessels, U41, was also located within the courtyard. All the features were placed on a mud floor, which extended from the inner face of the city wall. The courtyard is outlined by city wall F332 and wall F330 in the northeast. Its northwestern limit is most probably wall F110, but its relationship to that wall is unclear due to the lack of the floor in this area. That part of the floor, unrecognized in square 11A55, was excavated as part of deposit 141. The level of the courtyard breaks off in the southern part as a result of erosion. All features are preserved to a maximum height of 50 cm.

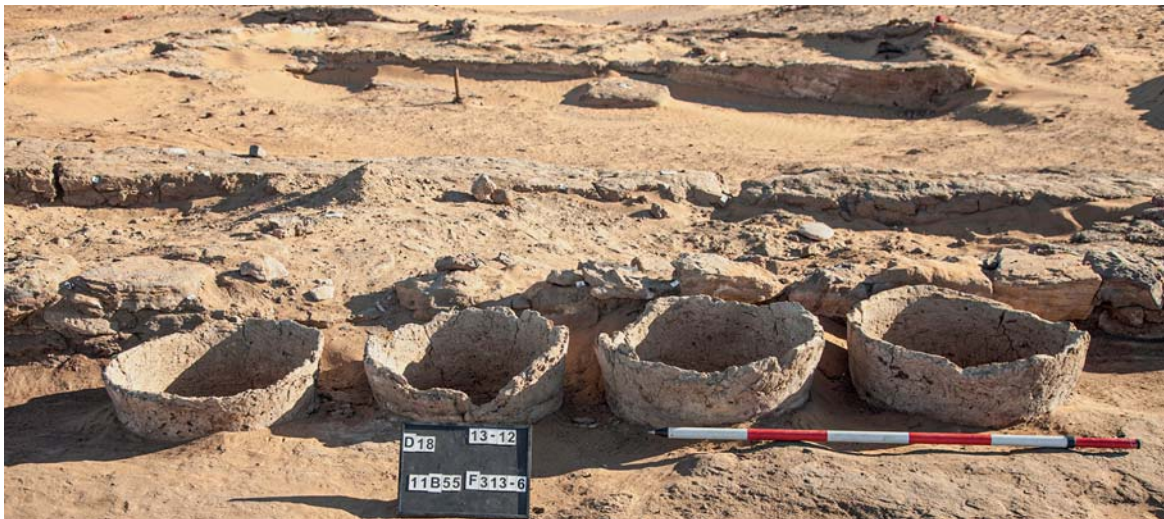
Fig. 91. Storage bins F313–F316

The courtyard was set up against earlier parallel walls, F330, F331, F332 and F333, forming part of the city walls. When it came into being, in period III.D or C, a sloping deposit along wall F330 was cut by a pit (F477) in its northwestern part, and sun-dried-brick walls F310 and F311 were built, forming an enclosed area, U41. Two storage vessels, F327 and F328, were sunk into the ground inside the unit. Stone wall F330 must have been demolished by then, as step F312 allowed one to ascend from the enclosed area (U41) to the top of that wall [Fig. 90]. The step is built on top of a rubble layer (236) deriving from either wall F330, F331 or F333. In the same occupational phase, four storage bins (F313–F316) were placed next to stone wall F330 [Fig. 91]. Another bin, F317, located in the southeastern part of the courtyard, was later used as a hearth, as indicated by soot on the inside of its walls. Burnt seeds of colocynth and acacia suggest that these plants were possibly burned as fuel. In addition to the bins, hearth F626 (filled with 186) was set up in the east corner of the courtyard.

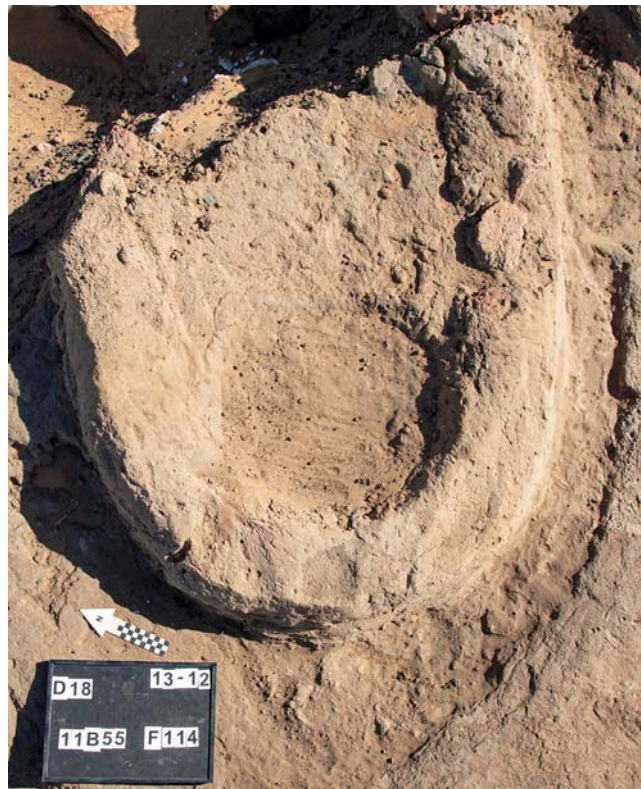
Fig. 92. Quern emplacement F114

After the features in the courtyard were established, the level of floor F326 gradually rose, with accumulation of several superimposed thin layers of mud abutting the bins and walls. Somewhat later than the other features, F114 was built on top of the floor [Fig. 92]. This structure can be interpreted as a quern emplacement with a fair degree of certainty despite the lack of a quern and bowl. In other excavated areas (e.g., U15 and U36) such mud bases with circular depressions also co-occur with concentrations of grains in botanical samples, storage vessels, and discarded grinding and pounding stones. A similar quern emplacement with a quern *in situ* is also preserved in U30, embedded in mud with an attached bowl [see Fig. 65].

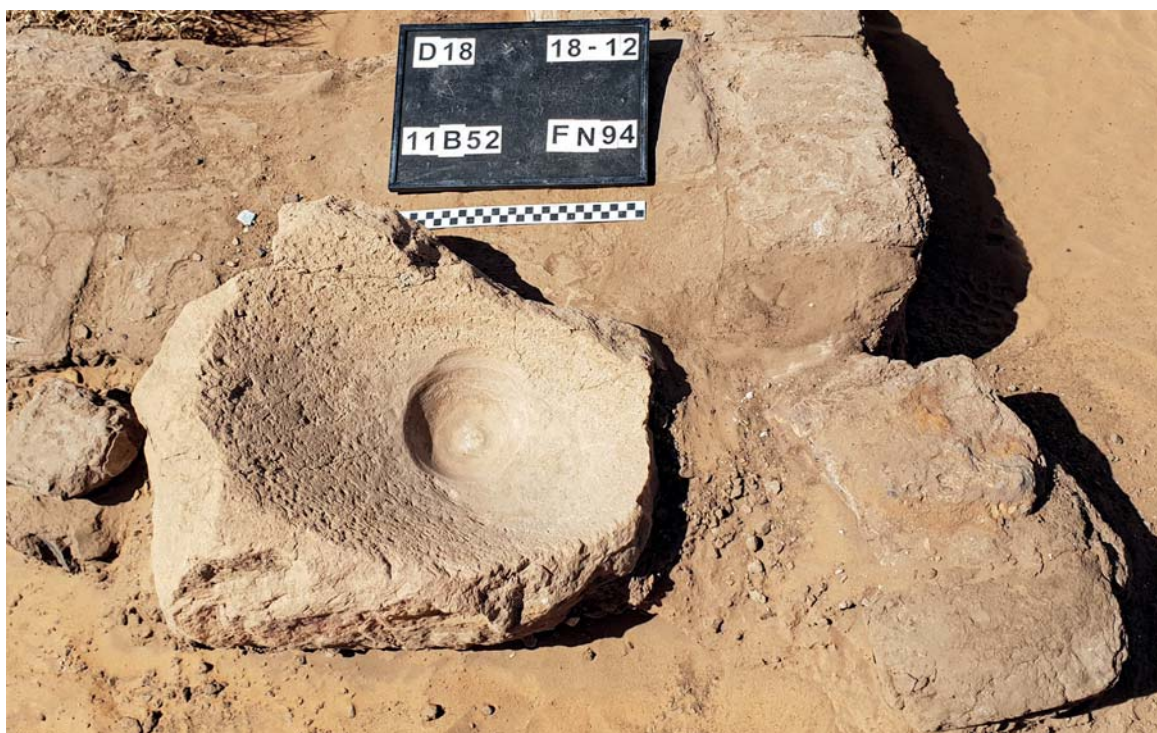
Fig. 97. Grinding stone reused for mounting a door pivot in the entrance to U87

In period II.C (early 18th century), the access corridor U87 opening onto the street was furnished with a small bench (F400) and closed with a door mounted on a reused grinding stone [Figs 96–98A–B]. Low walls were built across the main entrance corridor (F558, F559, F560), perhaps forming part of a ramp or flight of steps built to access the compound, located on a lower level than the street. Courtyard U88 in this phase had a floor (F396) but lacked other features. From this space, one accessed building U32/38/39 in the south [Fig. 99]. Two rooms of this complex, U32 and U39, are likely the latest additions in this area, while U38 seems to have been part of an earlier complex (see below).

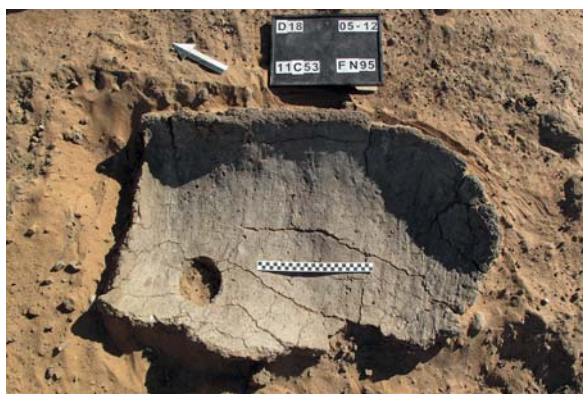
Fig. 102. Collapsed wall of a bin of sun-dried clay with a circular hole near the base found in room U32

U32 is a large, square room formed by walls F552, F404, F405 and F410, and paved with floor F427 [Fig. 103; see Figs 96, 99]. A bench (F426) built along F404 supported six storage bins made of sun-dried clay, fragments of which were recovered from the fill [Fig. 102]. Another long, narrow bench (F425) stood along F405. A base for a post made of a block of sandstone resting on a sun-dried brick stood almost in the center of the room. It suggests that a light, flat roof made of organic materials was constructed over this space. Whitewashed mud plaster covering the walls of the room descends seamlessly to the floor, but in some spots there were traces of earlier layers of plaster, indicating a prolonged use of the room. On the northwest and northeast sides, the floor has a rounded curb, which follows wall F552 and bench F426. Two rectangular structures formed by walls F406, F407, F408 and F409 (a stub wall flanking the entrance) probably constituted two more benches, completing the furnishings of the room on the western side. The structure outlined by F410, F407, F408 and F409 was filled with a layer of sand (289).

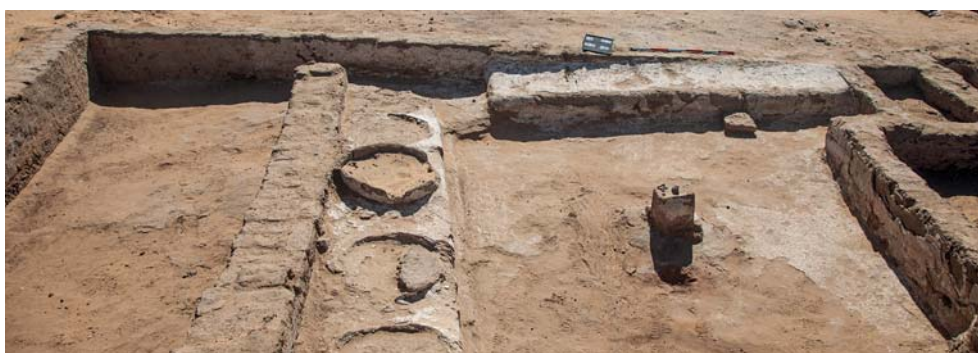
Fig. 103. Rooms U32 and U39, view looking southeast

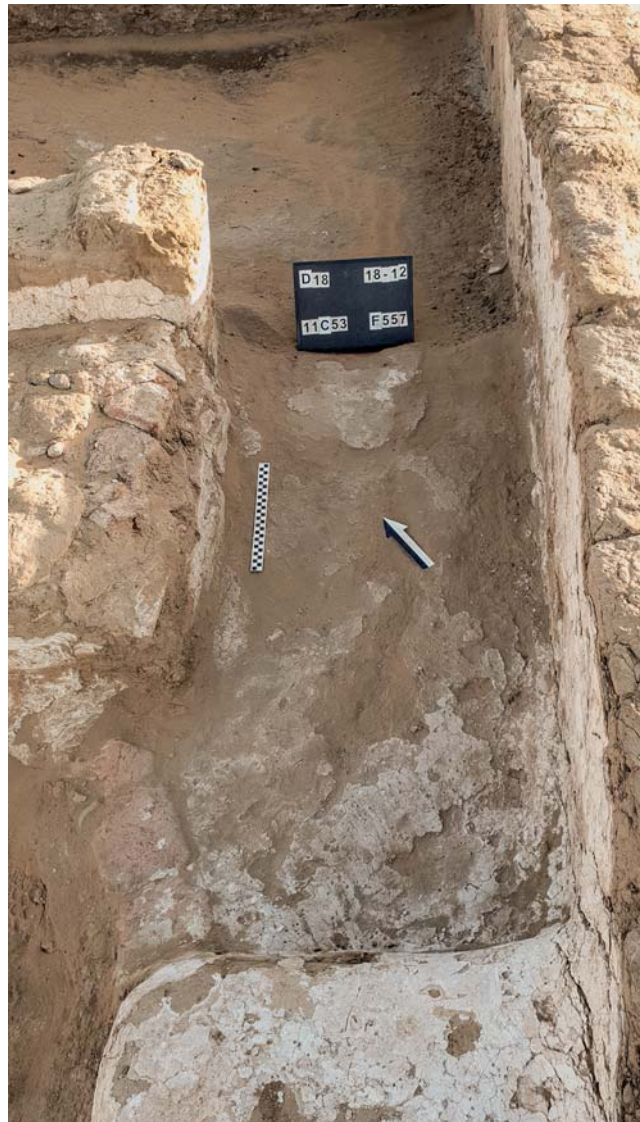
Fig. 104. Floor F557 between rooms U32 and U39

Another floor level (F557, elevation 18.43–18.55 m) connected U32 with U39, where the walking surface (F429, elevation 18.49–18.56 m) lies at a higher elevation than floor F427 (18.13–18.25 m). In this case, a small step was constructed with fired bricks and connected on the eastern side to a sloping surface in the passage between the two rooms. In its current state, F557 ends abruptly, while originally it probably spanned the whole of U39 [Fig. 104].

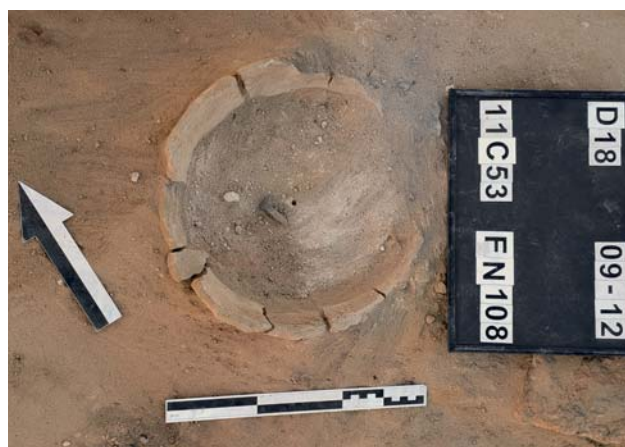
Fig. 105. Plate on the floor next to the pillar base in room U32

The occupational phase of the room was represented by a layer of sand mixed with organic material and loam (285) spread evenly all over the surface of floor F427. On the floor, next to the post base in the center of the room, there was also a small layer of ashes and charcoal (287), on top of which a ceramic plate was found still intact and containing a compacted white substance resembling *gir* or ash [Fig. 105]. A thick accumulation of yellow sand (283) on top of the occupational layers formed in the period that elapsed between the abandonment of the room and the collapse of the walls (thick layer 282, sealing the room) [Fig. 106].

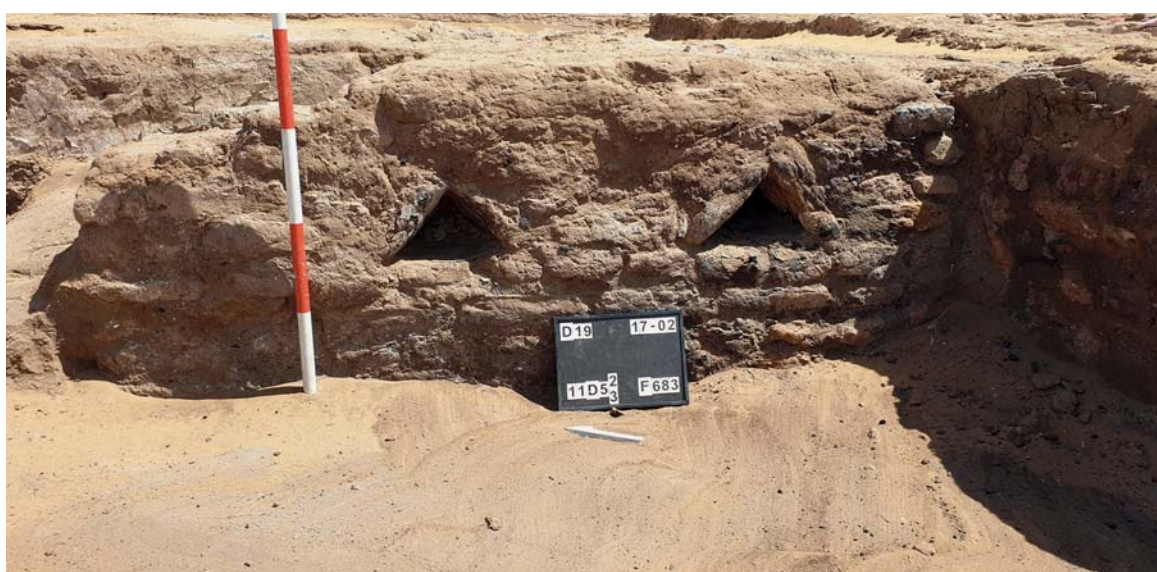
Fig. 109. Wall F683 with triangular niches

Beyond the door, wall F662 formed an access corridor to U52 together with stub wall F683, also made of a mix of sun-dried and fired bricks, and bearing traces of burning underneath the latest replastering on its northeastern face. On its southwestern side, the wall had two small, triangular niches [Fig. 109]. They were an original element of the wall, made by setting pairs of bricks diagonally on edge to create triangular recesses. Their purpose is unclear, but they may have held lamps

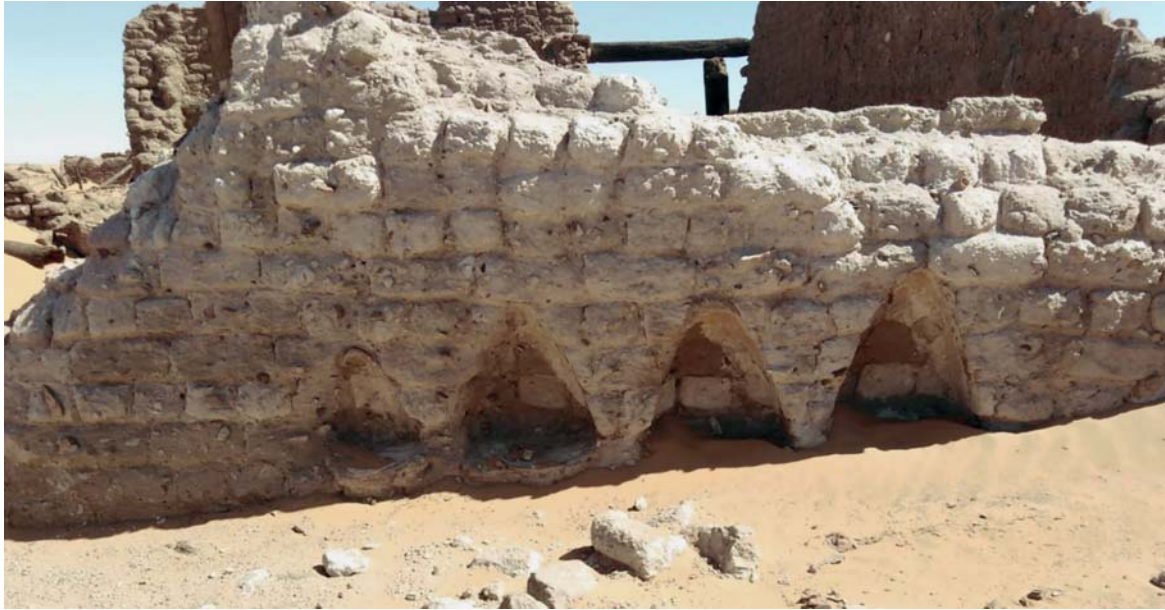
Fig. 110. Wall with triangular niches in the Abandoned Village

or had a purely decorative function. In the so-called Abandoned Village one can observe several such niches, testifying to the long-lived tradition of using this architectural solution [Fig. 110].

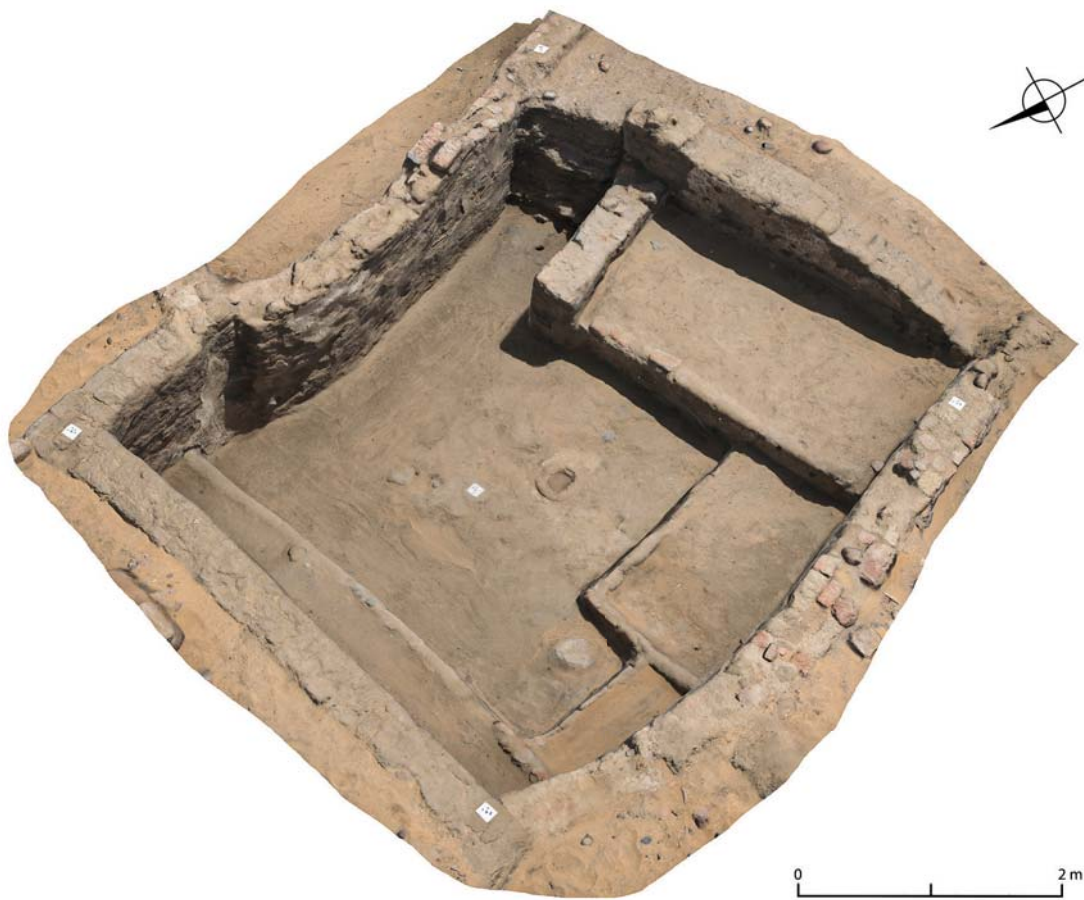
Fig. 111. Room U63, aerial view

Room U63 was enclosed within walls F562, F555, F579, F689 and F563 [Fig. 111]. F555 and F579 in the northeast and northwest, made of sun-dried bricks and bonded together, are the earliest walls of the unit (they may even predate it). They both bear traces of burning on the surface of the bricks but not on the latest layer of plaster. Traces of fire and refurbishment are also found on the southeast wall, F563. Clearly, at a certain point there was a fire after which the room was replastered. Wall F562 has more than one layer of successive replastering, only a fragment of which remains, characterized by the presence of mud plaster rich in organic temper, while the rest of the wall has the usual whitewashed mud plaster partially darkened by ashes dumped inside the room [Fig. 112]. In its northern part, the wall ends in a recess and abuts wall F555. Wall F579 is, in turn, abutted by F689, the southwest wall, made of sun-dried and fired bricks together with some blocks of sandstone, having a linear but irregular plan. It seems, therefore, that U63 was created by adding two longitudinal walls, F562 and F689, to older structures.

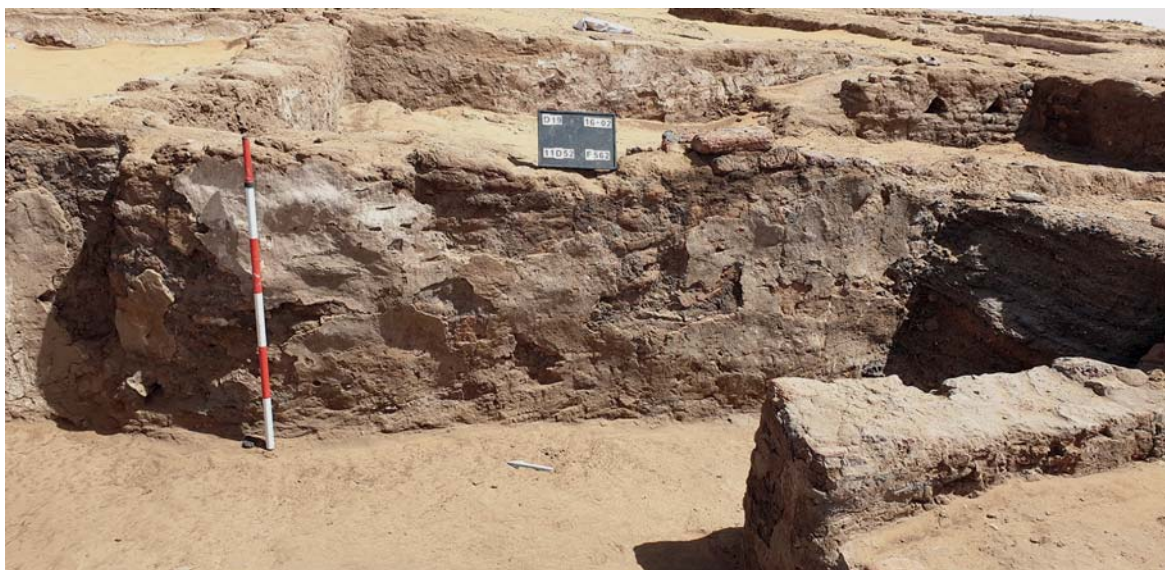
Fig. 112. Wall F562 with traces of burning

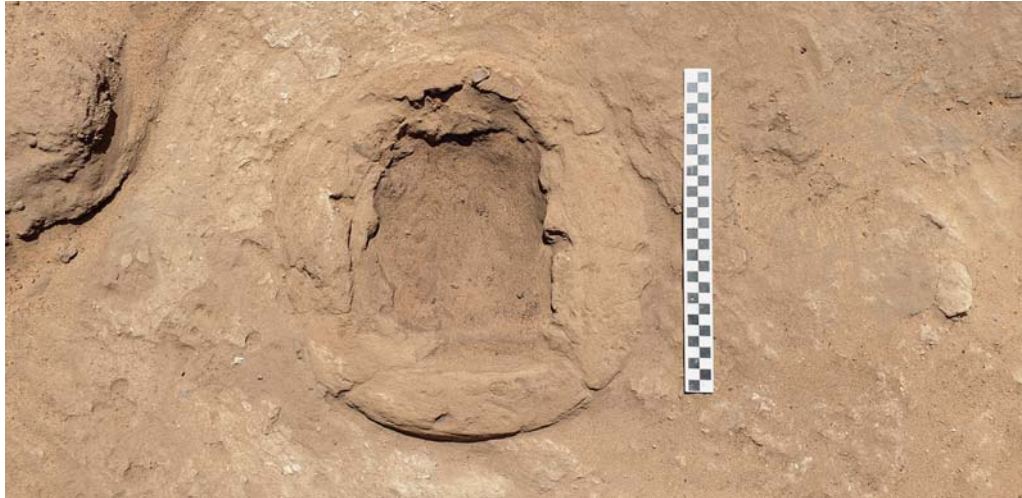
Fig. 113. Pillar housing F926

U63 is furnished with four benches built along the northwestern, southwestern and southeastern walls. The northern (F578) and the southern (F575) were the biggest ones, serving as the main rest areas of the room. On the southwestern side there is a smaller bench (F576), followed by an even smaller structure (F577) constituting a row of fired bricks connecting F578 and F576. In its inner part there were no traces of mortar and—because of its small dimensions—this structure could have been used as a shelf or a food-preparation area rather than as a place for sitting. In the central part of the room was the housing (F926) for a pole supporting the roof, made by filling a circular hole with mud mortar. The outline of the place for mounting the pole is square [*Fig. 113*].

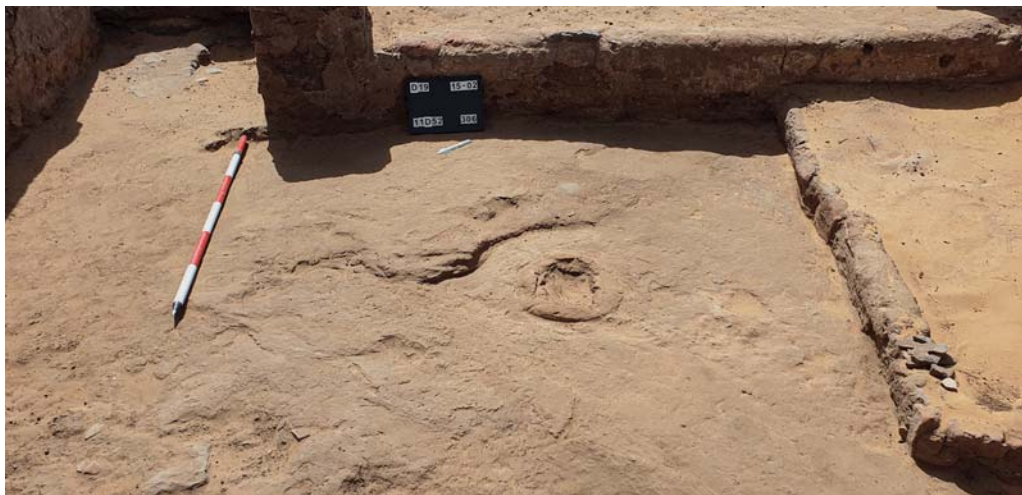
Fig. 114. Deposit 306

Deposit 306, a thin layer of loam with some sand and organic matter, covered the entire surface of floor F925 [*Fig. 114*]. It was compact and uniform, suggesting its formation during the occupation of the room and its extended use as a walking surface. On top of deposit 306 lay 351, composed mainly of sand, ashes, charcoals and some organic matter. It filled the entire space of the room, except for the benches along the walls. Given that it respects the architectural features of the room and extends uniformly over the floor area, this layer could be the latest phase of use of the house as a residential building (period III.A, late 17th century).

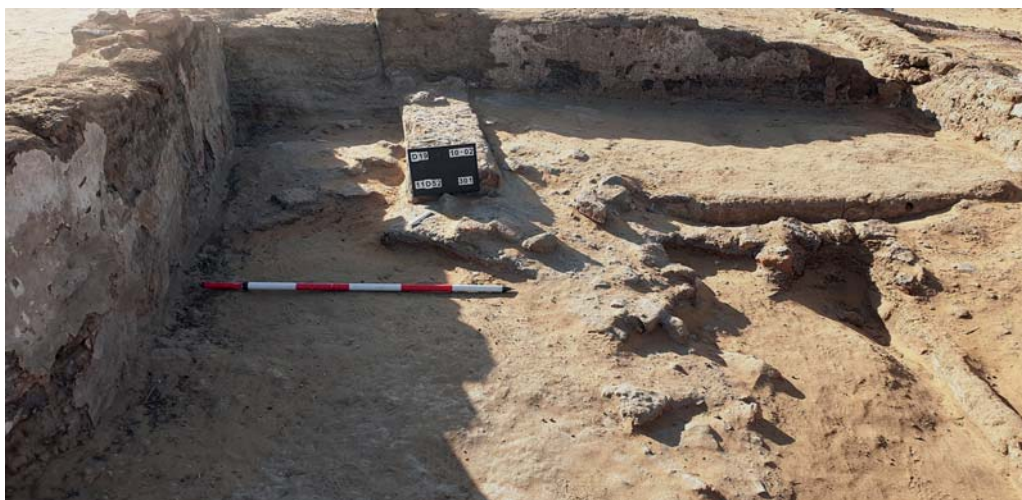
Fig. 115. Layer 301

In the post-abandonment phase (period II.C and later, 18th century), the central and southern part of the unit was filled by a layer of sand mixed with rubble from fired and sun-dried brick and ashes (301), deriving probably from the destruction of the unit itself [*Fig. 115*]. Subsequently, the room filled with three layers of ashes with some sand and organic matter, most probably dumped intentionally on the spot, sloping from the tops of the walls toward the center of the room (341–342–343). They were followed by layers of windblown sand with varying admixtures of ash and organic particles (334–339–340).

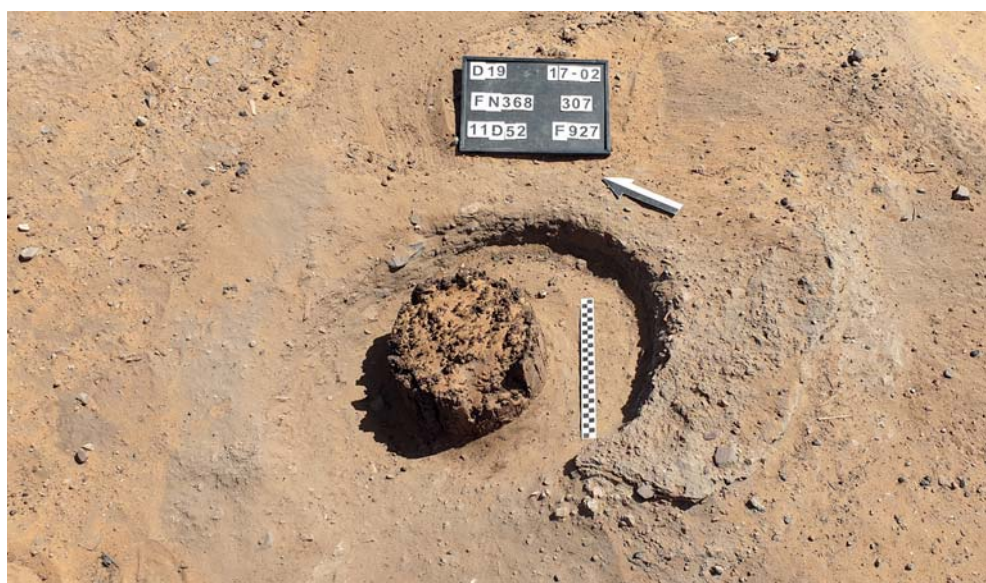
Fig. 116. Pit F927 filled by 307 with post FN368

Away from the walls, the floors were not preserved, and U65 was completely filled by layer 305, composed mainly of ashes and some sand. It has not been completely excavated due to the presence of the later walking levels. In its central part was a circular pit (F927) with the remains of a wooden post (FN368) [Fig. 116], related to a later phase of use of the area and probably connected with the latest floor levels (F573, F581) abutting the walls. Along wall F692, ash layer 305 was covered by 308, a layer of loam and organic matter covered by floor level F581. Given its even upper surface and its position directly below F581, 308 seems to be a preparation layer for this floor.

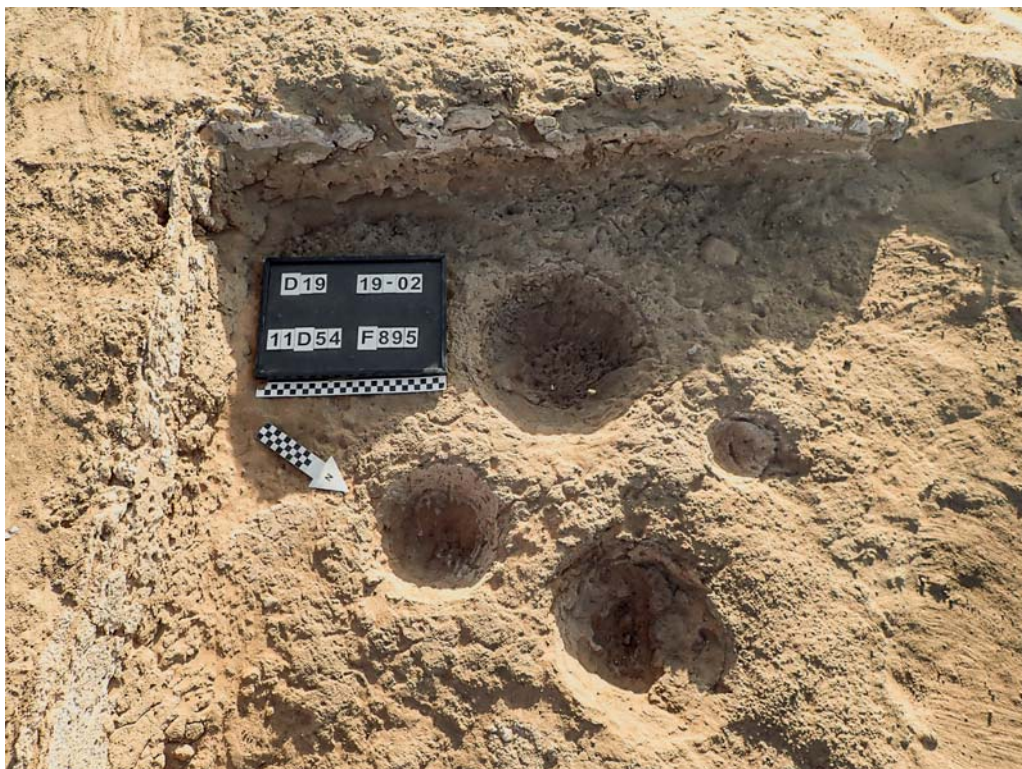
Fig. 121. Four depressions left by pots, F895

The best-recognized southeastern room of the building, U67, is very similar in layout to other late dwelling spaces in the neighborhood. Its floor (elevation 18.26 m) and other structures were found directly beneath the surface layer, and after the removal of the uppermost deposit several features came to light. A low step (F894) made of fired bricks in the west corner of the unit suggests the location of the main entrance to the room in this place, but the severely eroded state of the southwestern wall (F896) hinders precise identification [*Fig. 120*]. In the northern corner, outlines of a large bench (?) (F808) with a stove (?) (F893) were recognized but not excavated. In the east corner of the room, another bench (F806, 176–182 cm by 124–135 cm) was found. In the south corner of the unit, four rounded depressions (F895), obviously left by pots sunk into the floor, were found [*Fig. 121*].

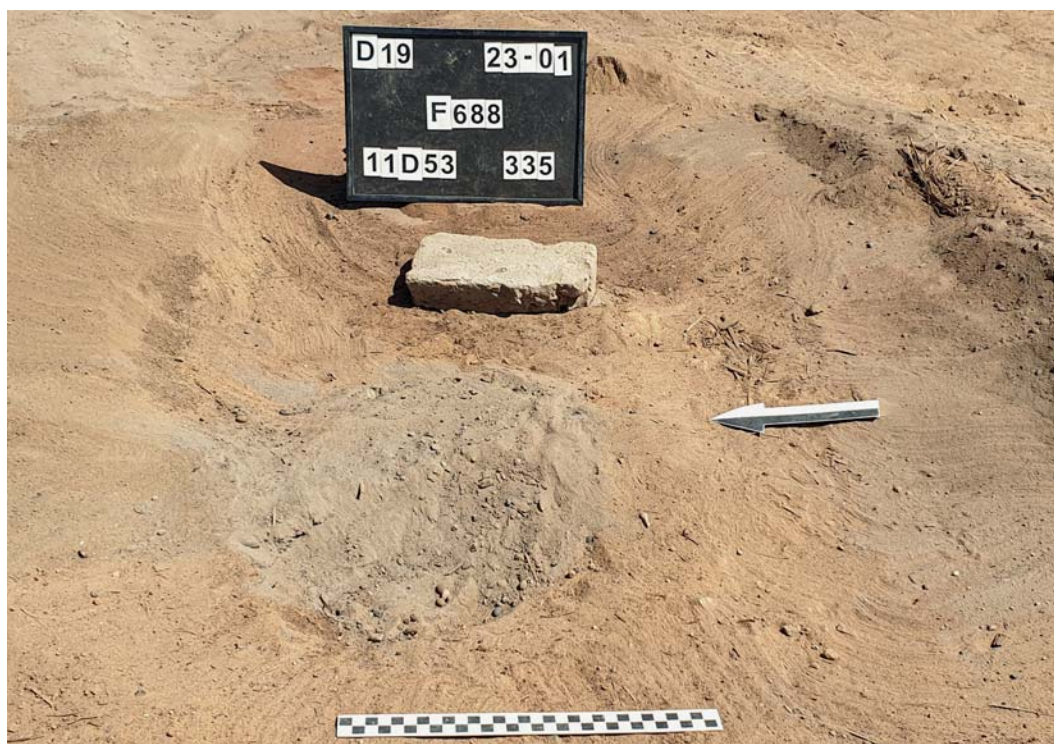
Fig. 122. Hearth exposed after removal of layer 330: pit F688 filled by deposit 335

To the south of the remains of the poorly preserved wall F687 separating U53 from the alley to the north were traces of a hearth. It consisted of a circular pit (F688) filled with compact ashes (335) underlying an upper layer of ashes and burnt matter (330). A fired brick found in deposit 330 could have been used as a support for pots inside the hearth [*Fig. 122*].

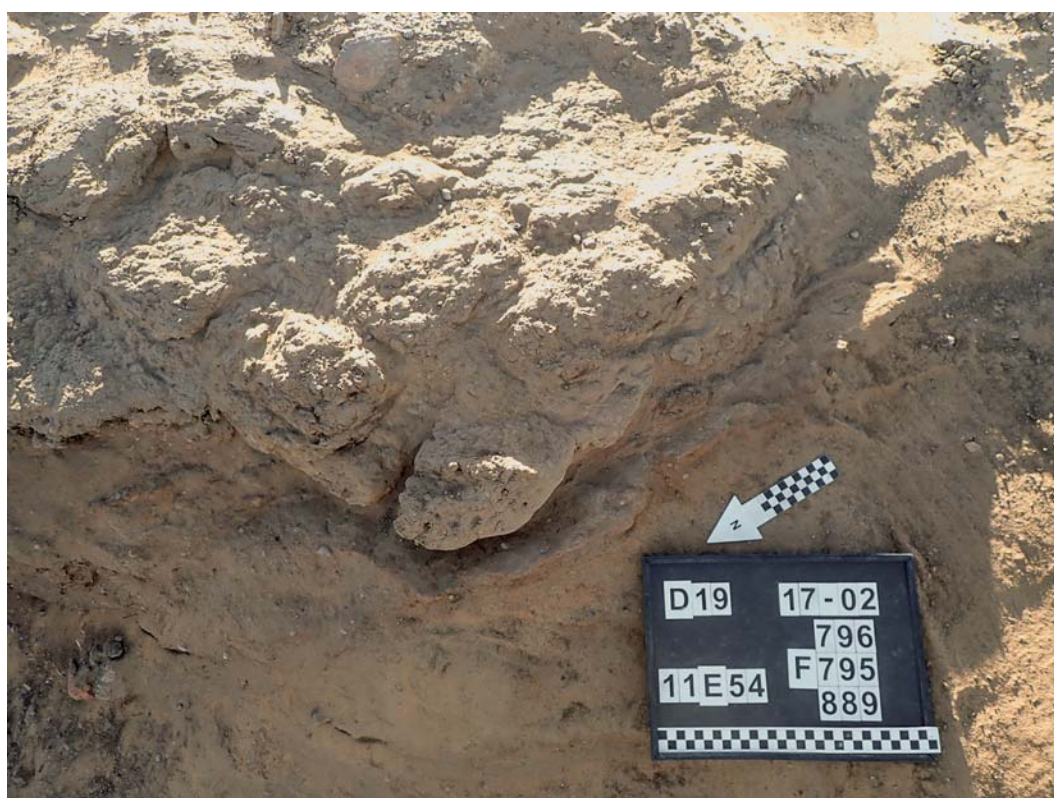
Fig. 123. Floor F889 and walls F796 and F795

In courtyard U91, the largest fragment of tamped surface (F889, elevation 18.15 m) preserved along the outer face of the southwestern wall of unit U64 served as a base for the foundations of the northwestern (F796) and southwestern (F795) walls of the building, which were constructed directly on top of it [Fig. 123]. Floor F889 was made of packed yellow sand and animal manure, and it clearly sloped down toward the north. It was the last floor in a sequence of similar tamped surfaces discernable in a section of the steep slope in this area. In the middle of the floor was a circular hearth (F797) with edges modeled in *gir* [Fig. 124].

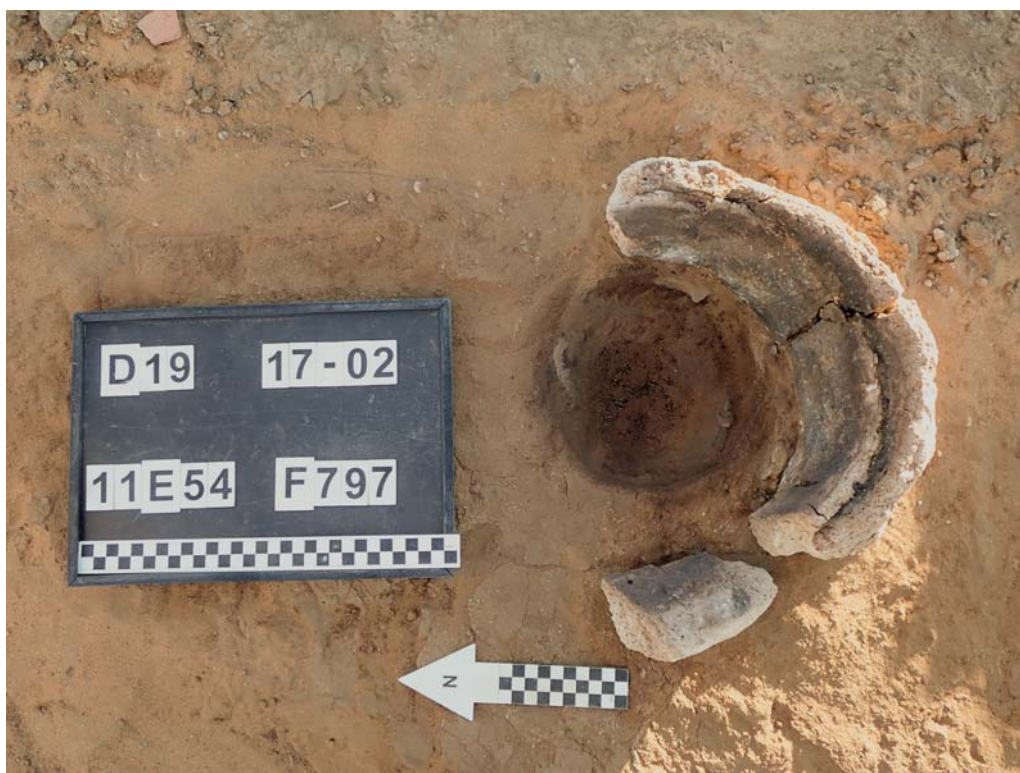
Fig. 124. Fireplace F797

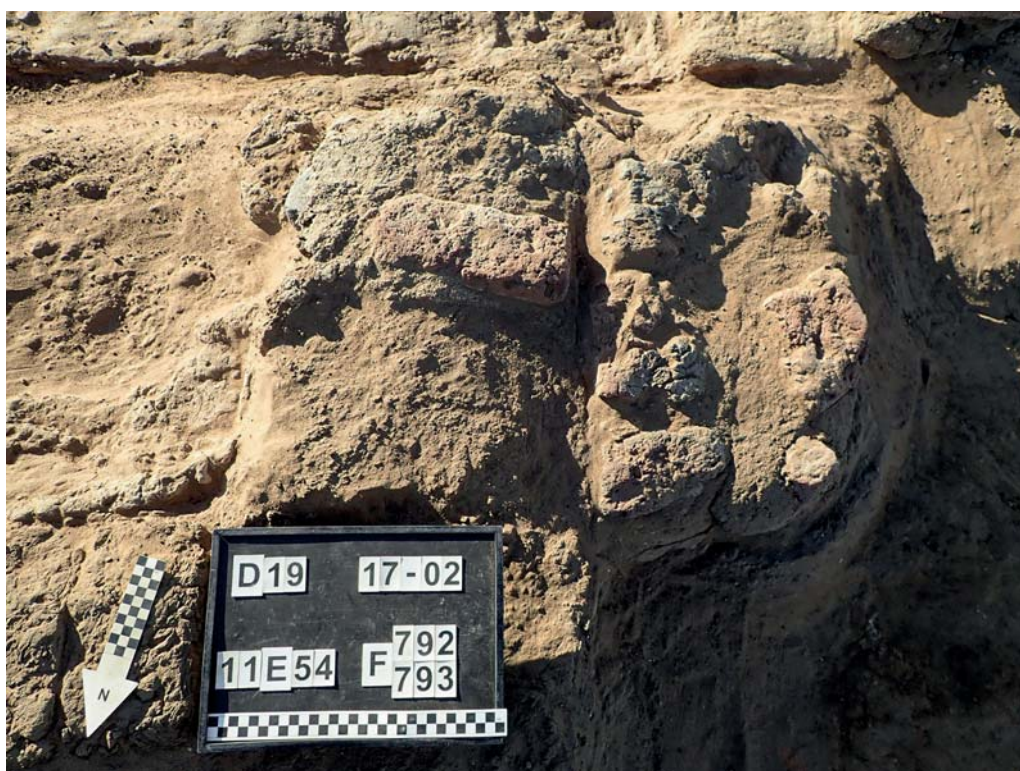
Fig. 125. From left to right: threshold F792, step F793, and floor F794

While floor F889 was definitely older than building U64, another floor (F794, elevation 18.27 m) just above it, made of tamped brownish-grey Nile alluvium, was contemporary with the entrance to the unit and its threshold (F792). At some point, the difference in levels (amounting to 13–16 cm) between threshold F792 and floor F794 was resolved by introducing an intermediate step (F793) [Fig. 125].
