# **OLD DONGOLA**

## **DEVELOPMENT, HERITAGE, ARCHAEOLOGY**

FIELDWORK IN 2018–2019. VOL. 1. EXCAVATIONS

EDITED BY Artur Obłuski and Dorota Dzierzbicka

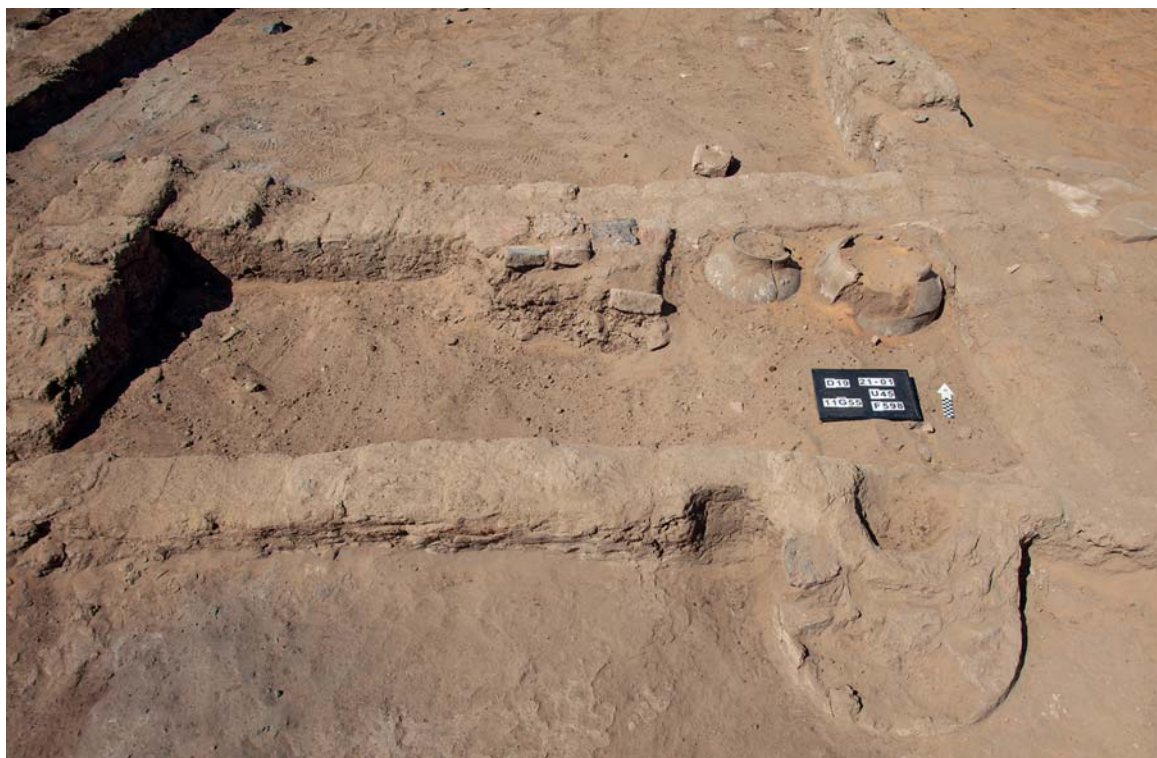
Fig. 130. Bench in room U45

U45 was a single-room building located in the southwest part of the compound and accessed from the courtyard through an entrance in the northern corner. It was a small room (3.50 m by 4.00 m) furnished with a large bench built against its northwestern wall, with two storage vessels (F599 and F600) embedded in the surface [*Fig. 130*]. The first one was filled with lumpy loam mixed with sand with a high concentration of organic inclusions, among which was a whole fruit resembling a pumpkin or melon (taken as organic sample S256). Within this deposition layer, a unique painted vessel made of sun-dried clay was discovered (inv. no. 1412, a bottle, K. Danys, personal communication, 18 June 2020). A quern emplacement built as part of the bench formed an extension of the facing wall. Another, smaller bench (F881) was installed against the southwestern wall. The last element of equipment was another quern emplacement installed against wall F604. It must have been a space dedicated to food preparation.

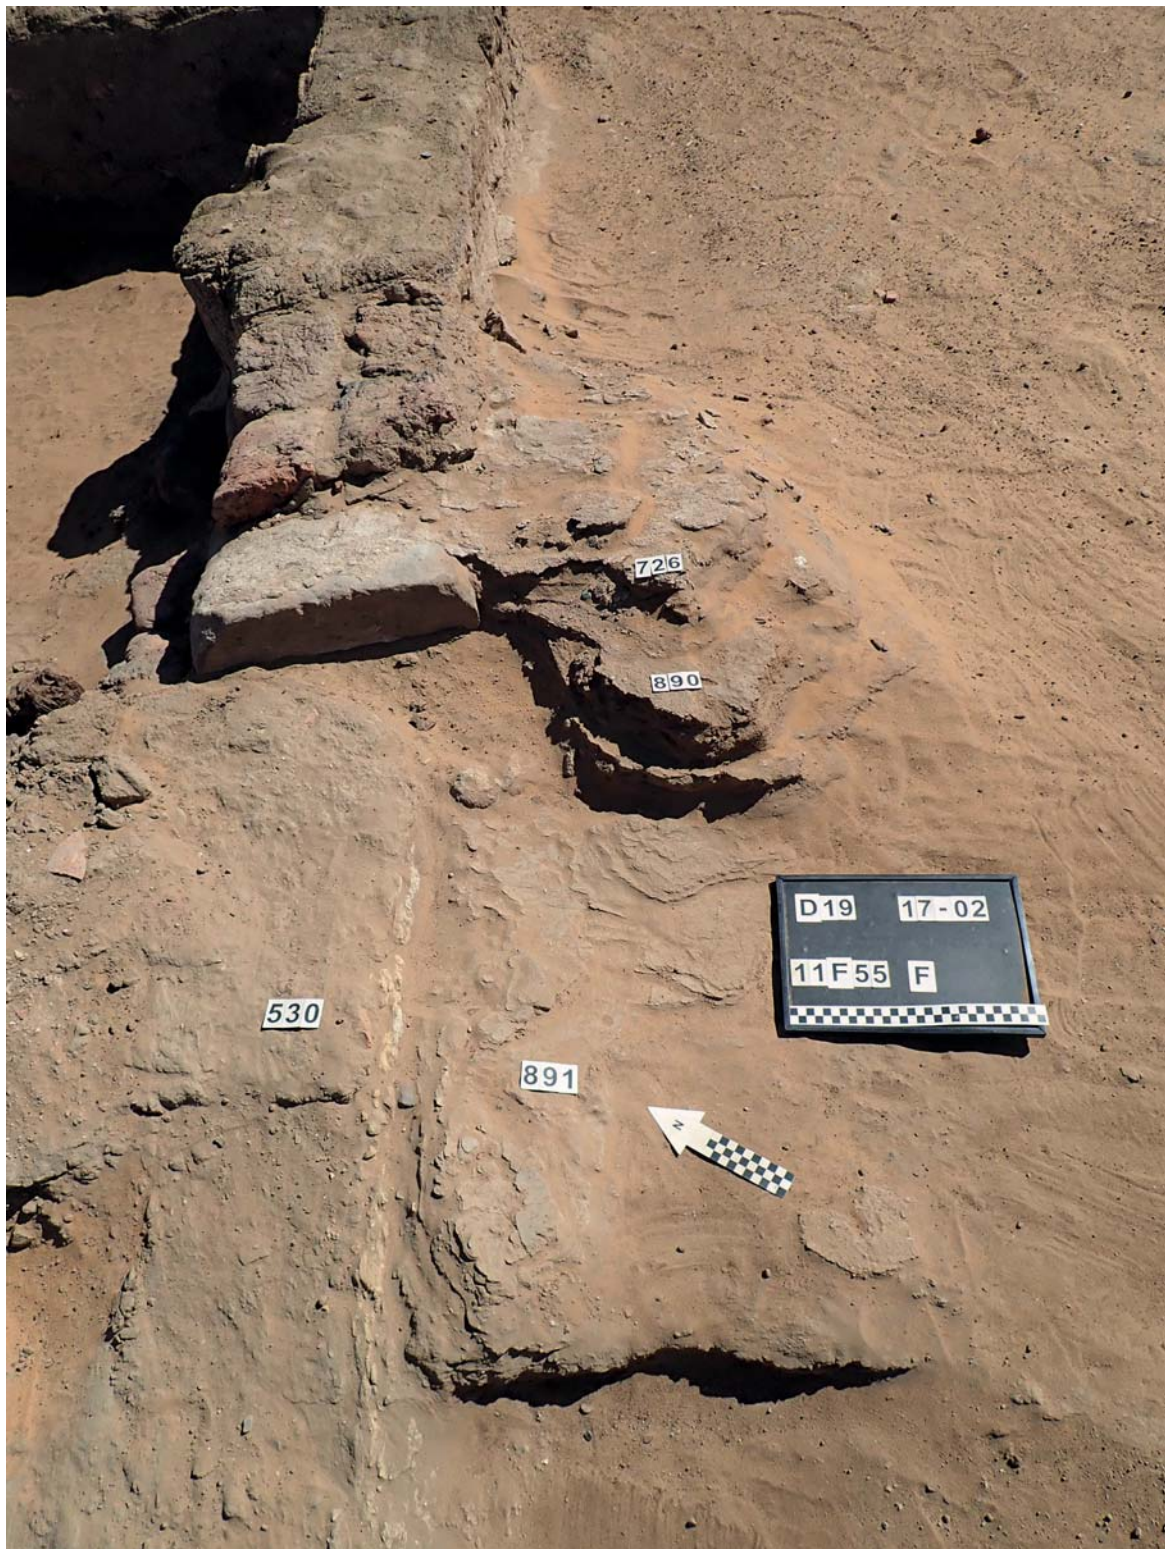
Fig. 133. Sequence of floors in front of the main entrance to building U44/48/55

The building constituting the main part of the household measured 6.40 m by 10.15 m. It was divided into three rooms designated (from west to east) as U48, U44, and U55 [Figs 131–132]. The building was entered from courtyard U71 located to the southeast of it. The entrance was in the south corner of the easternmost room of the building (U55). The difference of levels (about 30 cm) between the courtyard and the floor of U55 (F730) suggests that the house was used for a relatively long period. On the side of the courtyard, a sequence of tamped surfaces, some of them whitewashed (F725, F726, F890, F891, elevation 17.99–18.19 m), corresponded to the original threshold, F724, and one (F723, elevation 18.20–18.29 m) matched threshold F722 installed later. The entrance was about 0.7 m wide and 0.45 m deep (dimensions of threshold F724) [Fig. 133].

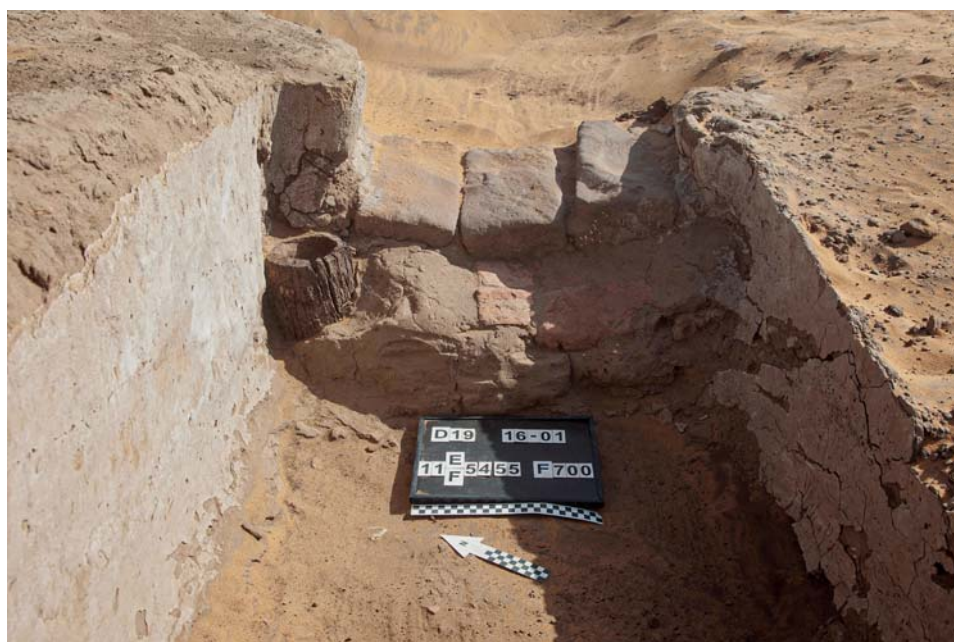
Fig. 134. Threshold F700 in the doorway between U55 and U44, looking northeast

To the left of the main entrance to the building was another doorway leading from U55 into an inner room of the house (U44). The threshold (F700, 65–75 cm wide and 50 cm deep) was made of three squared stone blocks (each about 46–47 cm by 20–21 cm by over 6 cm), and its upper surface was 15–25 cm above the floor level (F730, elevation 17.91 m) in U55. The western face of this threshold was abutted by a step, likely built in the same phase as the construction of the threshold itself [*Fig. 134*].

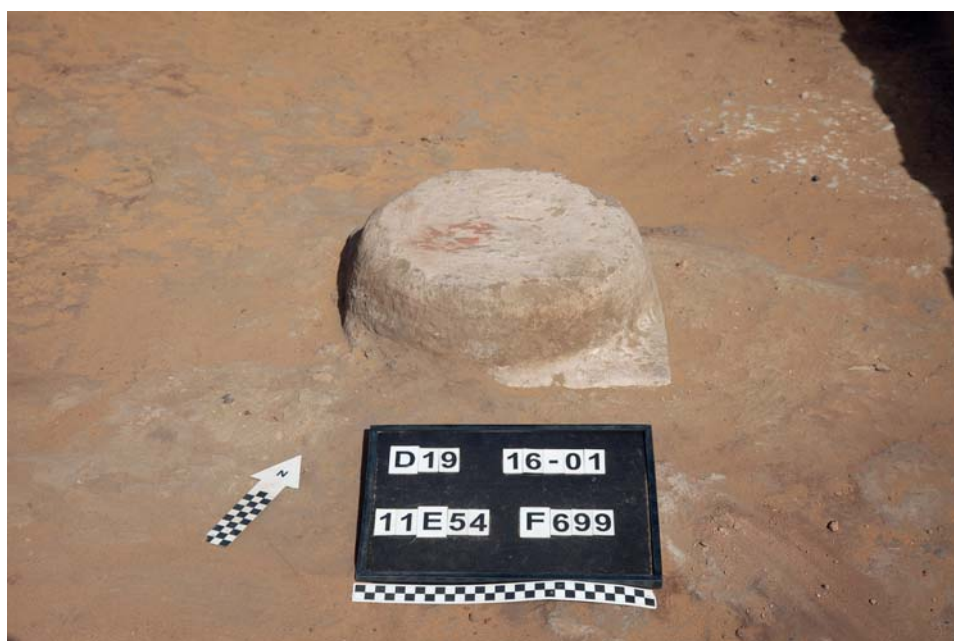
Fig. 135. Post base F699 in room U44

Through a narrow corridor (0.95 m by 1.6 m), one entered U44, the largest room of the building. Together with the corridor it measured 5.25 m by 4.3 m and was equipped with four benches. Against the southwestern wall of the room was a bench approximately 0.55 m wide (F531), which served as a stand for at least six bins made of sun-dried clay. The three other benches in the room, F542, F543 and F544, were built against its northwestern and northeastern walls. Roughly in the middle of the western half of the room, a stone base (F699, originally a capital?) for a vertical wooden post supporting the roof was sunk into the ground [*Fig. 135*].

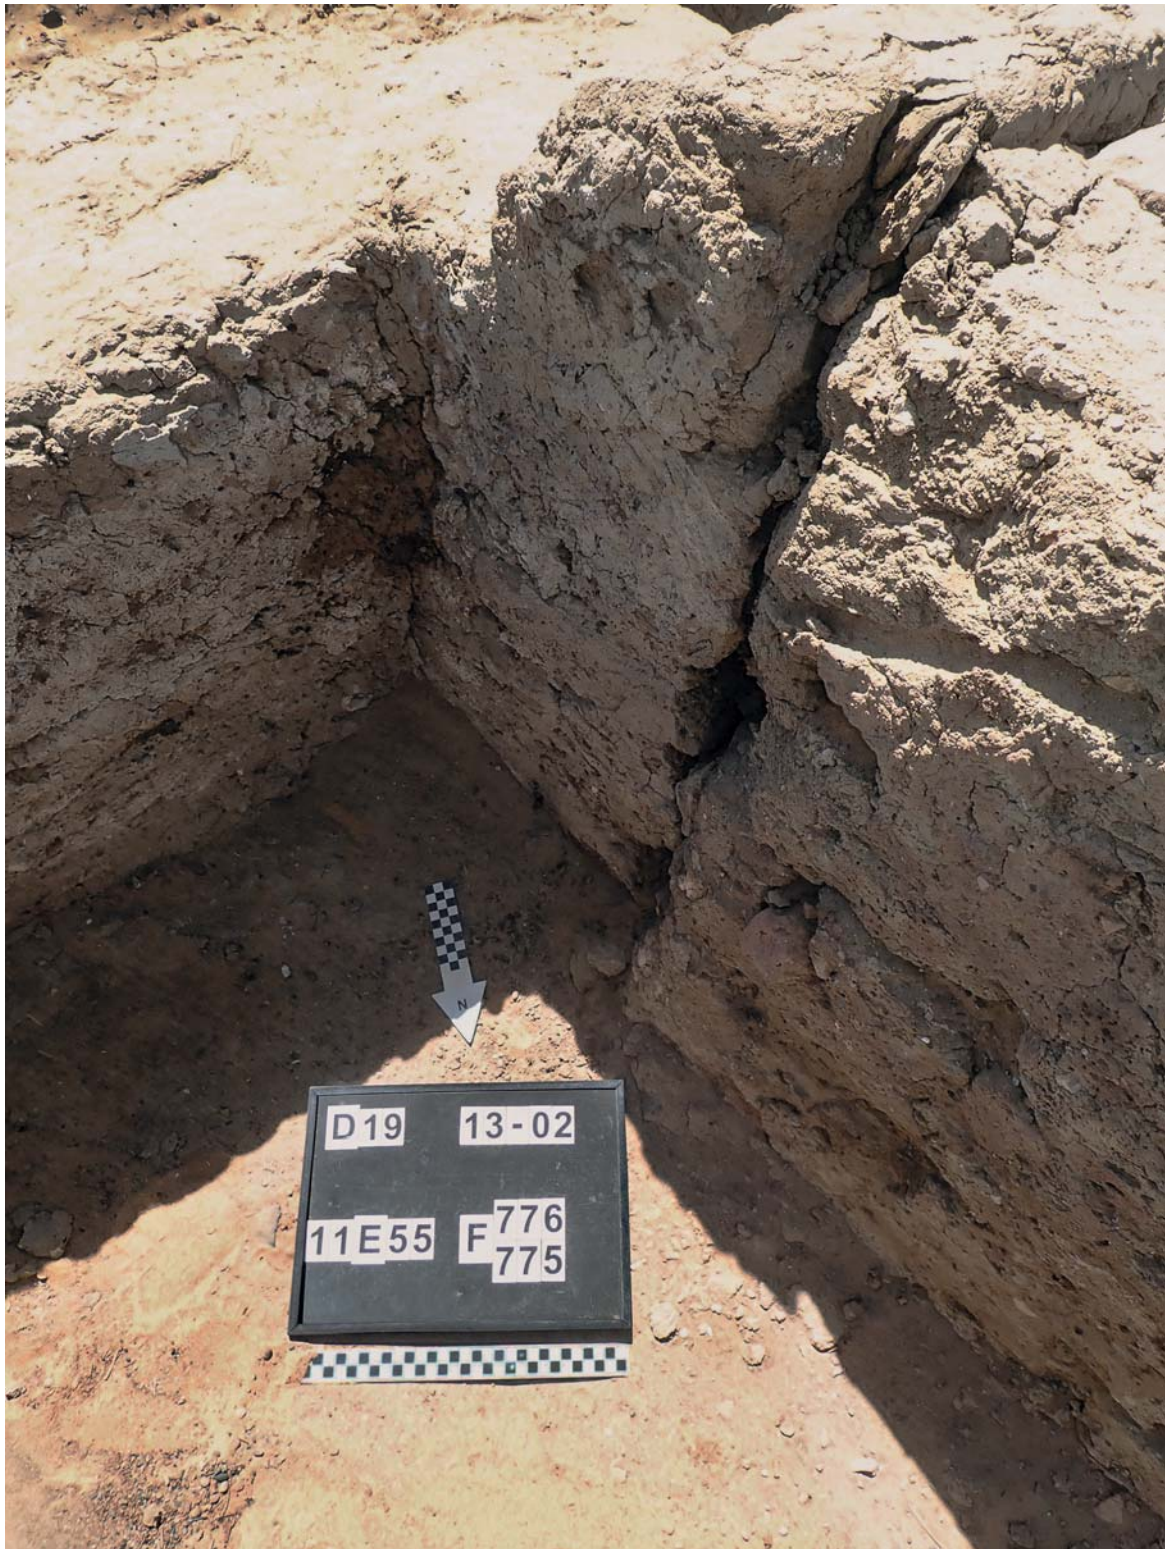
Fig. 138. Joint between walls F775 (left) and F776 (right)

Six building phases were recognized. Apparently, the oldest wall of the complex was the northwestern wall of U60 (F776), which may have originated from an earlier building. It is roughly cut at the southeastern end, and on its slightly sloping northeastern face there are numerous traces of burning, while no such traces were found on the floor (F783) next to it. F776 was abutted on the southeastern end by wall F775, which was bonded with most of the walls of the building (F774, F777, F778, likely also with F786) [*Fig. 138*]. The northwestern wall (F799) is also one of the older walls of the building (though not contemporary with F776), abutted by the east wall, F786. The youngest in the complex was certainly wall F887 (founded at elevation 18.20 m, phase U60.2), added at the western end of F799. Its purpose and relationship with F799 remain uncertain. No other foundations were reached and the lowest exposed elevation of the walls is 17.74 m for F775 and F777.

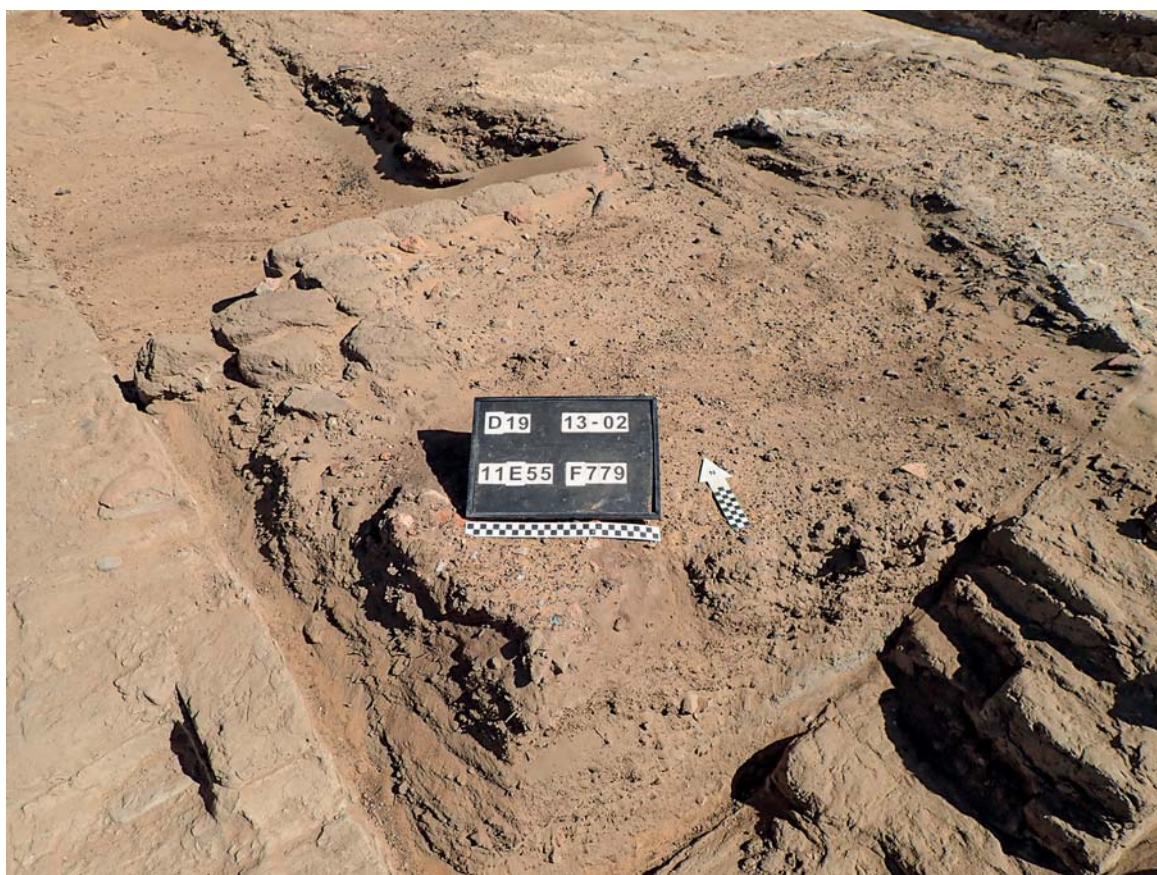
Fig. 140. Remains of bench F779 and floor F784 in the background, on the left

The earliest examined floor of this room (F784, upper elevation 18.69 m) was of tamped earth, now severely burnt. It extended from the remains of an earlier bench (F779) in the southwest corner of the unit to the remains of another bench (F810) against the northwestern wall of the unit [Fig. 140]. It was concealed under a conflagration layer (context 397, elevation 18.59–18.80 m) characterized by burnt plant remains (pieces of wood, fragments of mats, etc.) and fragmented sun-dried brick fired red and orange by the fire. This layer also yielded pieces of a blue-glazed vessel (inv. no. P4356). The layer on top of 357 (context 395, elevation 18.72–18.96 m) showed mixed contents including dark-brown earth, large amounts of sheep dung, and some lenses of ashes. These ashy deposits were preserved in the entire western half of the unit.

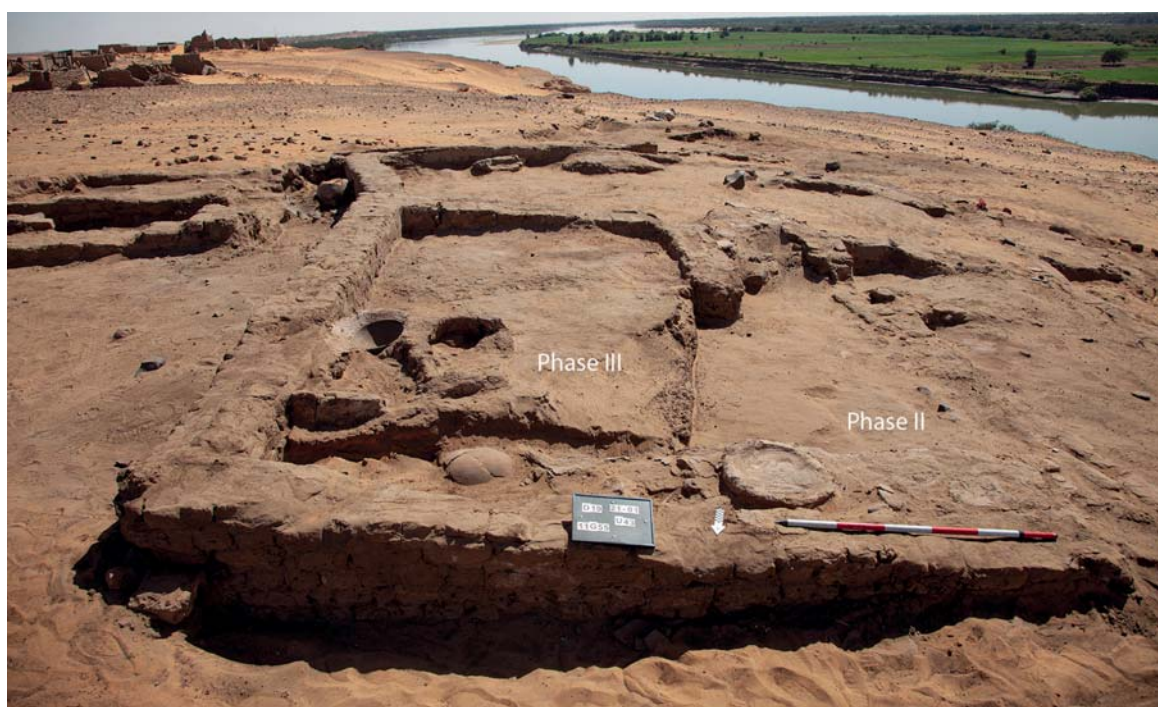
Fig. 144. U43, view looking south with indication of phases II and III

U43, located northeast of U51, is trapezoidal in shape and slightly larger, measuring 4.00 m northwest–southeast and 3.80–4.00 m northeast–southwest. It is the only space where a clear distinction is visible between the second and third occupational phases, although the earliest one has not been reached [*Figs 144–145*]. As in the case of U51, the entrance from the courtyard leads down through a doorway furnished with a stone threshold. Elements of a doorjamb preserved next to the threshold indicate that the passage was closed with a door. During the second phase, the space was covered with a floor comprising three consecutive layers lying one atop the other. The earliest one (F969, elevation 17.24 m), made of whitewashed *qurba*, is visible only in the northwest corner and is contemporary with the first layer of coating on bench F613. The second one, F886, 4 cm thick, was made of mud (elevation 17.28 m). Lastly, the floor was covered with a 6 cm thick layer of tamped mud and animal dung (F612, elevation 17.34 m). The space was furnished with two benches: long and narrow F613, located along the northwestern wall of the space (F618), with traces of five storage bins made of *gir* embedded in its surface (a relic of only one, F854, is preserved) and a second one (F609) between walls F608 (stub wall), F607 and F606. Bench F609 is covered with a later floor, F611 (see below, Phase III). All walls connected with this phase were coated with plaster sloping to the walking level and comprising three layers: grey mud, yellowish *qurba* and *gir* whitewash.

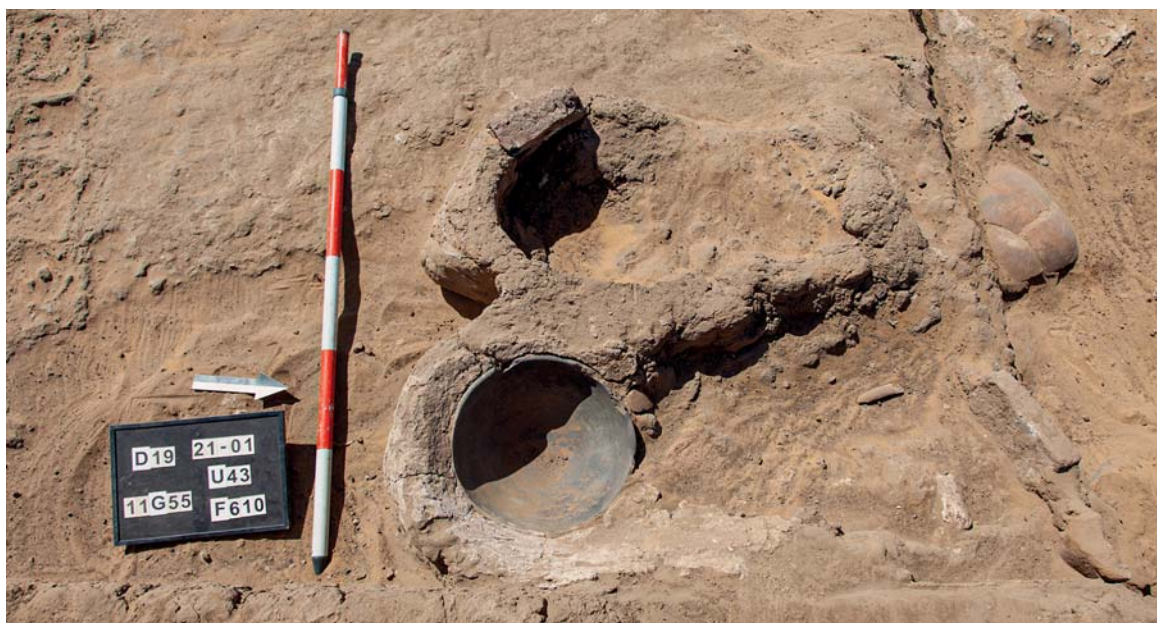
Fig. 146. U43, double quern emplacement F610 from phase III

In room U43, a new floor (F611) was laid about 30 cm above the earlier one, on the same level as the upper surface of bench F609 (elevation 17.67 m). The space between the floor levels was filled with sand with a high organic admixture (layer 389). Floor F611 was a thick layer of mud white-washed with *gir*. Another feature belonging to this phase in U43 was a double quern emplacement (F610) embedded in the floor next to wall F606 [Fig. 146]. It is very likely that the bins on bench F613 were in use also in the third phase, as there are no traces of a floor above them and the layer of surface sand descends to the top of the bench. Internal walls were covered with another layer of mud plaster, a relic of which is preserved in the corner formed by walls F607 and F608. Within layer 371 of subsurface sand mixed with organic matter filling the top of the unit, five grinding stones were recorded, most of them near the quern.

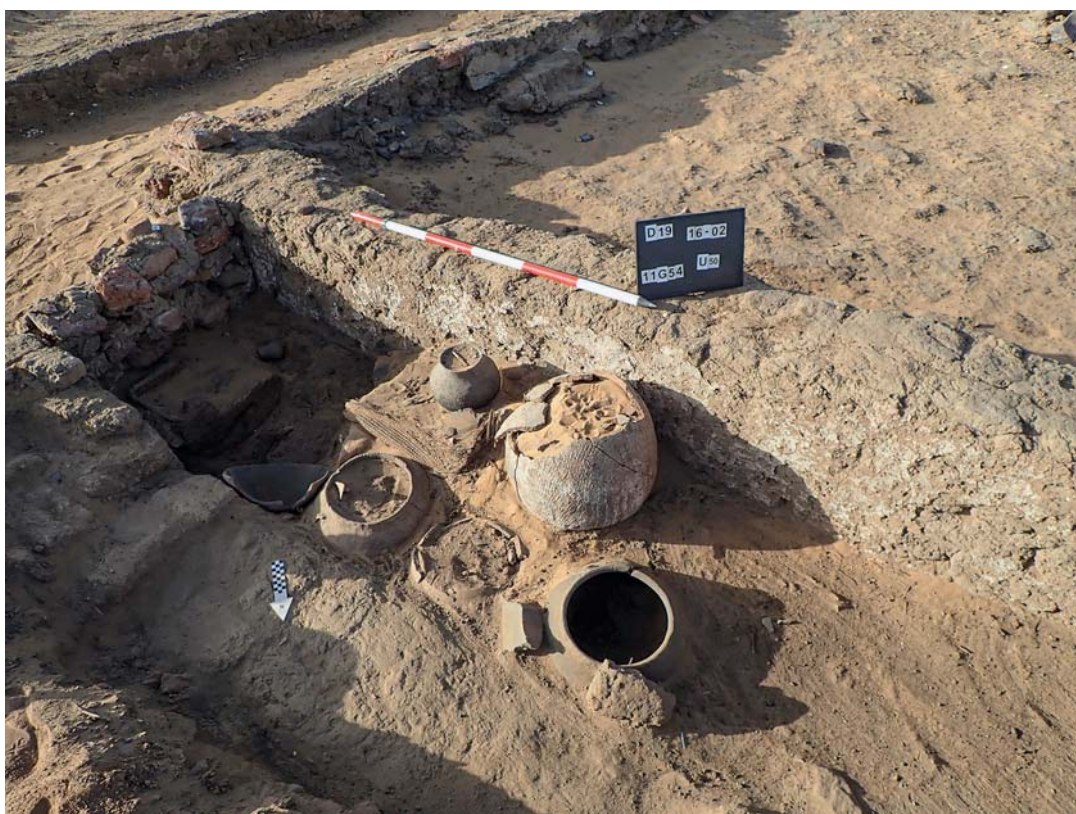
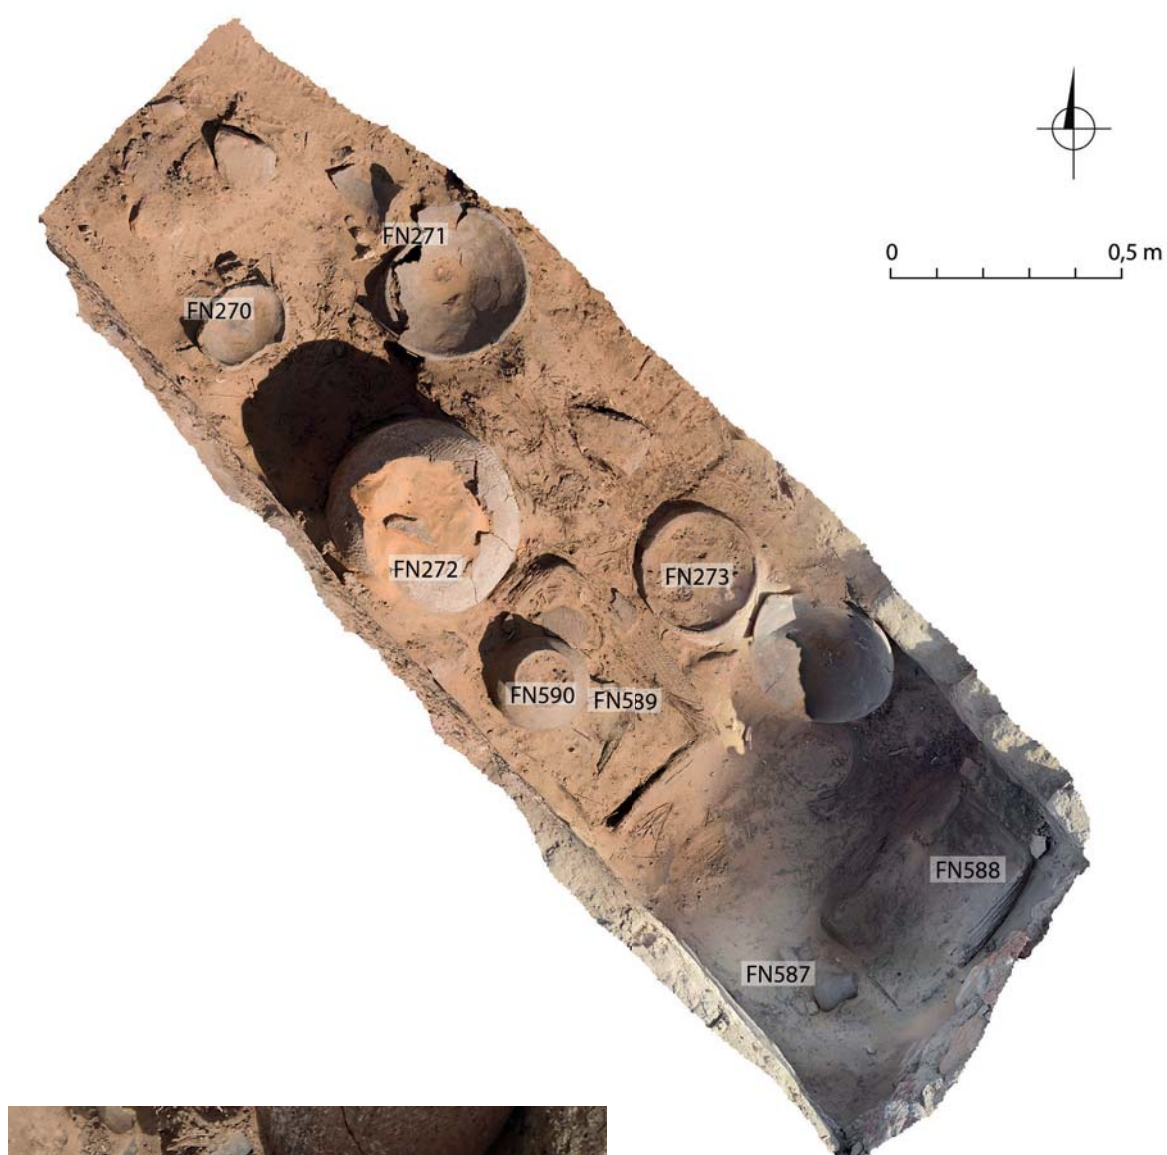
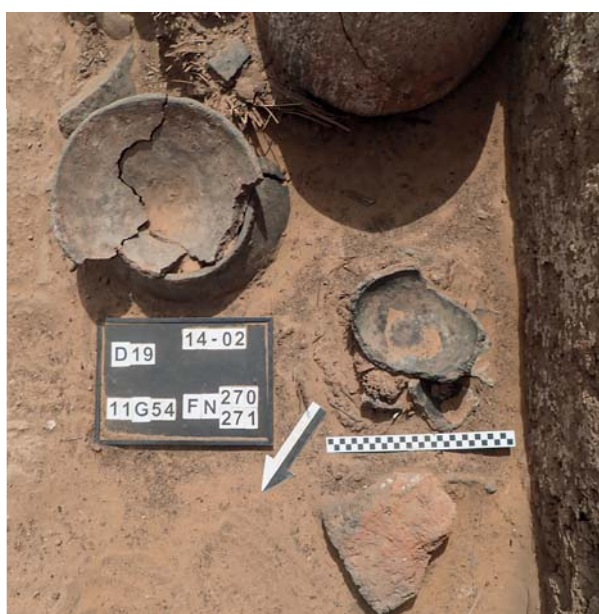
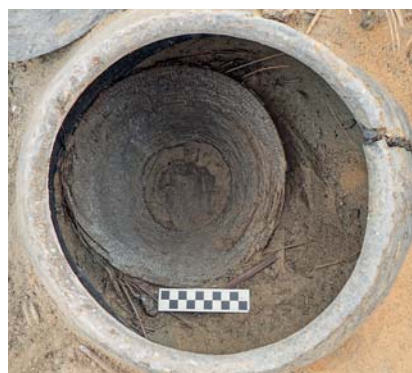
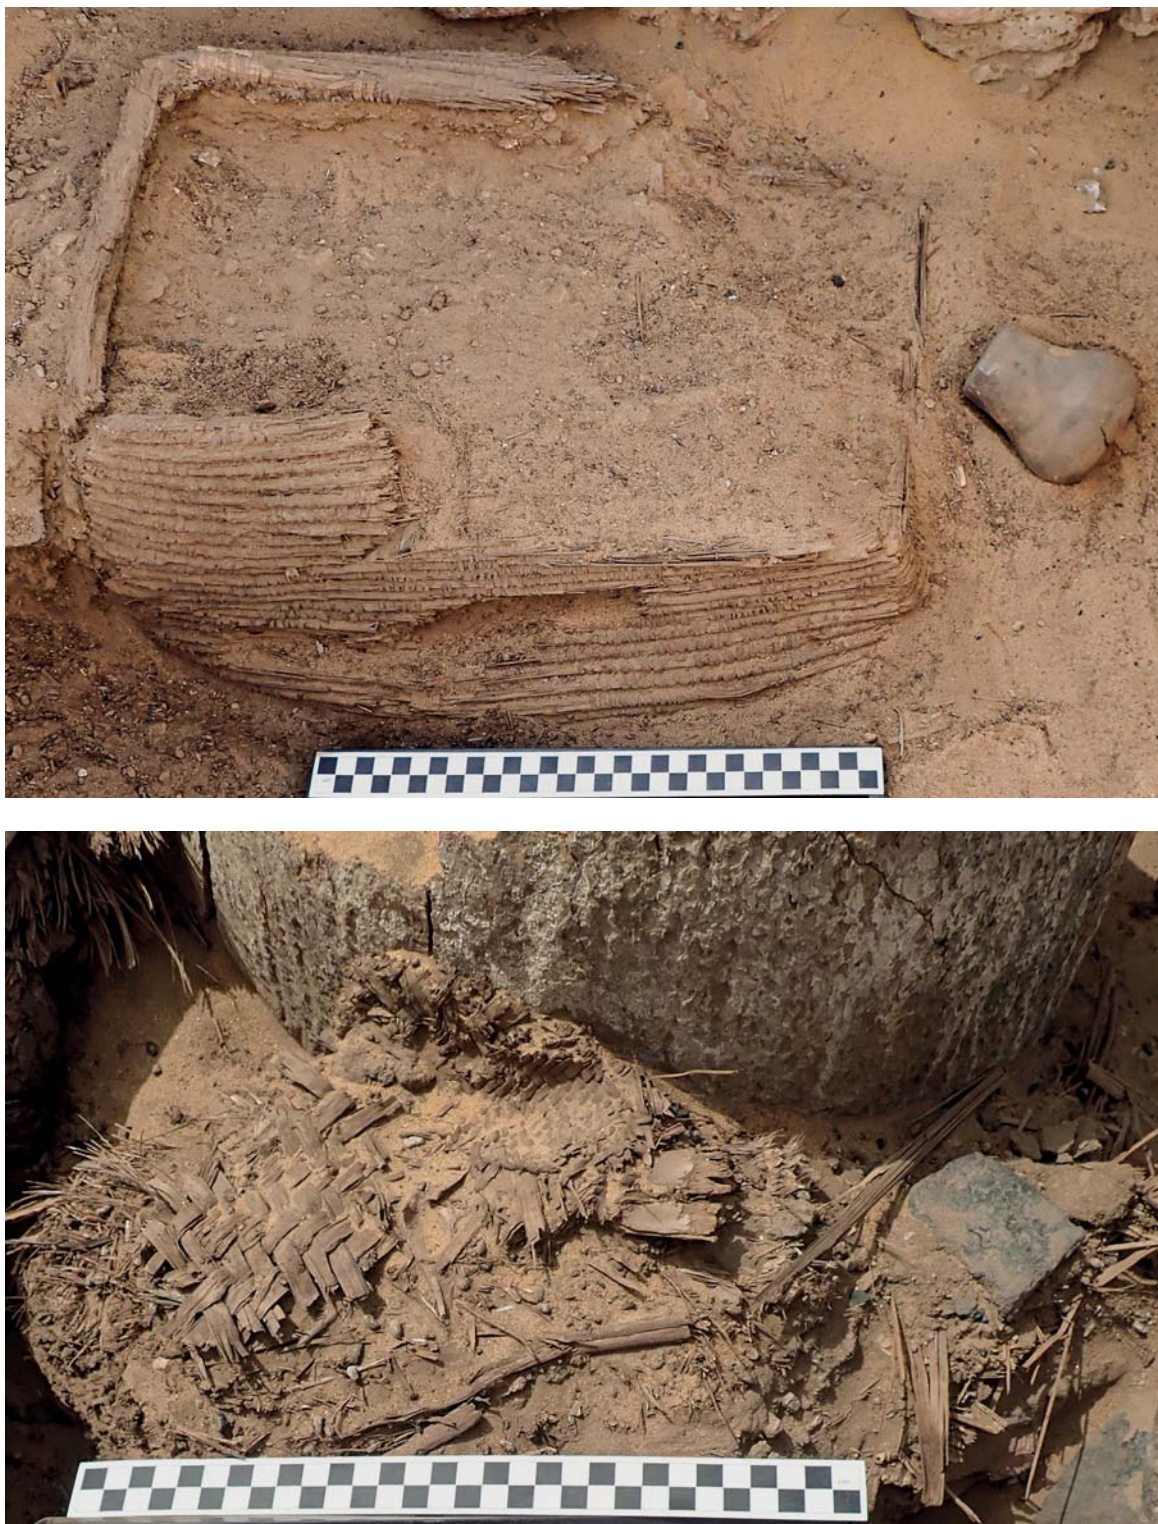
Fig. 147. Deposit of pantry equipment in U50, view looking south

Fig. 148. Deposit of pantry equipment in U50, orthophoto

Fig. 149A–B. Deposit of pantry equipment in U50, details: bowl FN270 on pot FN271 (left); basketry lid inside pot FN277 (right)

Fig. 150A–B. Deposit of pantry equipment in U50, details: rectangular basket FN588 and cup FN587 (top); fragments of mats (bottom)

U50 was a long and narrow room between two compounds. The upper, subsurface layer consisted of sand with organic inclusions (369), and the proper fill (371) was brown soil with a high admixture of organic matter including chaff, dung, shredded fragments of basketry, various seeds (stowed for archaeobotanical analysis) and ashes. After the removal of the two layers, an intact deposit of storage containers and household utensils was discovered [*Figs 147–150*]. It included the

following: two completely preserved rectangular baskets (FN589 and FN588), four large, complete pottery storage vessels (FN272, FN271, FN583, FN273), one small vessel (FN590), and remains of two more containers (FN268 and FN270). All pots were found standing on mats woven of plant fiber (e.g., FN586). Additionally, some of them were covered with basketry lids/plates (FN583). In the case of two pots, FN271 and FN273, the presence of lids made of reused handmade bowls was noted. With these two pots were also connected two round basketry plates (FN591 and FN585), one found beside the first pot and the second inside the other one. Possibly they were also used as covers. The storage inventory was completed by three wooden elements: a cup (FN587, inv. no. 1389) and two fragments of a door bolt (FN261 and FN262, inv. no. 1065). The containers and utensils were found in the order in which they had been left by the person who had used them, one standing next to the other and in some cases one atop the other. One pot was placed on each basket: FN590 on FN589 and FN268 on FN588. The unearthened pots were handmade, adorned with some basic incised and impressed decoration. They belong to a repertoire of wares typical of the late 16th and early 17th centuries (period III.A/III.D; see Phasing and chronology below, *Table 9*, pp. 234–235), as indicated by parallels from current excavations and past research at Old Dongola (Wodzińska 2015; Danys forthcoming).

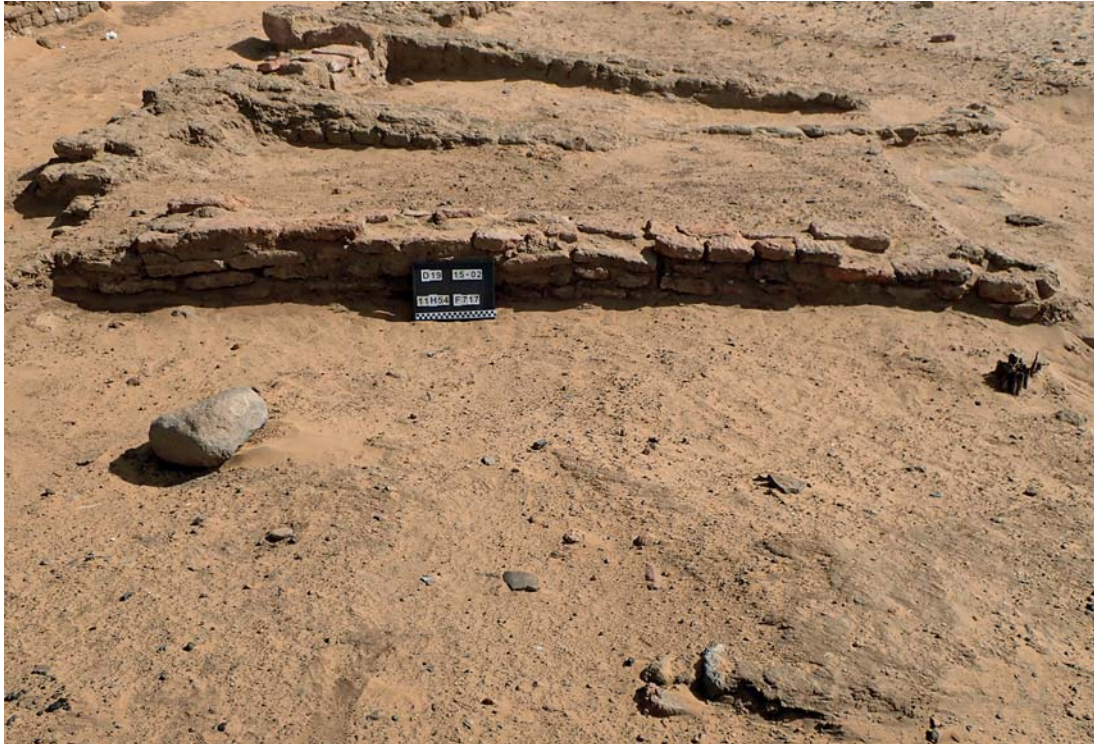
Fig. 158. Wall F717 (in the background) and floor F719

The oldest walls in the square were F717 and F718, built of fragmented fired bricks and tiles. They were abutted on the western and southern sides by a floor of more or less tamped earth (F719, elevation 16.49 m) directly underlying rubbish layer 231. On the northeastern side, wall F717 was abutted by another floor of tamped earth (F708, elevation 16.64 m), which survived in patches [Fig. 158]. There are at least two vertical wooden posts preserved in this floor, separated

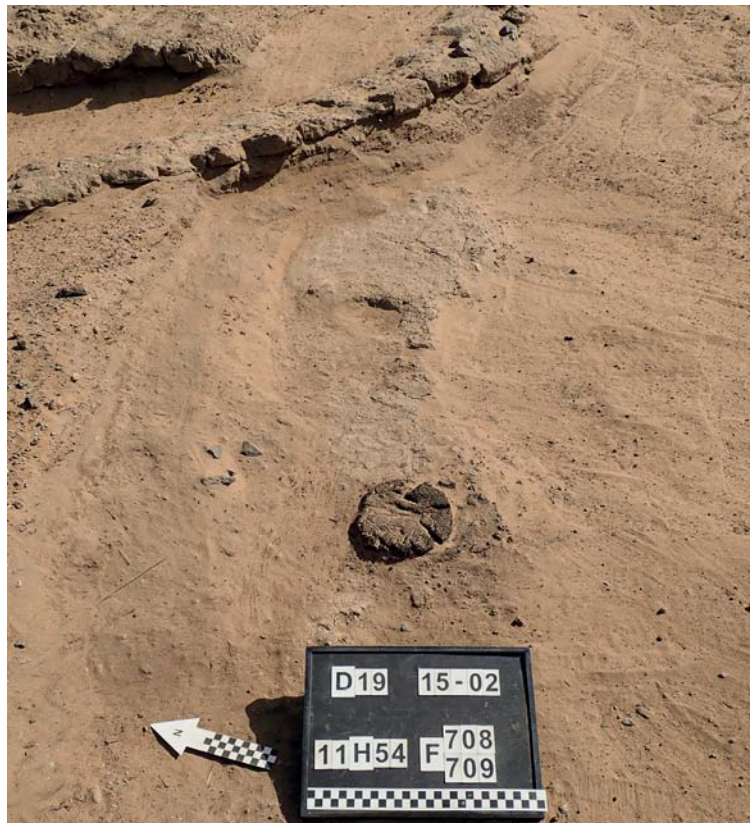
Fig. 159. Wooden post F709 in floor F708

by a distance of about 4 m (F709, F710). They were certainly earlier than the floor itself. Their tops were burnt [Fig. 159]. Floor F708 was covered by rubbish layer 230. On top of it, in the northeastern quarter of the square, a fragment of a circular structure (F707, lower elevation 16.82 m) of sun-dried bricks came to light [Fig. 160].

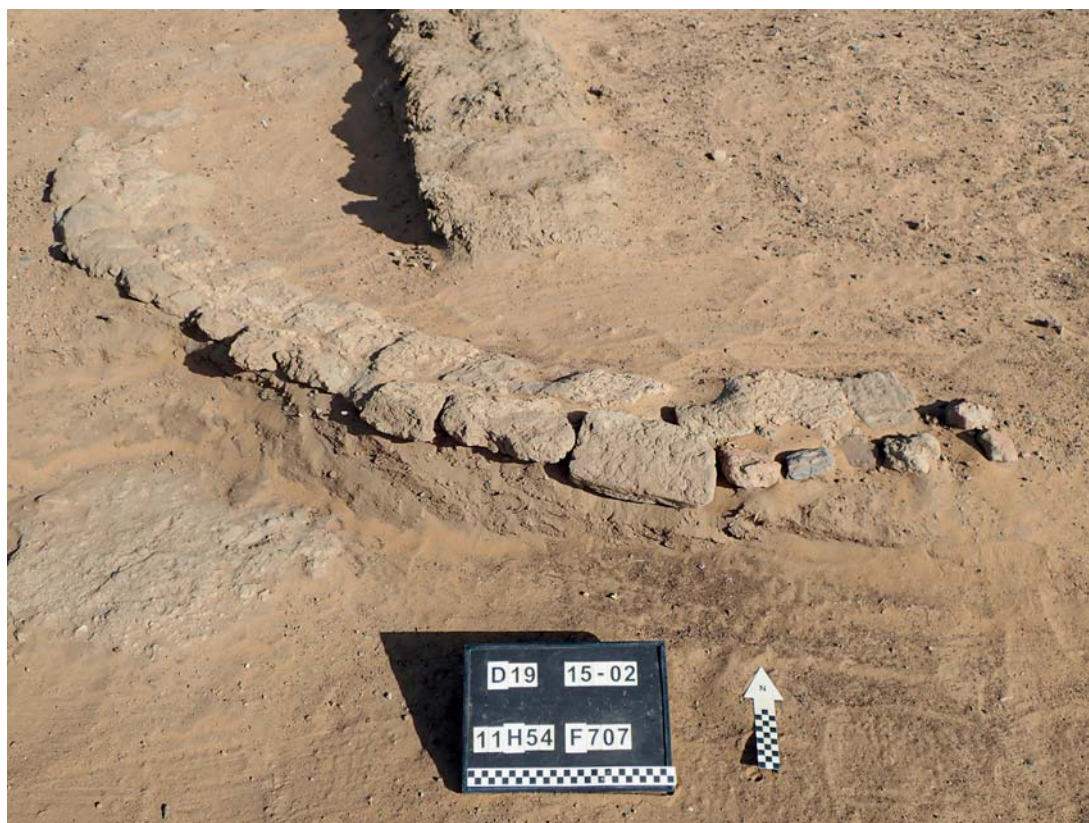
Fig. 160. Wall F707

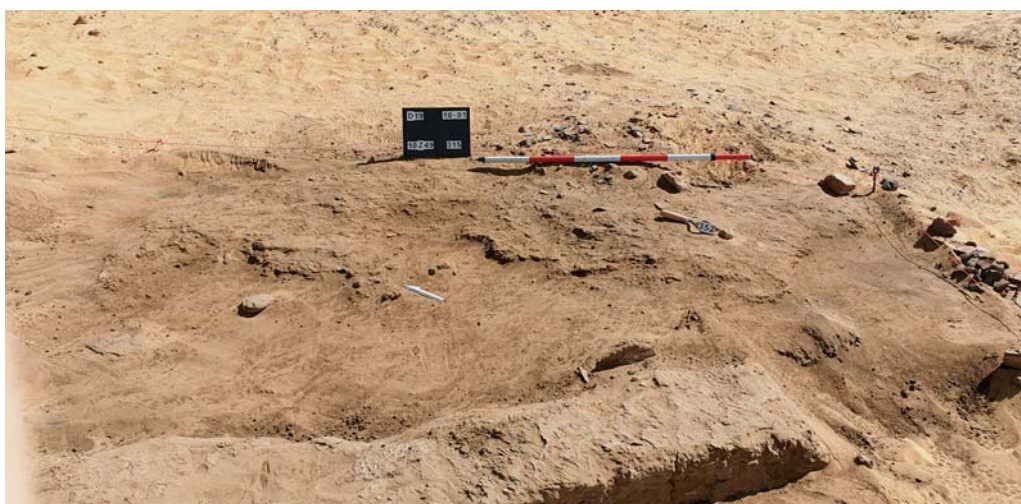
Fig. 164. Deposit 315 with FN352

Almost immediately under the surface, there was an organic layer with traces of burnt matter (315) sloping toward the west [Fig. 164]. The layer continues eastward beyond the edge of square 10Z49.

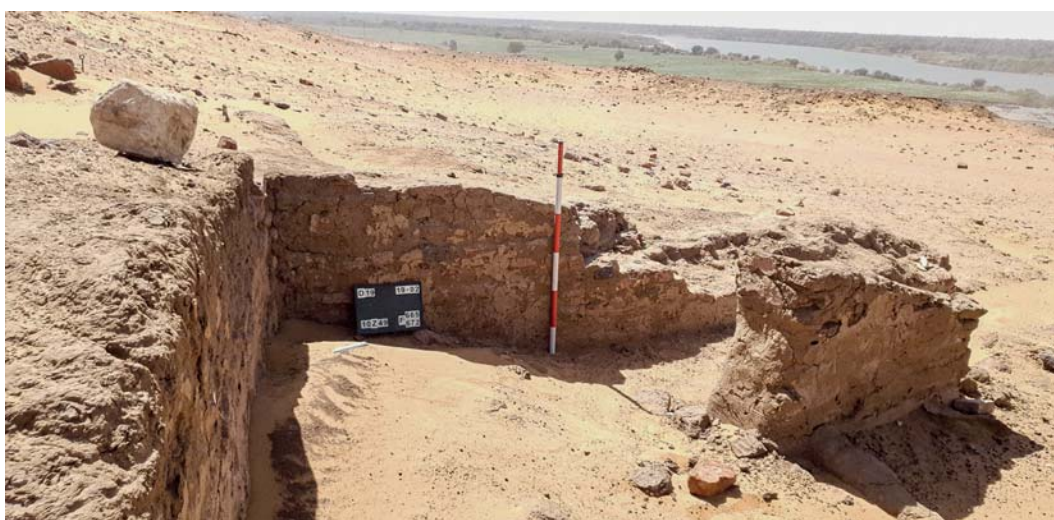
Fig. 166. Room U99, wall F665 on top of F672 and, in the foreground, stub wall F668

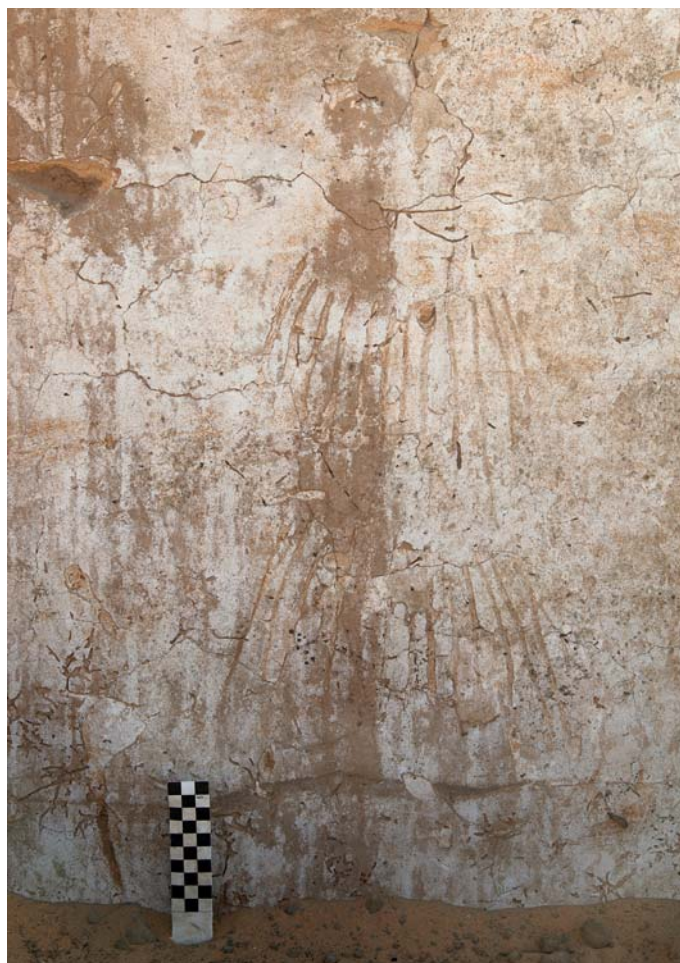
Fig. 167. Grooves on wall F643

The earlier and the later walls of the dwelling were plastered together with a new coating of whitewashed mud plaster to conceal the difference in the construction materials and give the new building a uniform appearance. The plastered surface of wall F643 bore a series of intentionally made vertical grooves [Fig. 167].

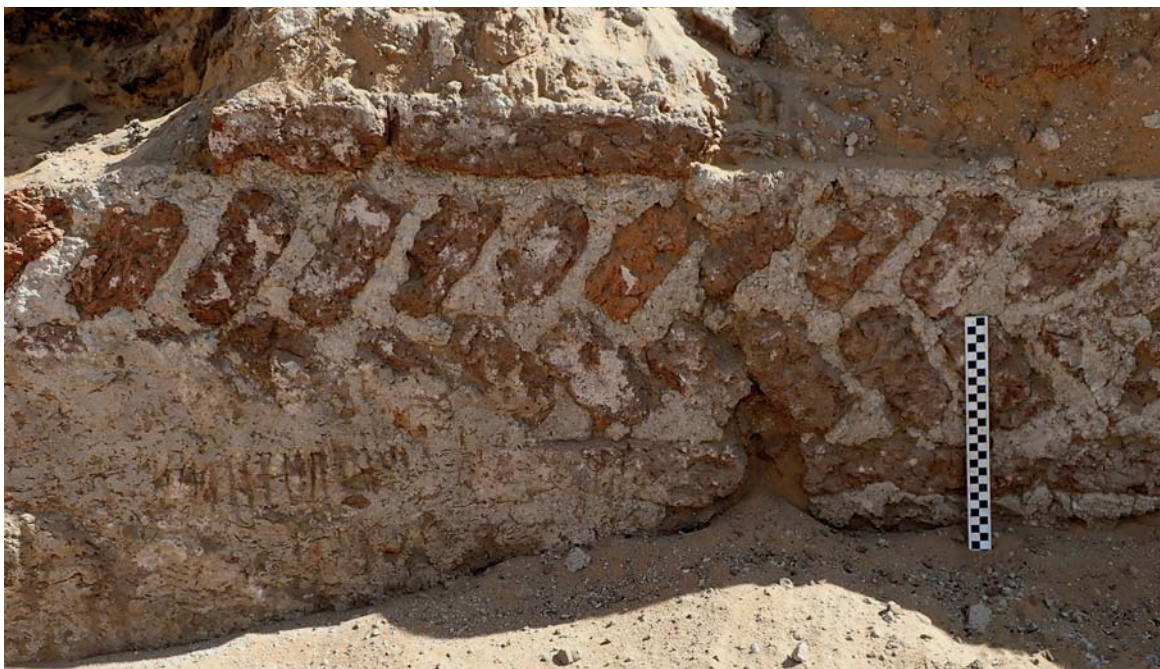
Fig. 168. Detail of F679: fishbone pattern of brickwork and vertical scratches on the plaster

The curved wall F679 is made of fired bricks bonded in alternating courses of stretchers and headers [Fig. 170] with a strong lime mortar applied in thick layers. In its uppermost courses, the wall presents a fishbone pattern carried out with bricks of greater thickness and shorter length than the ones used below. They are laid in an alternating, oblique pattern with an abundant use of lime mortar to fill the spaces. On top of the fishbone course there are traces of at least one more course of fired bricks in stretcher bond [Fig. 168].

In the southern part of the wall's inner face there were traces of painted lime plaster still *in situ*. The northern part of the inner face of the wall presents, instead, some traces of whitewashed mud plaster. This part of the inner face of the wall also features a sequence of deep, vertical grooves (15 in total) cut in the surface of the plaster/mortar and reaching deep into the bricks [see Fig. 168 and above, Fig. 165]. They all have the same height and are close together. Similar grooves are attested on other Christian sites (Żurawski 2012: 378–379; Kötting 1950).

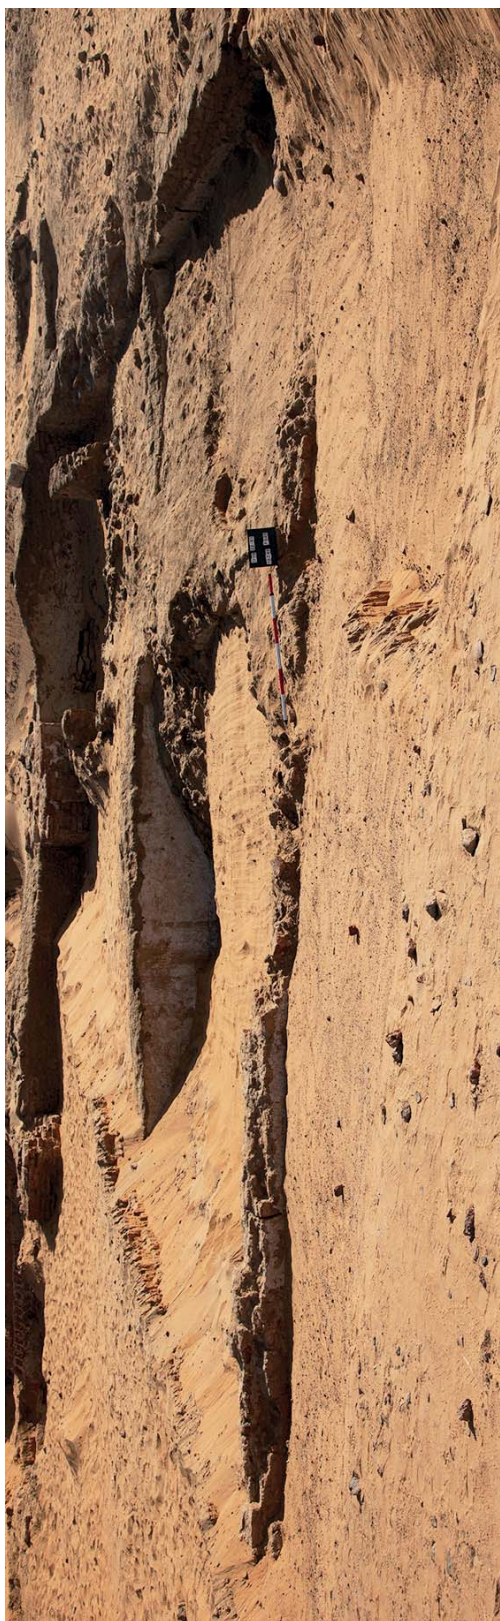
Fig. 169. Presumed church in Zone 1.5

The Funj-period residential building (period III.B) was constructed on top of an earlier structure [Fig. 169]. The two walls, F665 and F667, stood atop the remains of the earlier walls, F672 and F673, made of fired bricks, reused as foundations for the walls of U99. When the sun-dried-brick structures were built, the fired brick ones had probably already been abandoned for some time, as their tops appear to slope toward the west, following the natural inclination of the hill and suggesting that erosion may have been on-going for some time before their reuse. The features that formed part of the early building include the curved wall of the apse and three fired-brick pillars.
