# **OLD DONGOLA**

## **DEVELOPMENT, HERITAGE, ARCHAEOLOGY**

FIELDWORK IN 2018–2019. VOL. 1. EXCAVATIONS

EDITED BY Artur Obłuski and Dorota Dzierzbicka

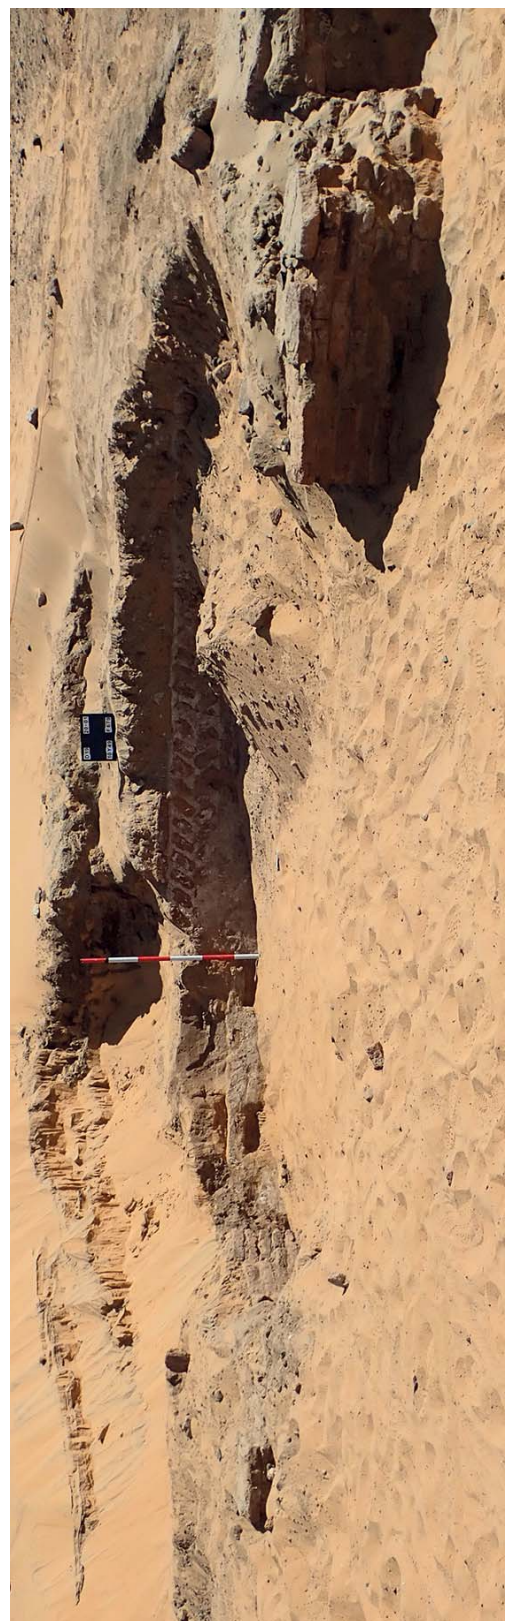
Fig. 170. Curved wall F679

The curved wall F679 is made of fired bricks bonded in alternating courses of stretchers and headers [Fig. 170] with a strong lime mortar applied in thick layers. In its uppermost courses, the wall presents a fishbone pattern carried out with bricks of greater thickness and shorter length than the ones used below. They are laid in an alternating, oblique pattern with an abundant use of lime mortar to fill the spaces. On top of the fishbone course there are traces of at least one more course of fired bricks in stretcher bond [Fig. 168].

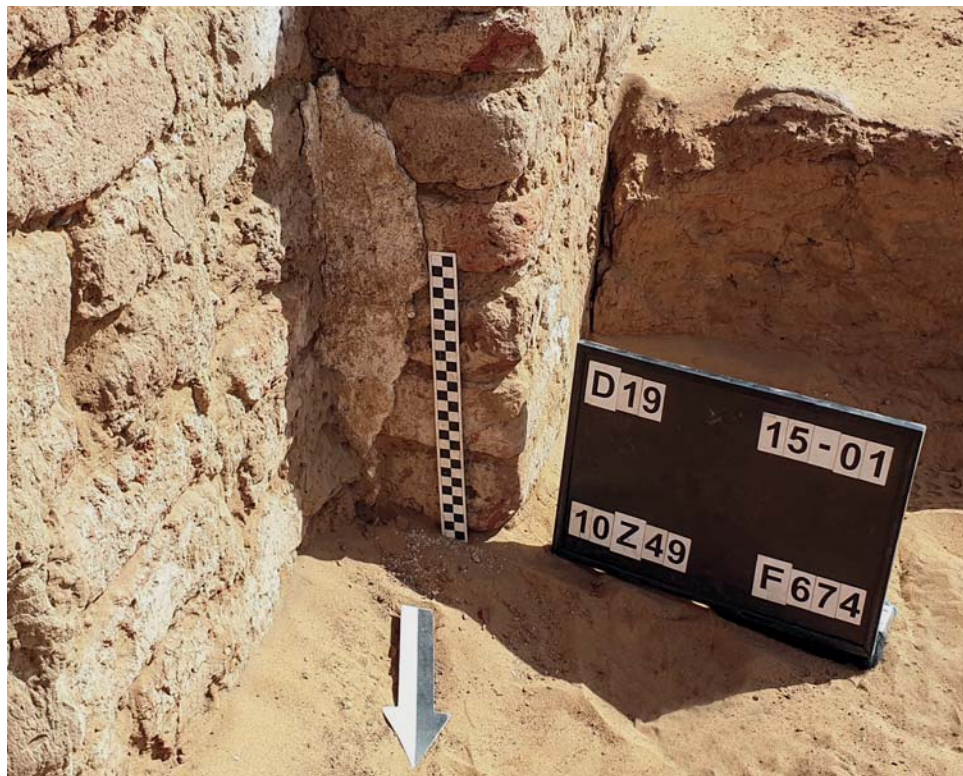
Fig. 172. Lime plaster F674 on pillar F670

The northern side of the pillar presents some traces of what could be its original plaster (F674), made of a thick layer of lime mixed with sand [Fig. 172]. On the northeast side of the pillar, there are traces of what was probably a wall (F671) made of white sandstone blocks, of which now four remain *in situ*, arranged in a row.

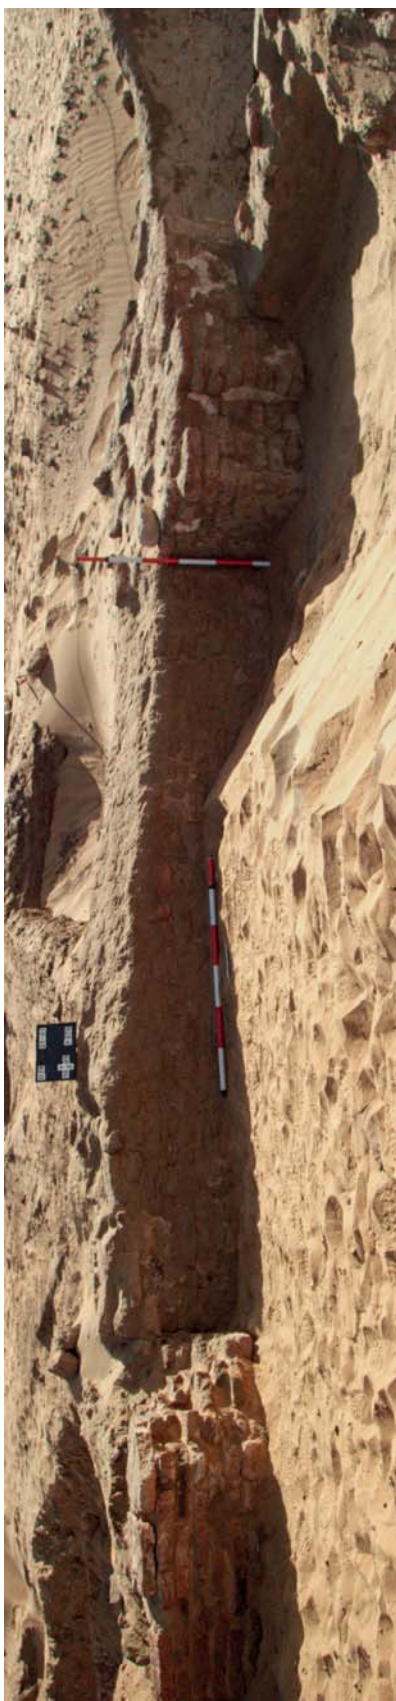
Fig. 173. Wall F676 between pillars F670 and F677/F678

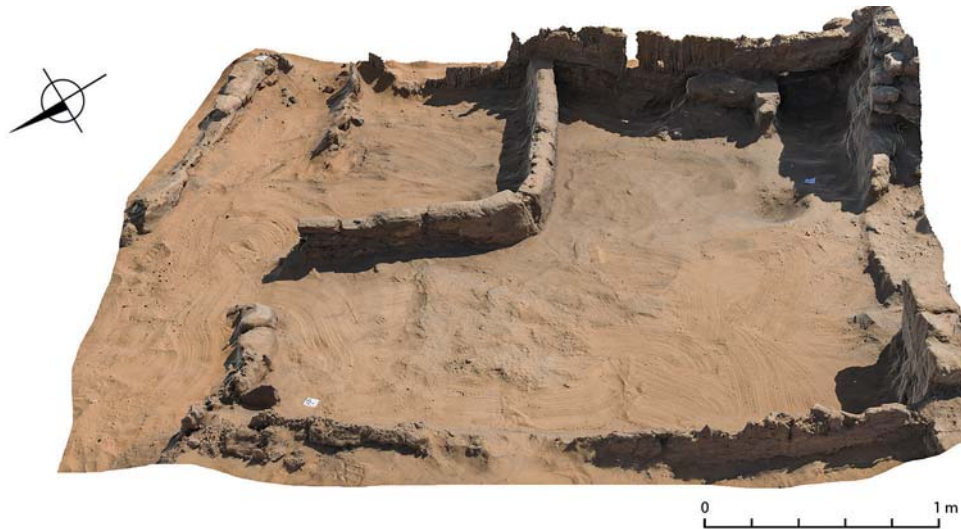
Fig. 178. Room U20a, aerial view

The room was constructed in period III.C when three walls (F297, F300, F307) were built to abut the already existing city wall (F301), which was replastered at the time (F321) [*Fig. 178*]. Contemporaneously, floor F306 (elevation 20.00 m) and bench F298 were constructed. In the southern part of the unit, a hearth was set up, leaving burnt layer 255 as evidence. The room was also associated with the space to the northeast, as wall F300 continued northeast of the unit (now destroyed by erosion).

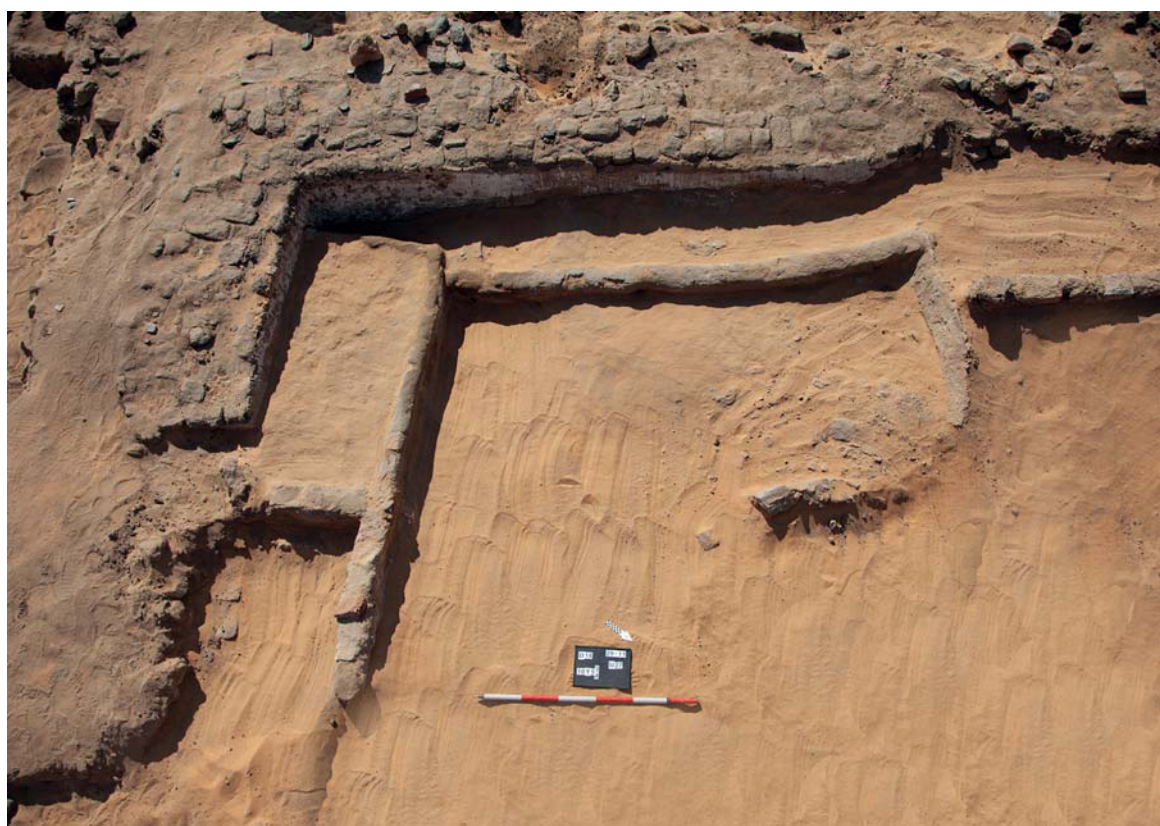
Fig. 180. Room U27, aerial view

U27 stood against the city walls (F340, F341) to the southeast of U20a/20b [Fig. 180]. Its features are preserved to a height of 60 cm. The room was constructed in period III.B when a wall made of reeds covered with mud (F345) was built abutting city wall F340, contemporarily with the construction of wall F346 and the laying of floor F347 (elevation 20.47 m). At the same time, bench F344 and a bench comprising walls F349 and F348 were built to abut city wall F341. Walls F341 and F340 were also given a new layer of plaster (F342). Subsequently, bench F343 was built abutting bench F344. In the corner formed by the two benches, a hearth with burnt layer 238 was set up.

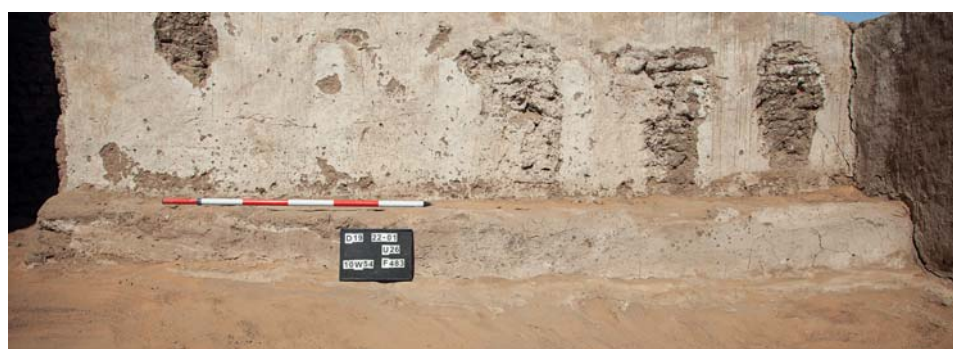
Fig. 184A–B. Bench F483 in room U26a, view (top); section of room U26a showing bench F483 (bottom)

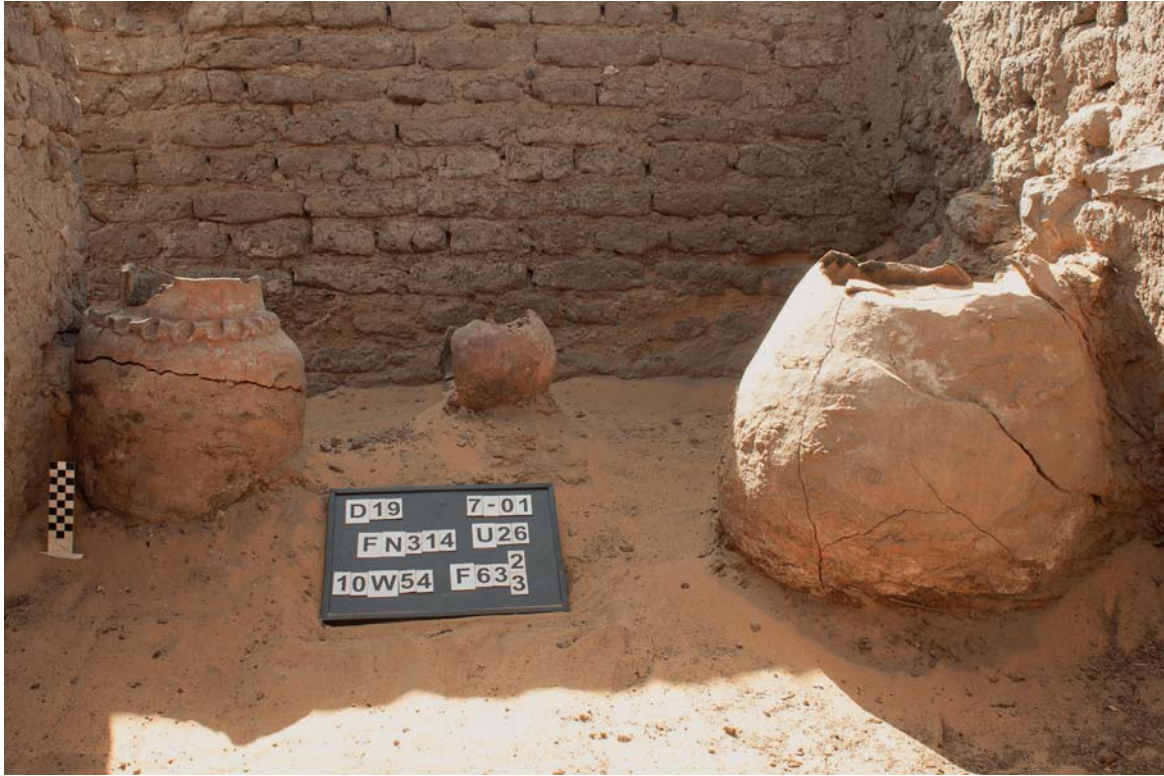
Fig. 185. Storage jars in room U26b

The northwestern room (U26b) is much smaller than the southeastern one. Its storage function is indicated by three storage vessels (F633, F632 and FN314) [Fig. 185], a quern and a large, shallow stone vessel with two handles, deposited upside down, possibly on purpose (both the stone vessel and the quern were found bottom-up on the same occupational level as the storage vessels). The vessel, a unique find at Old Dongola, is similar in shape to Islamic-period steatite vessels made in the Eastern Desert (Harrell and Brown 2008: 53; see also Edwards 2018: 655 for a parallel from Attiri) [Fig. 186]. The thick occupational layers in U26b suggest that this space was not swept. They yielded a dozen stone tools, as well as spindle-whorls and basketry lids, which

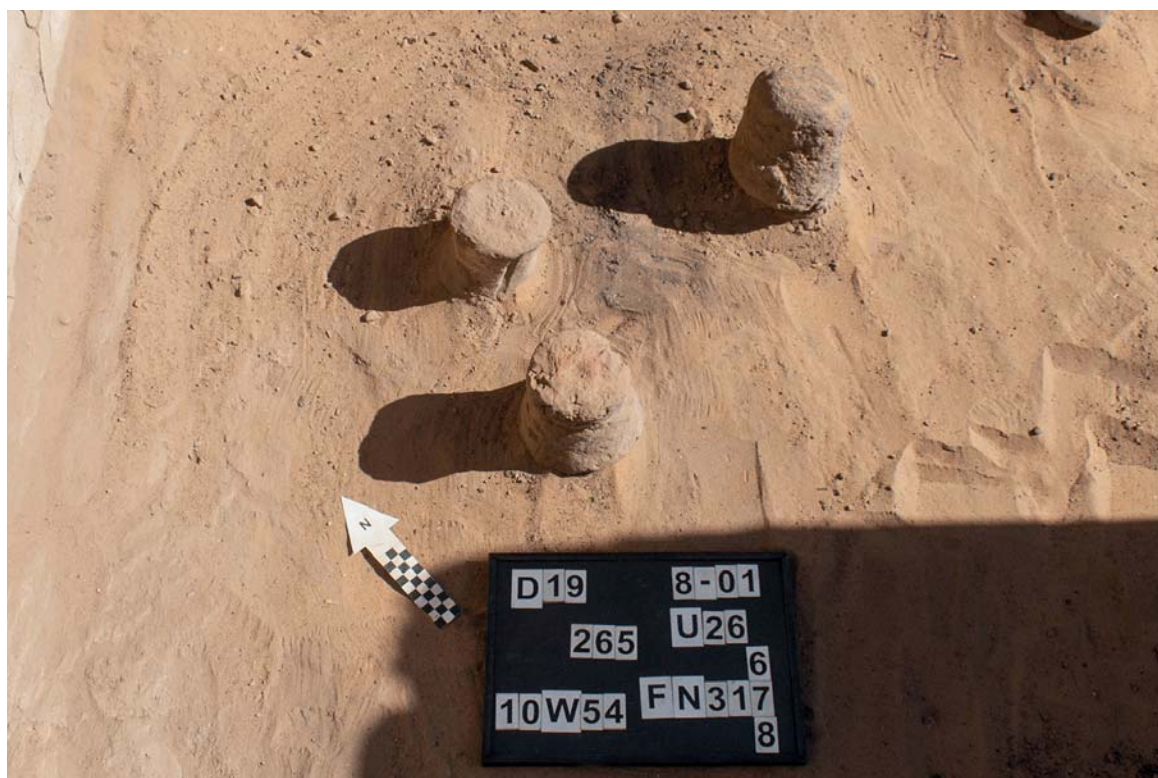
Fig. 187. Hearth in room U26a

In U26a, a hearth (burnt layer 265) with three firedogs, FN316, FN317 and FN318, was in use at this time [*Fig. 187*]. Together with the benches, they indicate that U26a most probably

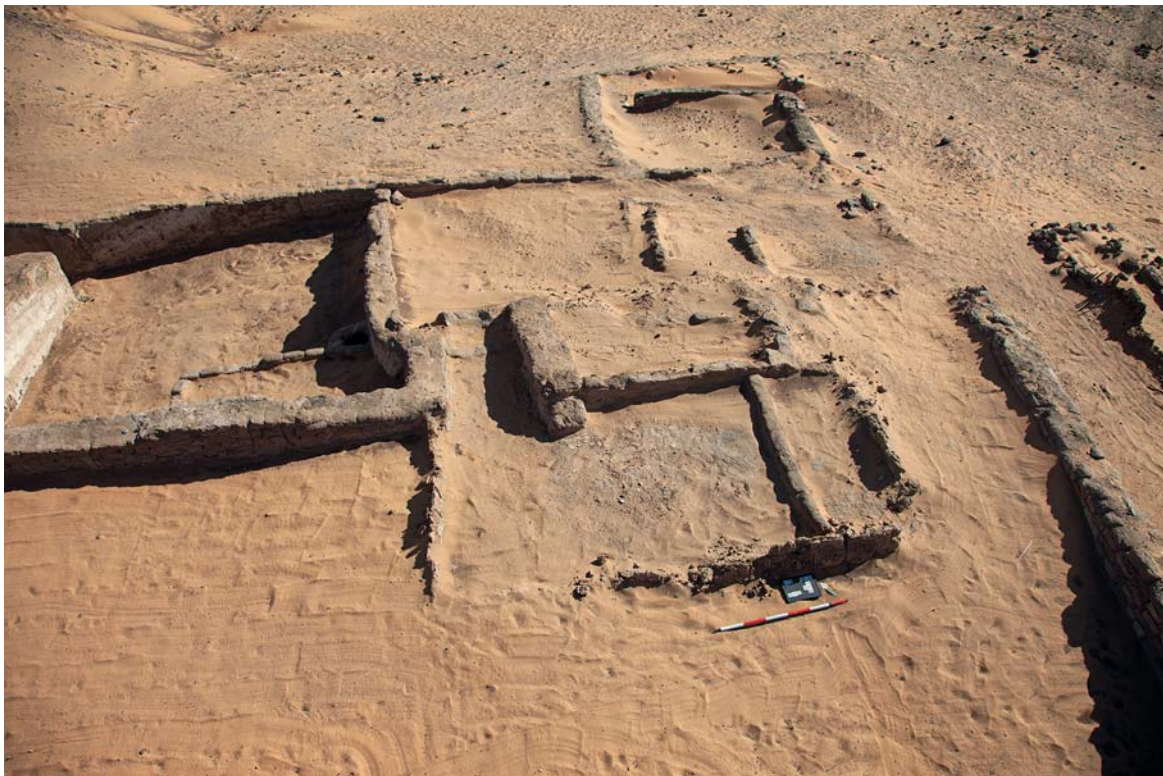
Fig. 188. Compound U15/37/40, aerial view looking northeast

After the abandonment of house U15/26a/26b and the accumulation of sand to the level of 19.30–19.70 m, in the 17th century (period III.C; see Phasing and chronology below, *Table 9*, pp. 234–235) the space of U15 was adopted as a house workspace by the inhabitants of newly constructed U37 with courtyard U40 established on the level of 19.29 m [*Fig. 188*]. The unit

was delimited by a plastered mud-brick wall (F637) in the northeast, by wall F323 in the northwest, and by abutting walls F116 and F117 in the southwest and southeast. The southeastern wall consists of walls F117, F274 and blocking wall F275. Traces of wear on the top of blocking wall F275 suggest that the previously blocked entrance to U15 was used again for accessing the unit. Floor F470 was constructed on the sand deposit (155).

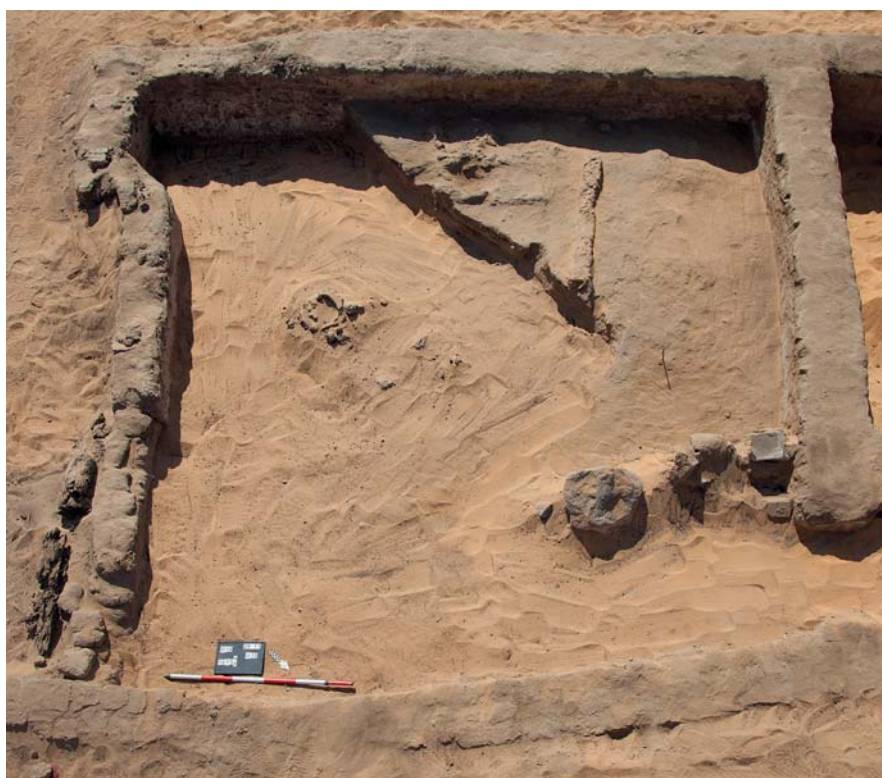
Fig. 189. Room U15, aerial view with a visible quern emplacement in the southern part

In this phase (U15.1), the room was equipped with a quern emplacement, F324, built next to the southwestern wall F116, a hearth set up in the corner of the room and filled with burnt layer 152, and a storage bin located in the middle of the room. The quern was later removed and used to create stub wall F339, additionally screening U15 from U26a [*Fig. 189*].

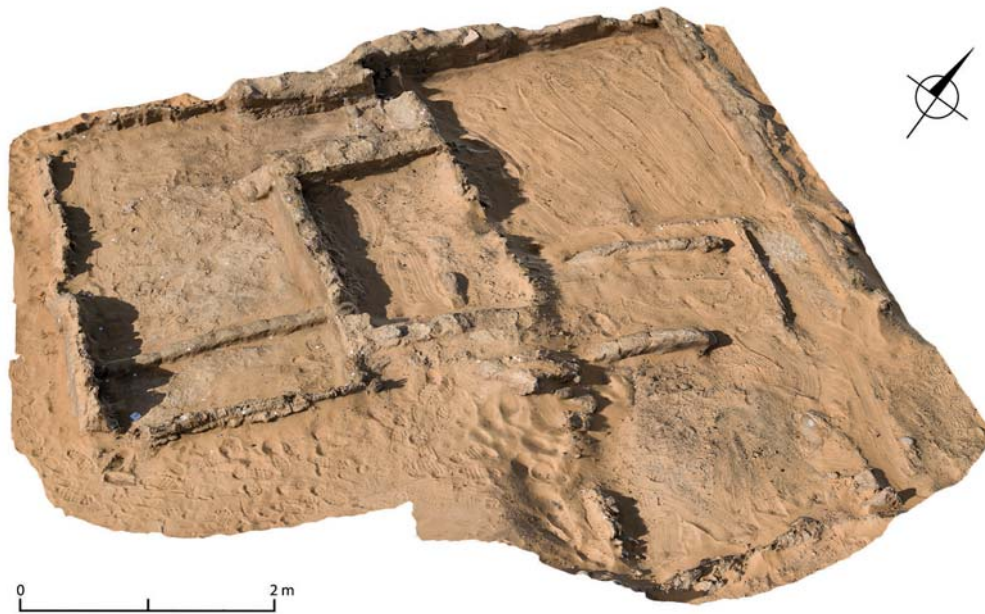
Fig. 190. U37 and U40, aerial view looking northwest

U37 is a square room built abutting the walls of U15 in the south. The room is delimited by a plastered mud-brick wall (F117), by wall F472 made of reeds covered with mud in the northwest, and in the northeast, southeast and southwest by walls F115, F283, F284 and F285, all made of reeds covered with mud. Its features are preserved to a maximum height of 30 cm. U37 has a stub wall that screens off the entrance located in the northeastern wall (F115).

Room U37 had the common form of a square room equipped with two abutting benches and a stub wall screening off the entrance. Evidence of activities performed inside is scant and restricted to the phase after abandonment, when it was used for keeping livestock. The damaged and slightly burned surface of the floor is evidence of fire-related activity, but traces of food processing are lacking.

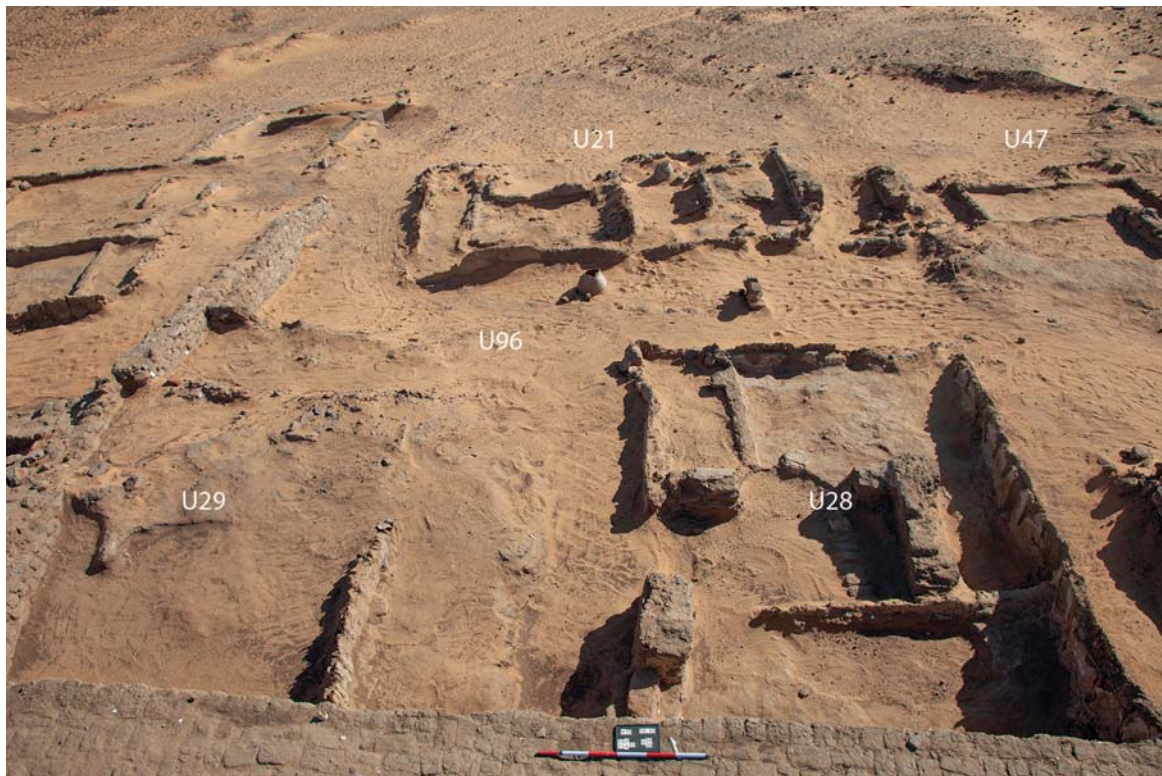
**Fig. 192.** Compound U21a/21b/28a/28b/29/47a/47b/96, general view with indicated unit numbers, looking north

In squares 10Z55–56, 11A55–56, and 11B56, the space investigated outside the city walls was delimited in the northwest by wall F72, built of reused bricks of different types and of stones laid without a regular bond [*Figs 193, 194A–B, 195*]. The wall most probably served as a fence as well as wind barrier for dwelling U21 situated southeast of it. In the southwest, the area was bordered by the city walls and tower U42 (see above). The whole area was filled with windblown sand (layers 52, 53, 62, 68, 683, 390), in some points reaching a thickness of 80 cm and covering most structures, with the exception of zones stretching along city walls F112 and F523 above U28 and U29, where several anthropogenic layers indicating intense human activity were found (cf. Harris matrix). The compound excavated in this area consisted of four buildings clustered around a centrally located courtyard [*Fig. 192*].

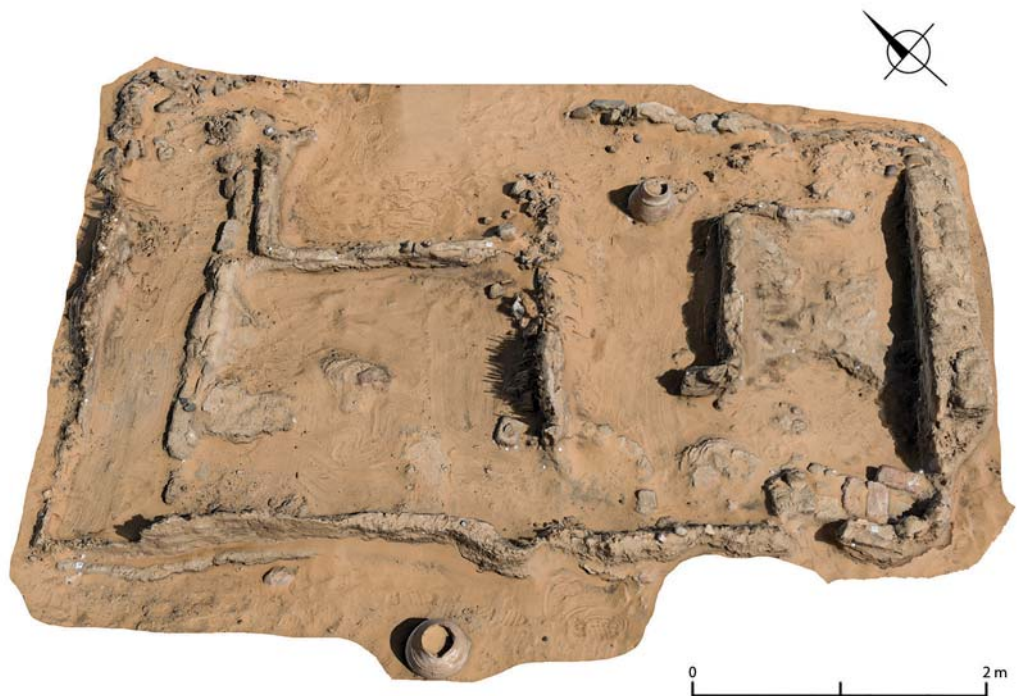
Fig. 196. Building U21a/21b, aerial view

The building was a rectangular structure measuring 7.5 m by 5 m [*Fig. 196*]. Only one wall (F77), delimiting it in the southeast, was made of sun-dried brick. The others (F217, F57, F206 and F208, an extension of F77) were built using the wattle-and-daub method described above, with twigs and reeds used as vertical elements. They do, however, differ in some details, for example F217 stands on a stone foundation, and only a small relic of its wooden framework has been preserved.

also have been placed on them. The main entrance, equipped with a threshold (F204) made of fired brick, was situated in the south corner. An oval concavity served as housing for a door pivot. The building was divided into two spaces, U21a in the southeast and U21b in the northwest, separated from each other by a partition wall made of twigs and mortar (F199). The two rooms had mud floors (F196 and F210) and were furnished with benches: L-shaped F78 with an embedded storage vessel in U21a, and F205 and F209 located in U21b. The latter bench, standing on floor F210, was a later addition. No traces of structural changes or renovations are present. Both floors feature circular burnt spots more likely left by a censer or lamp than by a hearth. The two spaces were connected with a doorway furnished with a semi-circular threshold (F439) located in the southwestern part of the partition wall.

The house undoubtedly served as a dwelling space. There is no trace of an area connected with food preparation within, except a relatively small vessel embedded in a bench inside U21a and some sorghum remains above floor level, which might suggest that food was kept or processed in the house. The main kitchen area must have been situated outside, possibly in the courtyard (U96) [Fig. 198] located west of the building and forming a space that was apparently shared with other houses in the vicinity (see below).

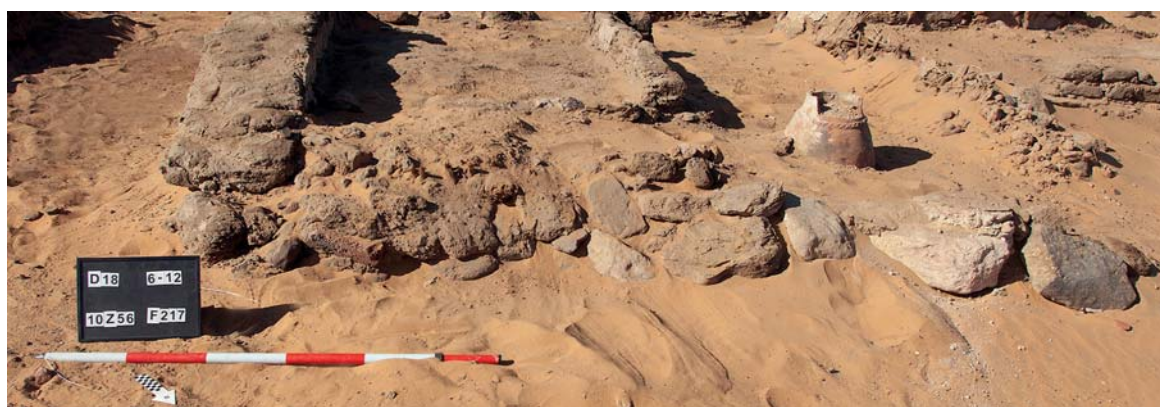
Fig. 197. Stone footing of wall F217 in building U21a/U21b

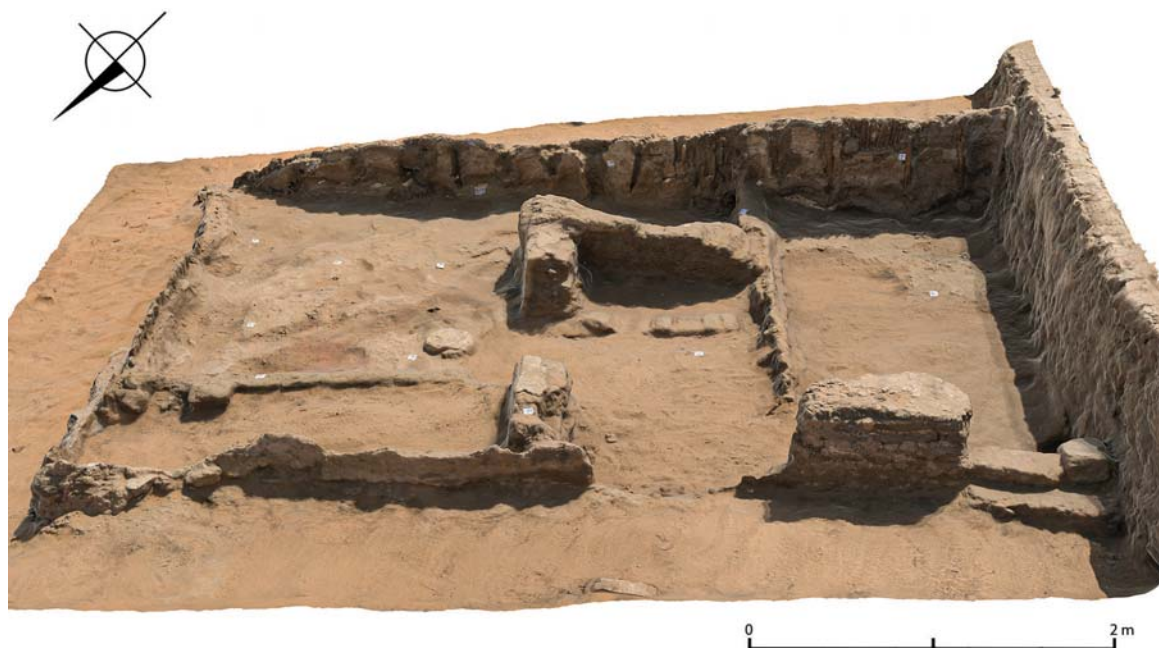
Fig. 199. Building U28a/28b, aerial view

The most representative building of the area was U28a/28b, adjacent to the fortification wall, F112 [Figs 199–200]. The house was rectangular and measured 5.70 m northeast–southwest and 4.10 m southeast–northwest. In the southeast, the house was delimited by a twig-and-mortar wall, F232, preserved up to a height of 75 cm [Fig. 201]. This is the best-preserved wall of this type. The vertical supports of F232 were made of branches about 4–6 cm thick, located 40–60 cm apart and interlaced with horizontal elements. The space between the timbers was filled with vertically placed reeds and twigs. On the northwestern face, mortar and plaster were smoothed over the protruding posts and the recessed infill between them, forming a pattern of concave depressions. The same layer of plaster continues on the northeastern face of wall F112. The feature was coated with mud mortar, and both faces were smoothed with *qurba* and whitewashed with *gir*. Wall F207, constituting the northeast wall of the house, stands on a stone footing. The northwestern wall comprised two elements: a short wall of sun-dried bricks (F432), and a wall of twigs attached to it (F594).

The house consisted of two spaces separated by wall F597, made of twigs and mortar: U28a in the southwestern part was a narrow vestibule accessed through the main entrance, furnished with a threshold of stone slabs in the northwest corner. From the vestibule a further doorway, located at the southeast end of the partition wall, opened onto the main living space, U28b. The layout of the main room was typical of Funj-period housing. The doorway opened onto a short, narrow entrance corridor separated by a sun-dried-brick stub wall (F456) from a large bench (F458), now mostly destroyed by a later looters' pit (F467). Subsequently, a smaller bench (F463) was added

along the northwestern wall. The walking surface was covered with a mud floor (F462) overlapping a centrally located, round stone base for a pillar (F468), which was part of the construction supporting the roof. An accumulation of ashes (layer 356) along bench F463 may point to the existence of a hearth inside. The hearth likely belonged to a later occupational phase, when the room was no longer used for sleeping but for food preparation.

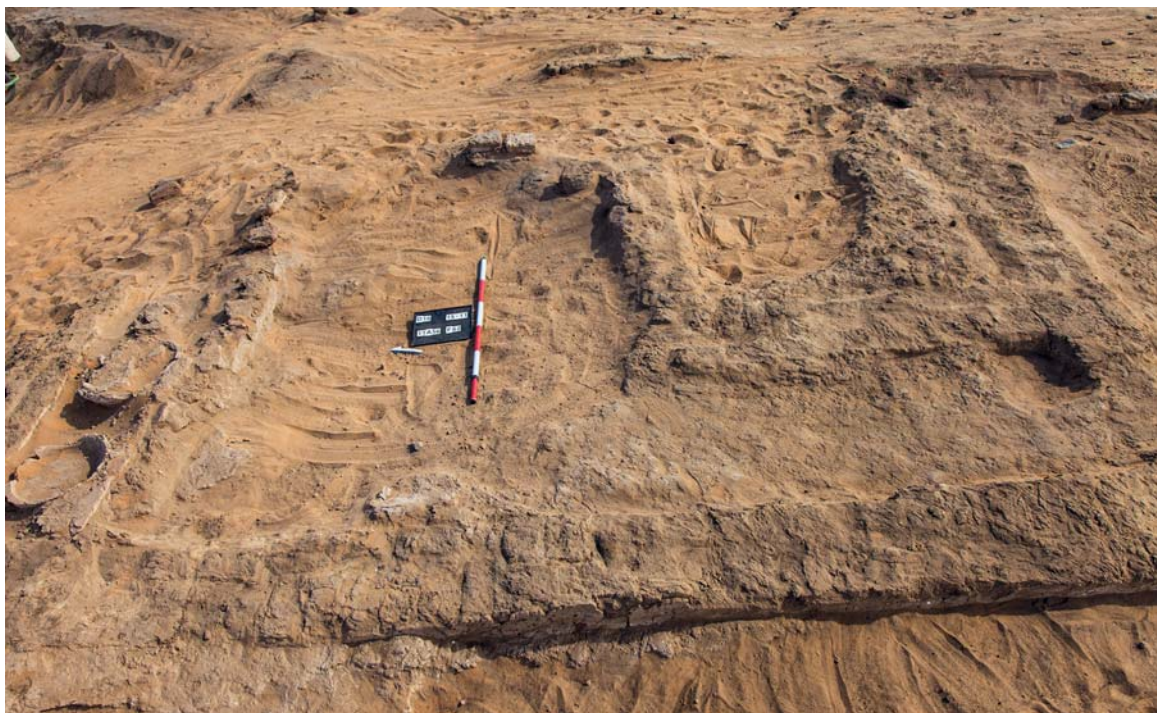
Fig. 210. Room U9

The building comprises two rooms labeled as U9 and U10, separated by wall F56 [Figs 210–211]. Access to the building was from a large courtyard (U94) located to the southeast, between the building and the city wall. The entrance leading to room U10 from U94 was located in wall F59 and was furnished with a sun-dried-brick threshold. On the right there was another doorway connecting the two spaces. U9 had a square plan with each side measuring about 4.60 m. Along walls F58, F68 and F65 there was a U-shaped bench (F61 + F63 + F70) with a thick facing wall made of fired brick (the only preserved relic of the structure). The width of the bench ranges from 80 cm to 170 cm. In the part located against wall F58, three storage vessels of sun-dried clay (F451, F452 and F453) were installed. In U10, the floor, coated with a layer of smoothed mud, was burnt in the eastern part. In its southwestern part, a large hearth was installed (burnt layer 57)

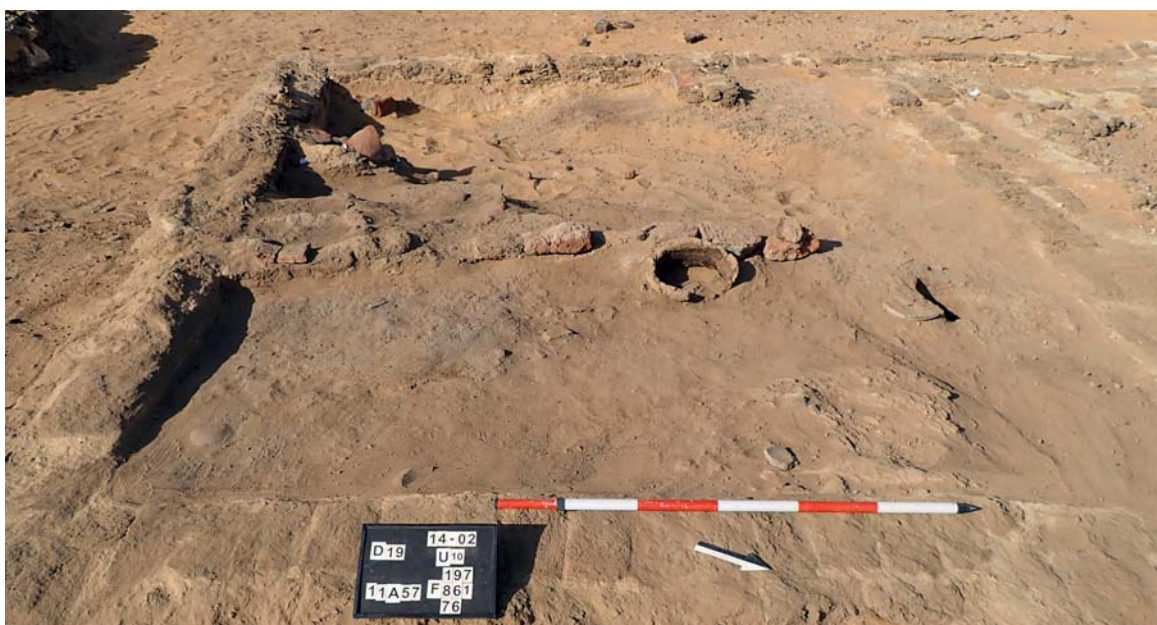
Fig. 211. Room U10

screened off from the entrance by wall F69. The features in the room included a low dividing wall of fired brick (F197) with vessel F861 attached to it. Both the walls and the hearth lay on top of floor F76, which covered the whole surface, indicating that these features were not original furnishings of the unit. Against wall F450 and aligned with it was a ceramic bowl embedded in the floor surface, covered with an inverted pot and coated with mud mortar (F442) [Fig. 212].

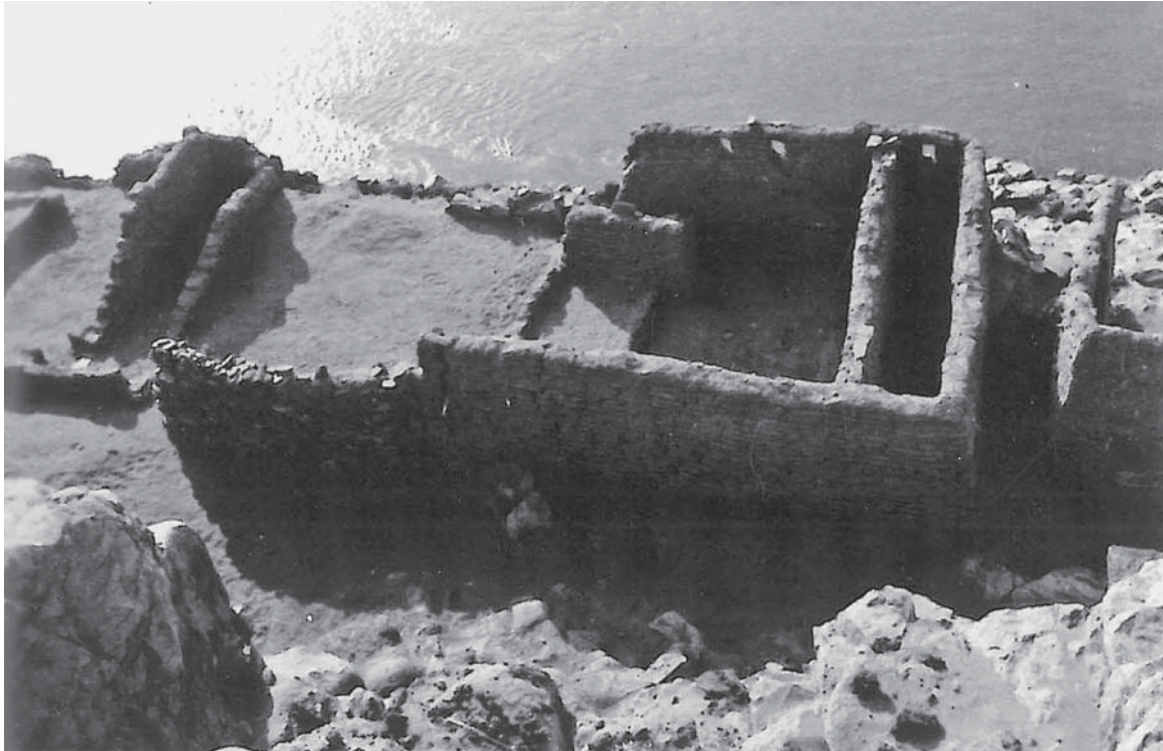
Fig. 226. House at Attiri (After Osman and Edwards 2012: Fig. 7.19)

Research on Funj-period architecture is very limited. Similar houses are recorded in the area downstream from the Fourth Cataract of the Nile at least as far as Meinarti, but this type of housing could have been more popular and widespread. The known examples of similar housing structures come from Attiri, Ginetti (Adams 1987: 337), Gergetti Island (Vila 1977b: 32–37), Diffinarti/Abumulgum (Edwards 2018: Fig. 1) and Jebel Kadamusa (Osman and Edwards 2012: 187–194) [*Fig. 226*]. In some cases there were no entrances to the storage rooms on ground level, which suggests they were accessed through an opening in the roof. The family houses at Qasr Ibrim, more elaborate than those at Old Dongola, were built of stone. They were entered by two doorways; a main entrance would have been used chiefly by men, and a rear door was likely intended for women. Inside, a series of separate units were clustered around one or more courtyards. The most elaborate houses had an entrance lodge. Beyond it was the largest chamber, a reception room with recessed cupboards and well-made floors. A door led from the courtyard into the private, family rooms and a kitchen area (Alexander and Adams 2018: 48).
