LATE ANTIQUE WALL PAINTINGS FROM PORPHYREON IN THE SIDON HINTERLAND

Julia M. BURDAJEWICZ

PEETERS
LEUVEN – PARIS – BRISTOL, CT.
2022

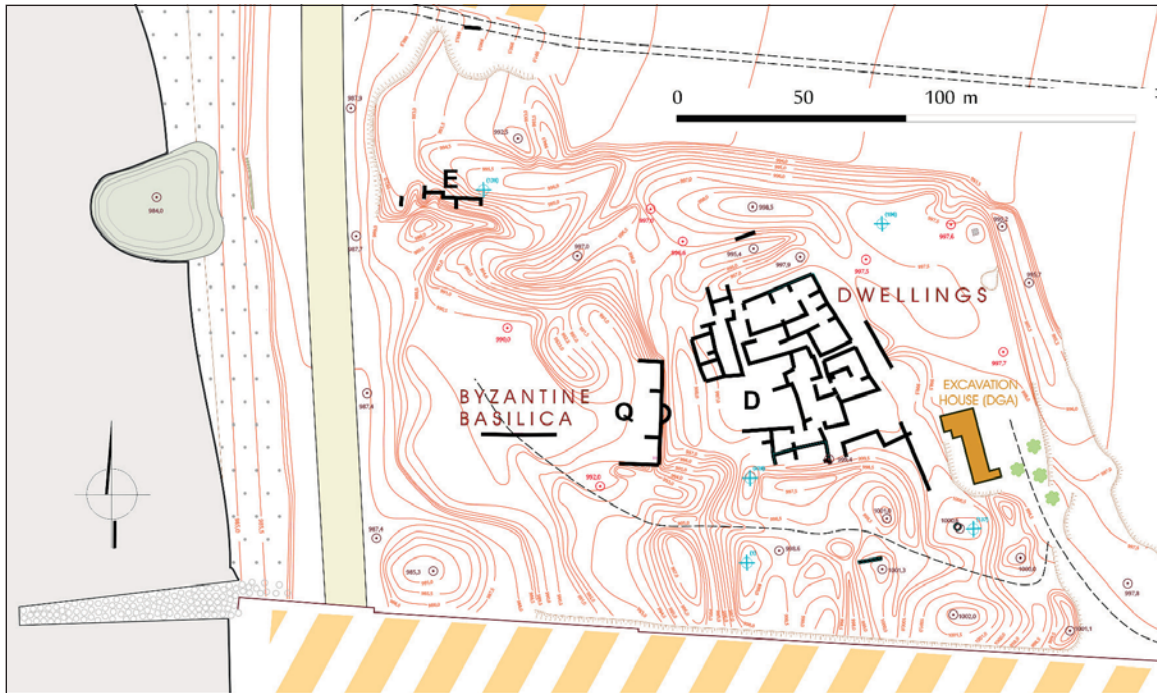
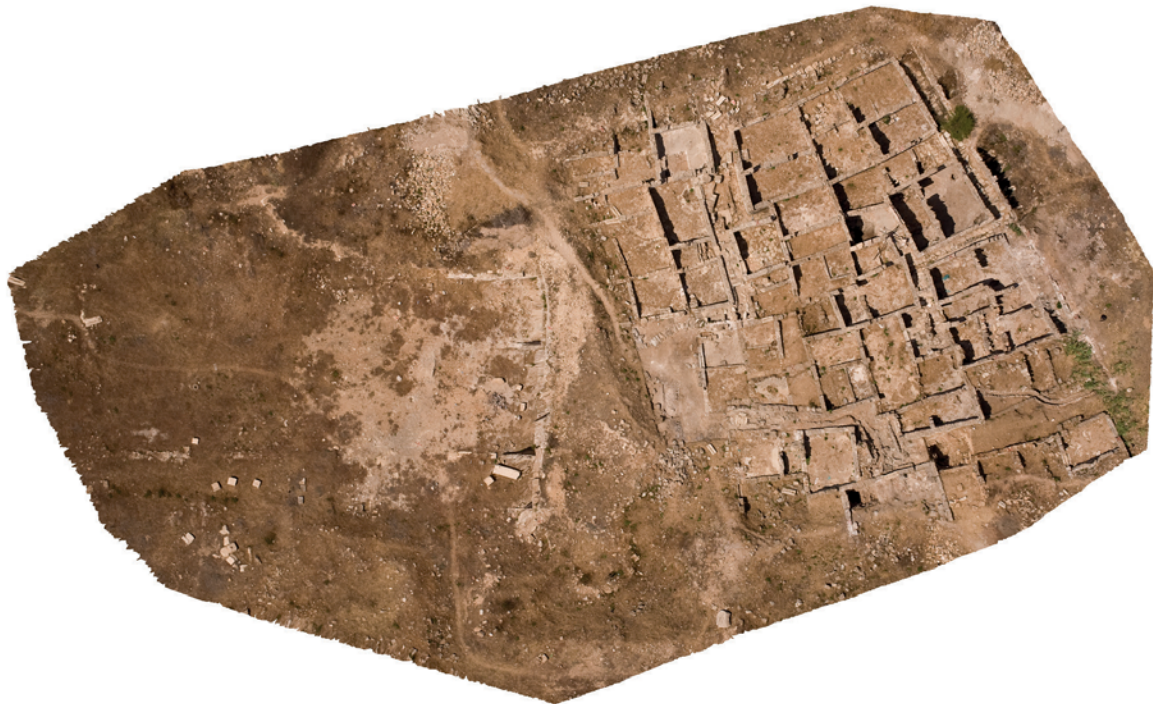
Fig. 2-2. The site of Porphyreon: top, topography of the excavated part with the early Christian basilica and residential district to the west of it (2004); bottom, aerial view of the site (2009)

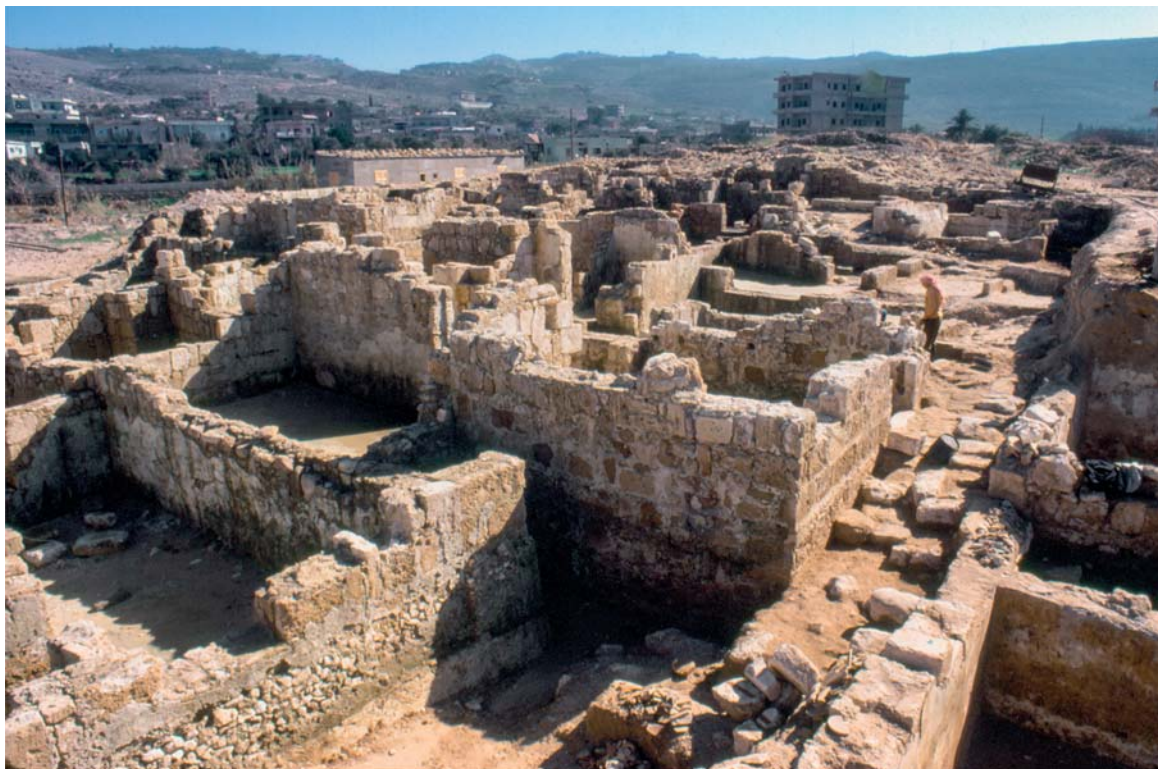
Fig. 2-4. Residential district during the 1975 excavations conducted by Roger Saidah; view southwest looking from room 72 (in the bottom right corner, partly visible room 45; see *Fig. 2-14*)

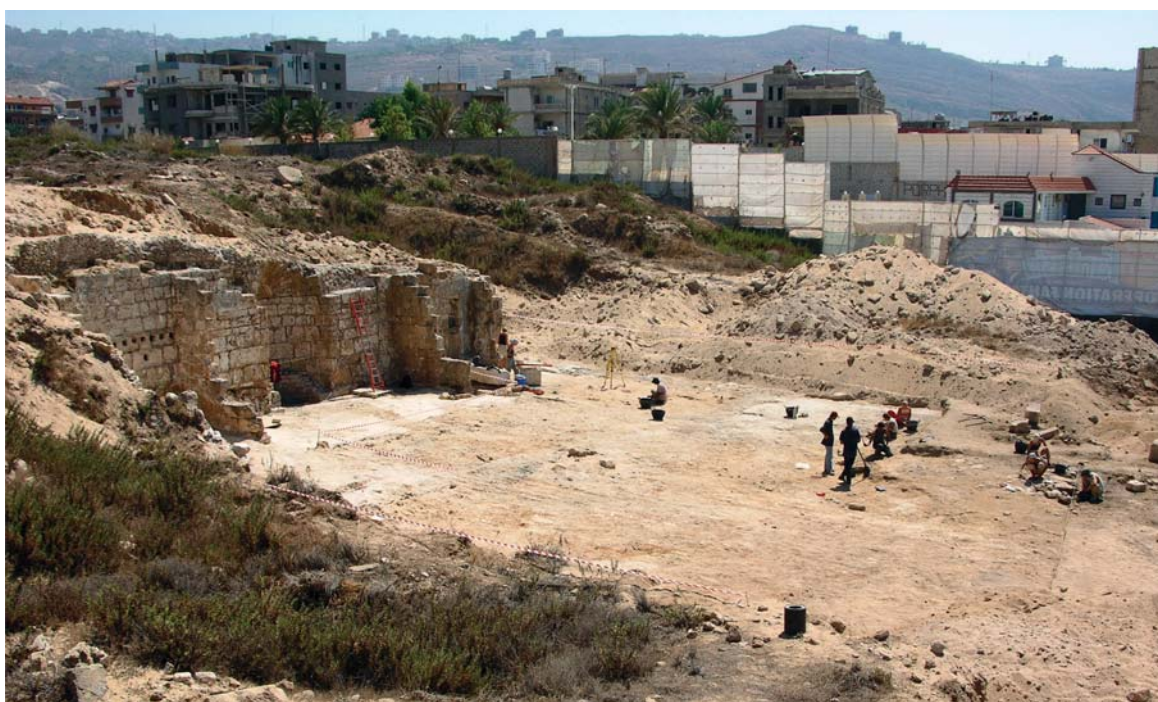
Fig. 2-5. Excavations in Basilica Q in 2005, looking southeast; note the well-preserved east wall of the basilica and the practically missing lateral and west walls

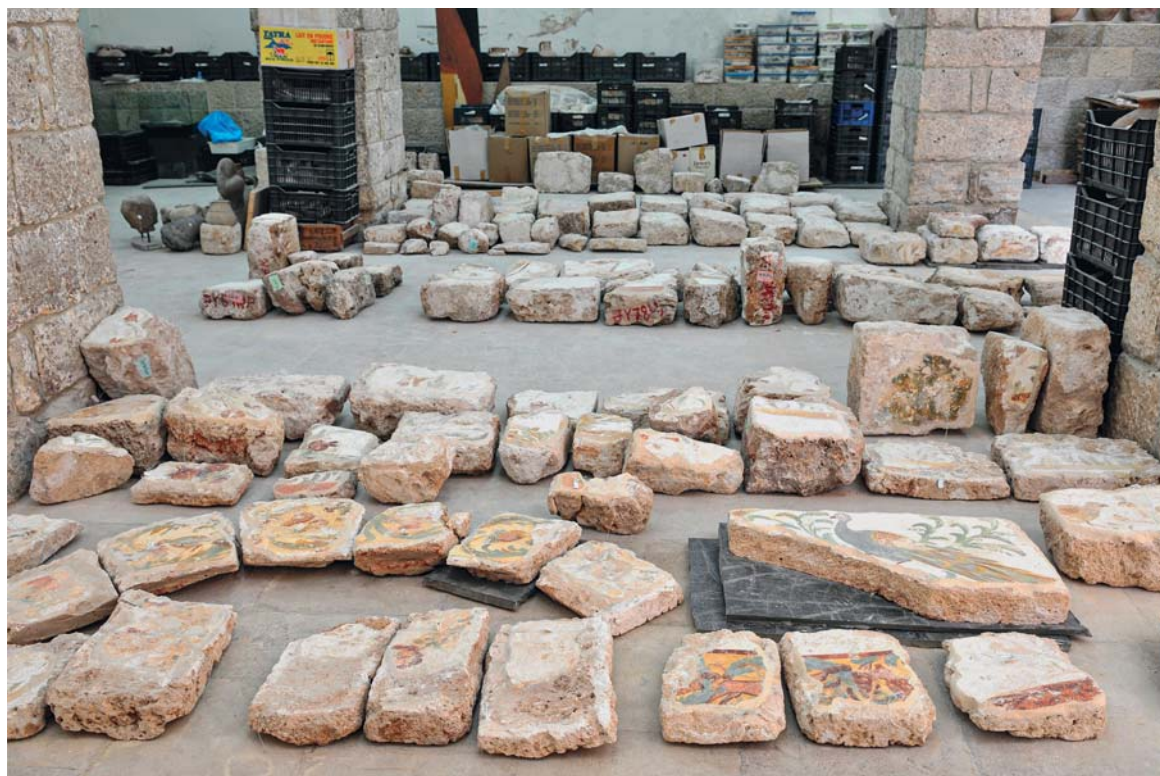
Fig. 2-6. Blocks with wall paintings from Porphyreon in the storage facility of the Beiteddine Museum

Initially, all of the ashlar and stones with painted plaster from the PCMA-DGA excavations were placed in a small on-site storage facility in Jiyeh. As their number grew and the condition worsened due to poor storage conditions, it became evident that a proper environment for their preservation should be provided. In 2012, 41 fragments with the most interesting iconography were transported to Beiteddine and placed with the fragments found in 1987. The remaining 61 fragments were left in on-site storage until 2016 when transport to Beiteddine was arranged. In consequence, all of the fragments of wall paintings preserved on ashlar and stones that were discovered between 1987 and 2014 are now stored in Beiteddine [Fig. 2-6]. A few crates of small fragments of painted plaster collected from the debris during cleaning of the site are kept in the DGA storage facility at the site of Chhim.

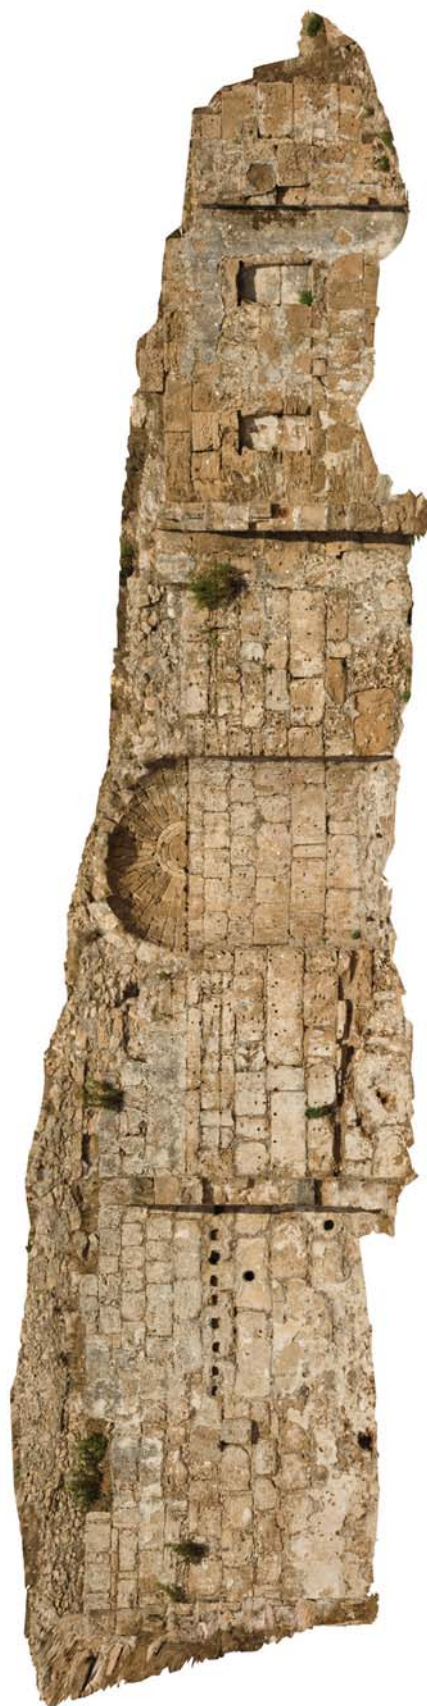
Fig. 2-8. East wall of Basilica Q

The east wall of the basilica is very well preserved; in some places it reaches a height of about 5 m [*Fig. 2-8*]. The nave ends in an apse, the aisles have straight end walls. The apse appears disproportionately small compared to the overall dimensions of the building. It is covered by a partly preserved semi-dome, with a keystone featuring a representation of a cross carved in high-relief. A synthronon, that is, a semi-circular bench for the clergy, was constructed in the apse at some point.

A local sand conglomerate, popularly called *ramleh*, was used as building material (see below, § 3.3). The walls of the basilica are constructed of roughly dressed ashlar of highly diversified sizes, arranged in courses of various heights [Figs 2-8, 2-10]. Some parts of the masonry follow a header-stretcher bond, although in most cases the dimensions of the ashlar are so diverse that the bond is rather random. Only the trapezoidal elements of the semi-dome, which are precisely dressed and matched, seem to be carefully pre-planned. A lime-based mortar was used to bind the elements of the masonry and to seal the joints between them (see below, § 3.4).

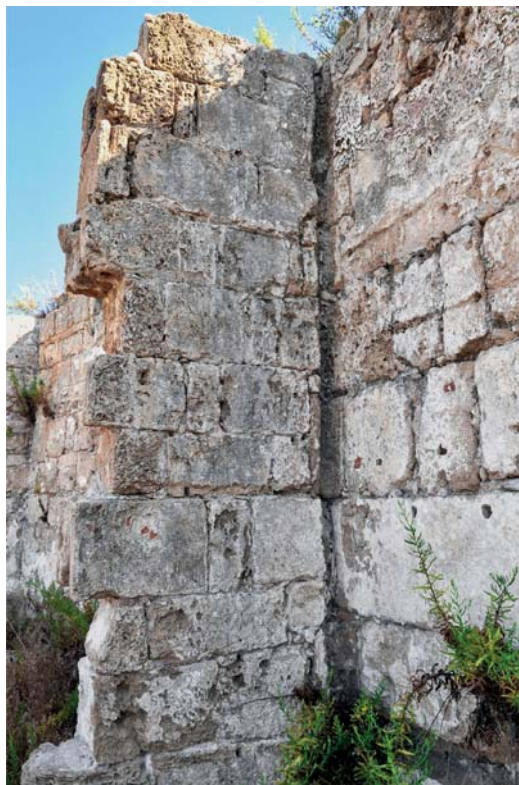
Fig. 2-9. Partition wall between the presbytery and the northern aisle; note that it is not engaged with the east wall

The presbytery was separated from the aisles by walls, remains of which still adjoin the basilica's east wall, but are not interbonded with it. This fact suggests that they might have been added at a later stage [*Fig. 2-9*]. A threshold was discovered between the presbytery and the southern aisle. Remains of a transversal partition that separated the presbytery from the rest of the nave were also found (Waliszewski and Wicenciak 2007: 424).

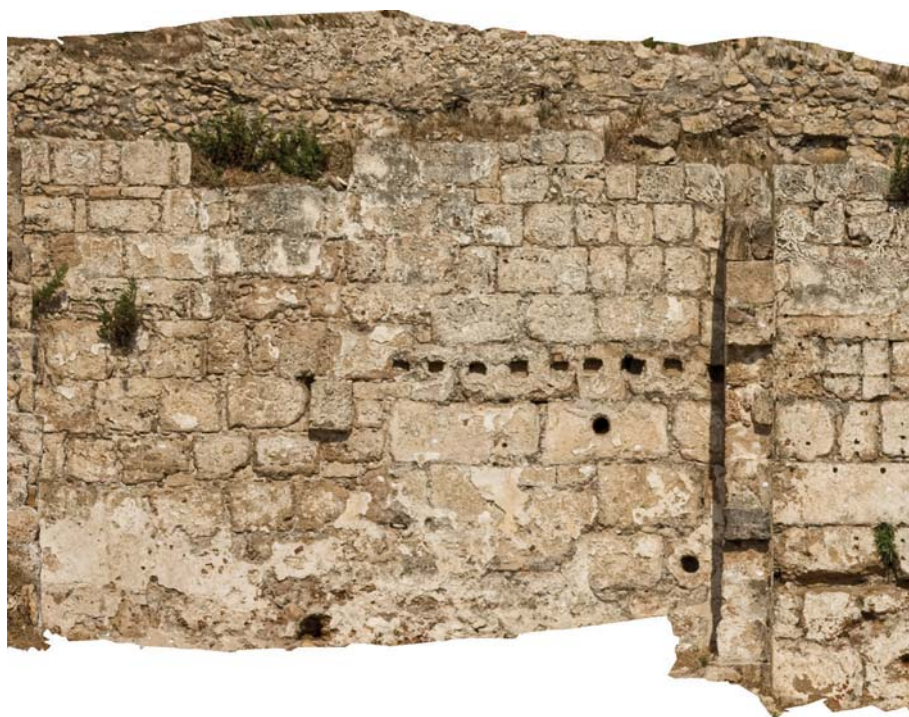
Fig. 2-10. East wall of Basilica Q, a close-up of its northern stretch; note the series of horizontal sockets presumably for the gallery supports, and the interrupted courses of the masonry to the left of it

A horizontal series of rectangular sockets in the east wall of the northern aisle suggests that it had an upper floor supported on wooden beams (Waliszewski and Wicenciak 2007: 425) [Fig. 2-10]. Interestingly, sockets of this kind do not appear in the southern aisle.

Stratigraphic research outside the east wall of the basilica, as well as interrupted courses visible in the northern part of the east wall [see Fig. 2-10], indicate that at some point the northeastern corner of the basilica collapsed and was rebuilt, probably using the same stone members. Also, the orientation of the walls changed slightly; the eastern part of the northern aisle became wider and the northeastern corner was cut by five degrees (Waliszewski et al. 2015: 460) [see Fig. 2-7]. Interestingly, the sockets for wooden beams supporting the alleged upper floor appear only in the original masonry and were not made in the rebuilt part of the wall, suggesting that the upper floor ceased to be used after the event that caused the collapse of the corner of the building [see Fig. 2-10].

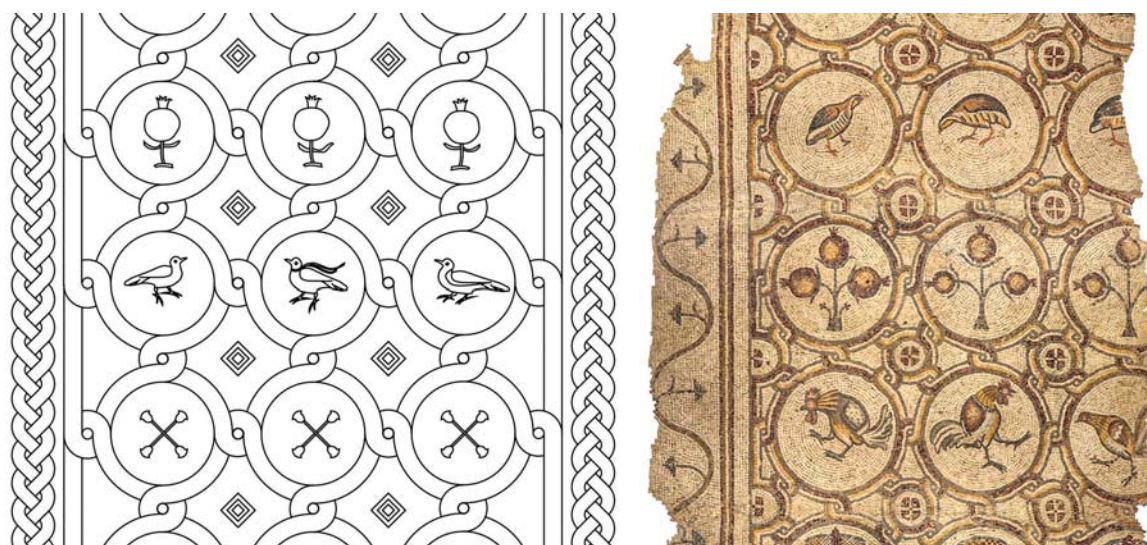
Fig. 2-12. Reconstruction of the aisle mosaic in the basilica excavated by George Contenau, based on his drawings and photographs; right, detail of the mosaic from the western end of the northern aisle of Basilica Q

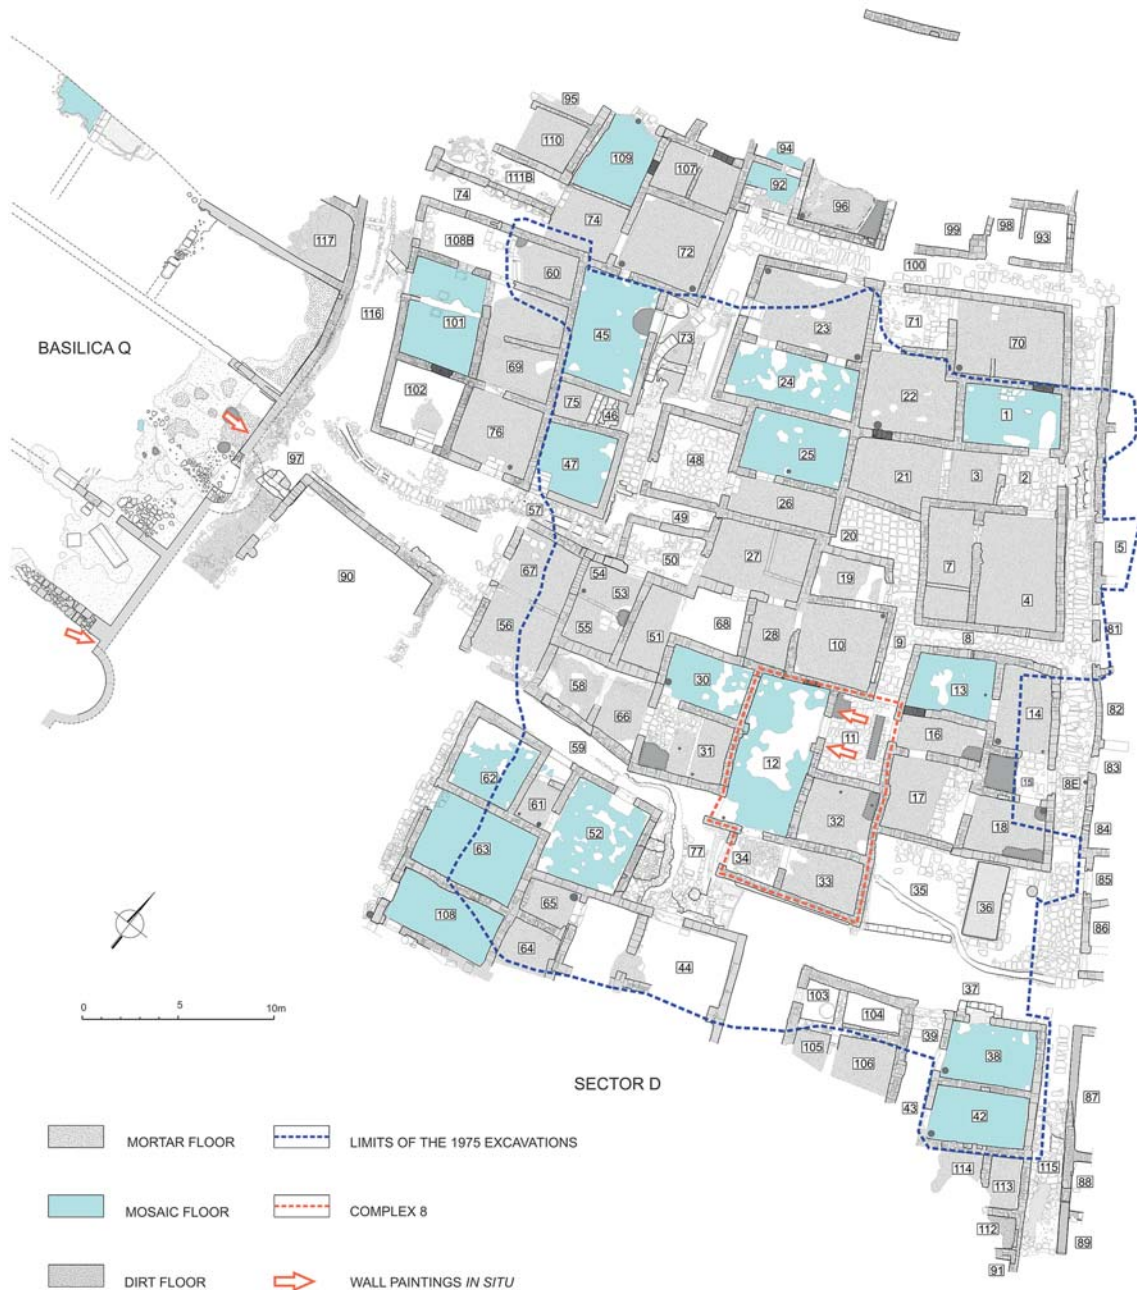
Fig. 2-14. Plan of the residential district (Sector D) located east of Basilica Q; arrows indicate location of paintings discovered *in situ*: Cat. 44 and Cat. 76 in the basilica and Cat. 187 and Cat. 188 in residential Complex 8

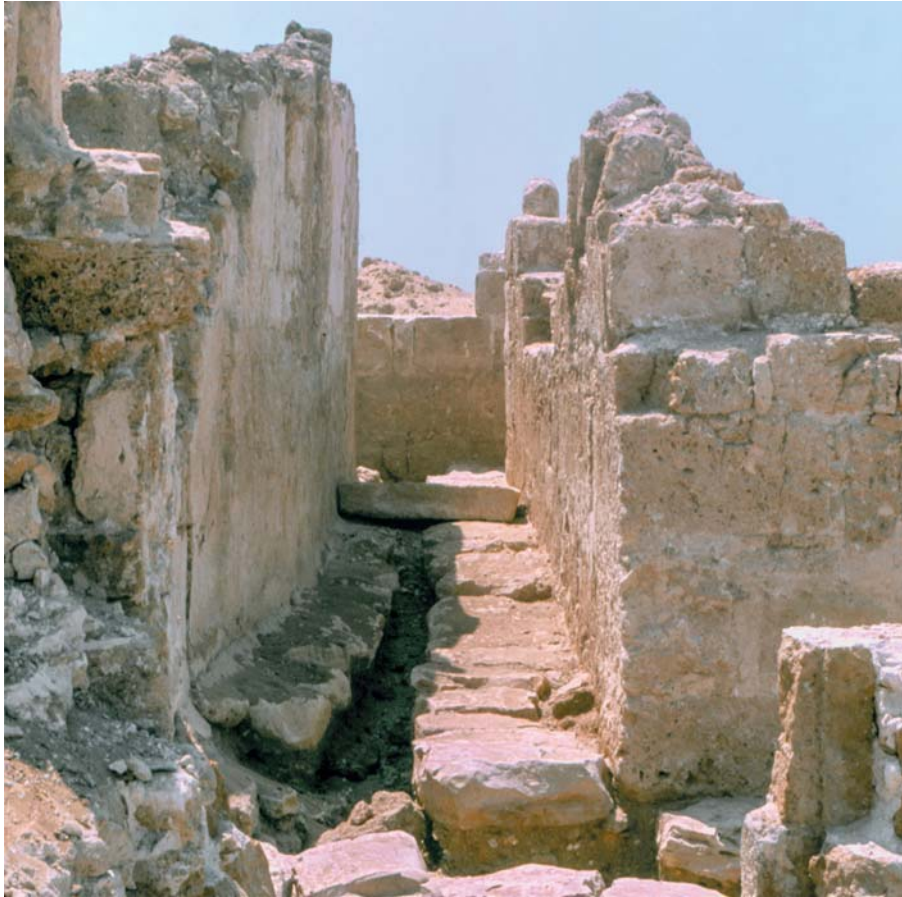
Fig. 2-15. Paved street (street 8, view towards west) with a drainage channel as documented in 1975

the partition walls, which are thinner (Dzik 2015: 479). The walls of the houses were coated with white plaster on the inside and outside of the buildings [Figs 2-15, 2-16].

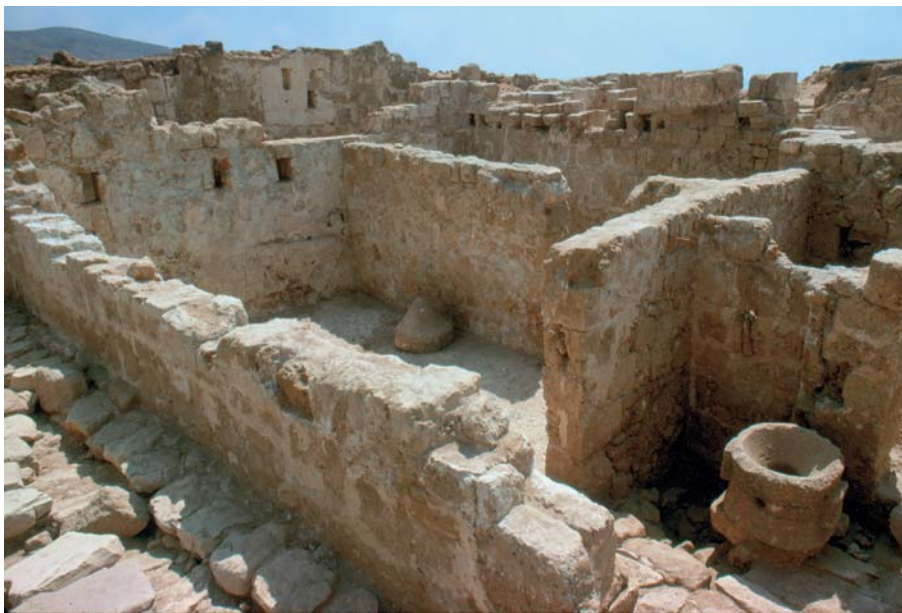
Fig. 2-16. House in the residential district as documented in 1975; looking southward;
in the foreground, rooms 4 and 2

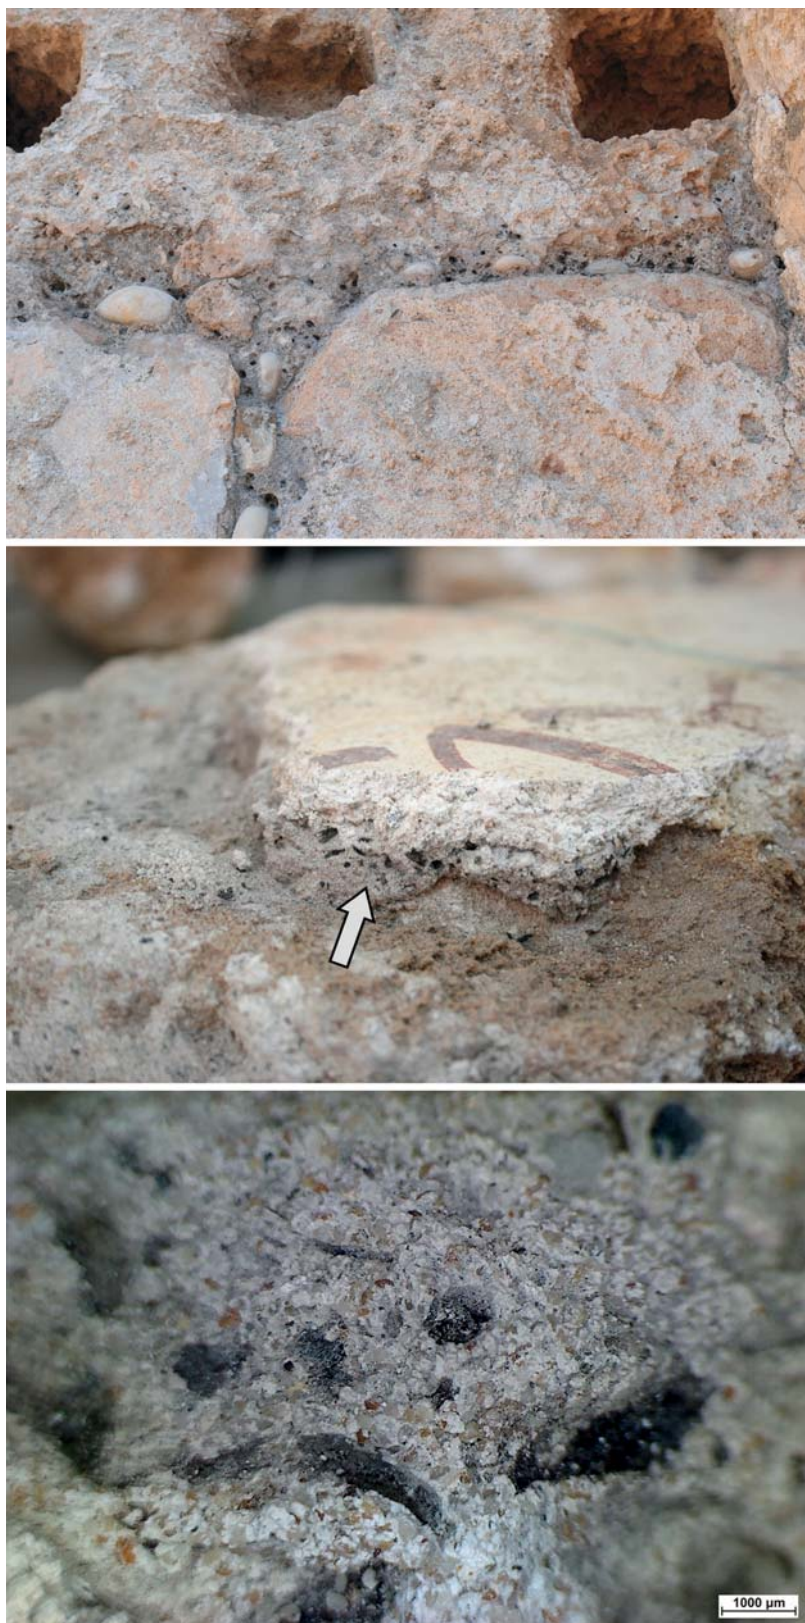
Fig. 3-3. Type 1 mortar: top, in the joints of the masonry of the east wall of the basilica; center, underneath the plaster (*Cat. 197*); bottom, microphotograph showing charcoal particles

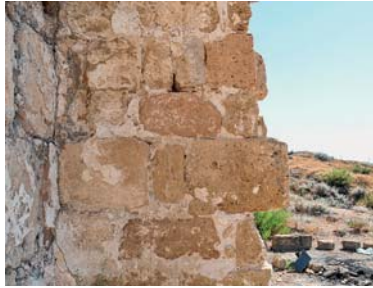
Fig. 3-5. Type 2 mortar spread over the joints of the wall separating the northern aisle from the nave of the basilica

Type 2 mortar was employed in an identical manner as the first type, to bind masonry members, seal the joints between them, and compensate for surface defects of particular elements [*Fig. 3-5*]. Thus, its thickness ranges from several millimeters to a few centimeters. Because it was applied to the joints between particular masonry members, but not always to their faces, it can be observed chiefly on the perimeter of the ashlar faces [*Fig. 3-6*]; only the very rough and irregular ashlar and stones have it also on their faces. In several instances, evidence of keying of the mortar is noted; this procedure is necessary to improve adhesion of the plaster. Judging by the appearance of the keying, it was done when the mortar had already set [*Fig. 3-7 top*]. Fragments of pottery

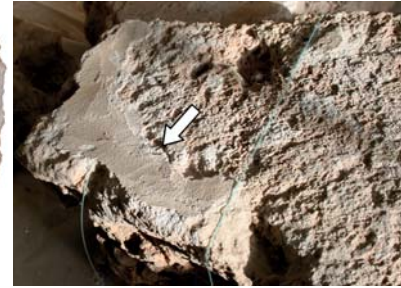
Fig. 3-7. Type 2 mortar: top, evidence of keying of the mortar before the application of plaster visible on the side of ashlar *Cat. 151*; bottom, potsherds pressed into the mortar; ashlar *Cat. 42* has a rough, irregular surface, hence the application of a thick levelling layer of mortar with potsherds

sherds are at times incorporated in the thick parts of the render [*Fig. 3-7* bottom].⁸ Also, small fragments of worn-out glass are present occasionally [*Fig. 3-8* bottom].

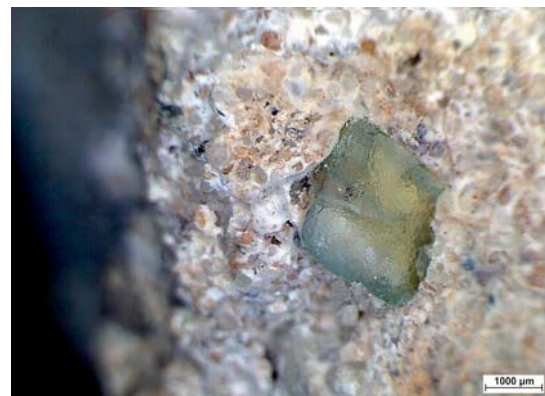
Fig. 3-8. Microphotographs of Type 2 mortar: top, *Cat. 70* – note the even distribution, tight arrangement and uniform sizes of aggregate grains; bottom, *Cat. 152* – piece of glass embedded in the mortar

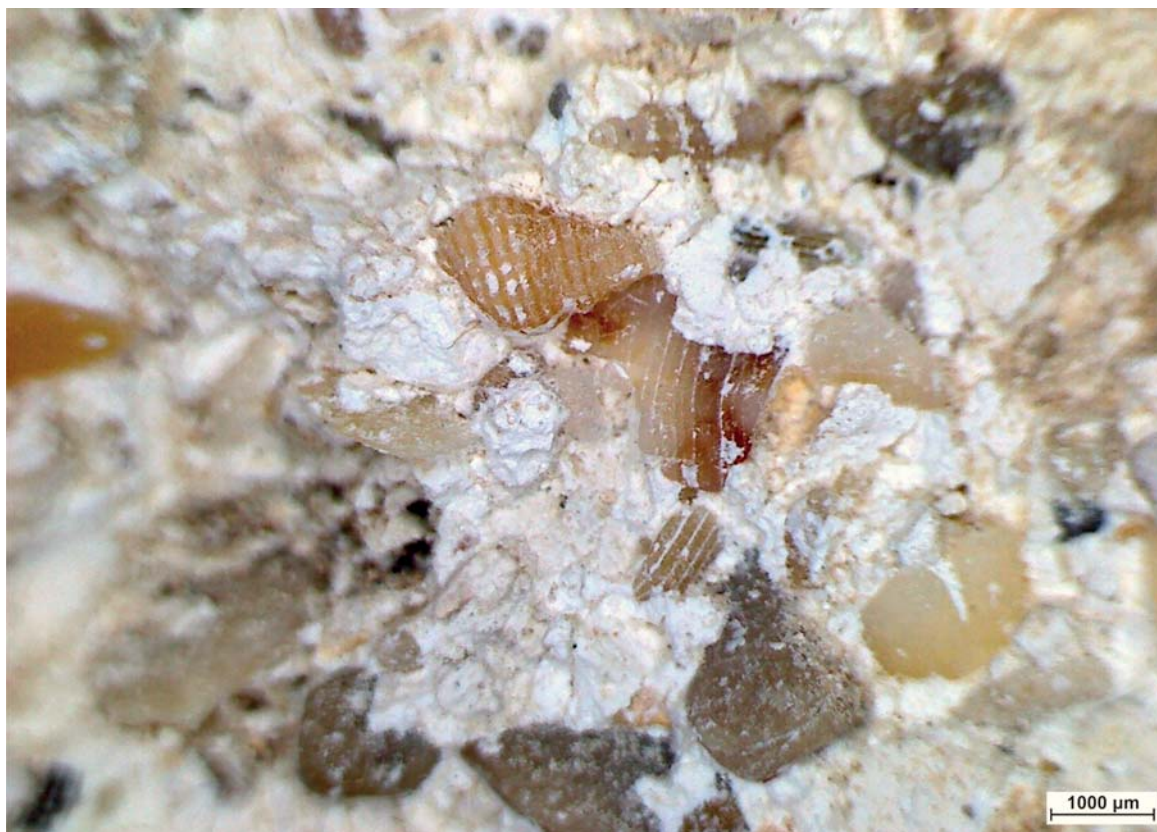
Fig. 3-12. Microphotograph of plaster (*Cat. 70*)

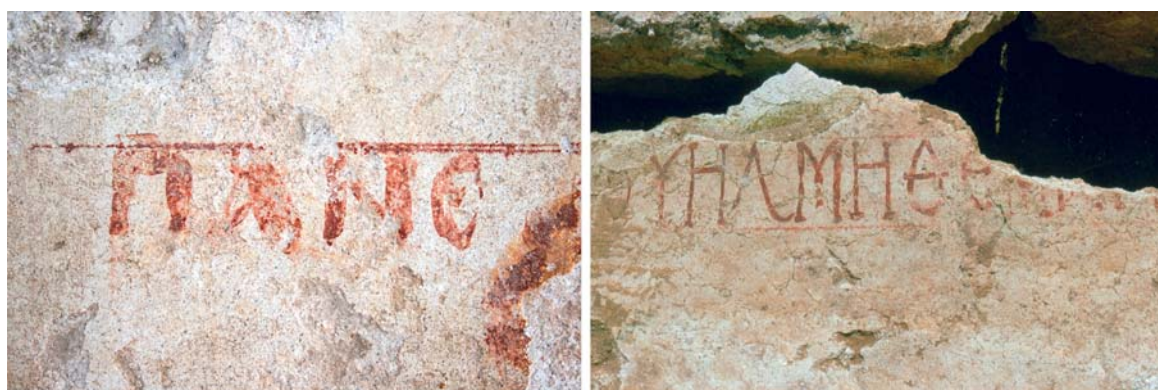
Fig. 3-17. Guiding lines executed with the snapped-line technique: left, above the script on *Cat. 88*; note the splashes of paint made when the string snapped against the surface of the plaster; right, above and below a painted inscription (*Cat. 191*)

Few preparatory marks for laying out designs have been observed in Porphyreon despite the degree of complexity of some of the painted motifs. A “snapped line” technique was employed to score guiding lines for aligning letters of inscriptions. In this method, a piece of string is stretched, pulled back, and released so that it snaps against the surface, leaving a straight line, either incised if the plaster is still fresh, or colored if the string was dipped in paint. It was commonly employed by ancient wall painters to plan out geometric designs or decorations based on vertical, horizontal, or diagonal axes (Barbet and Allag 1972: 985, 1052–1054; Ling 1991: 204; Barbet 2000: 171; see also Bonifacio and Sodo 2002: 143–144). For the wall paintings from Porphyreon, a cord dipped in red paint was used [*Fig. 3-17*]. There is no evidence of imprints left by the string in the plaster surface, which indicates that the plaster was already firm when the paintings were executed.

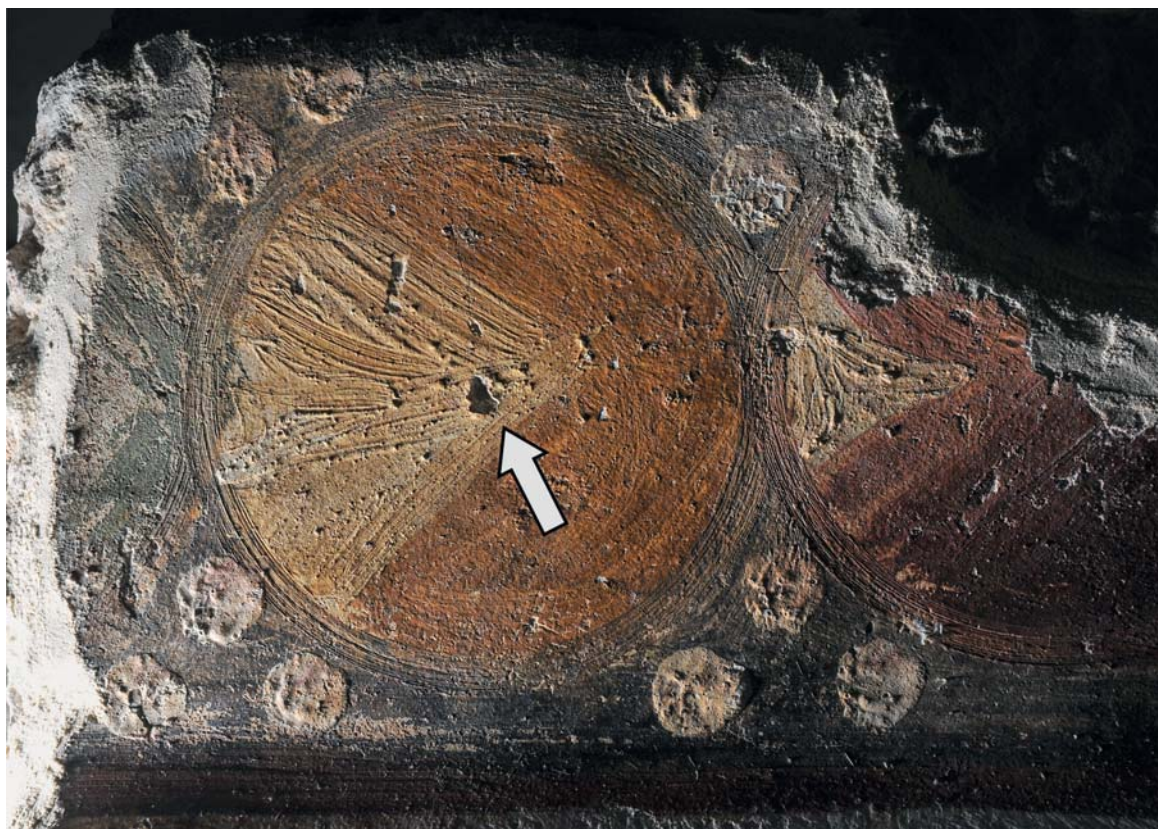
Fig. 3-18. Pit left by the point of a compass (*Cat. 77*), view in raking light

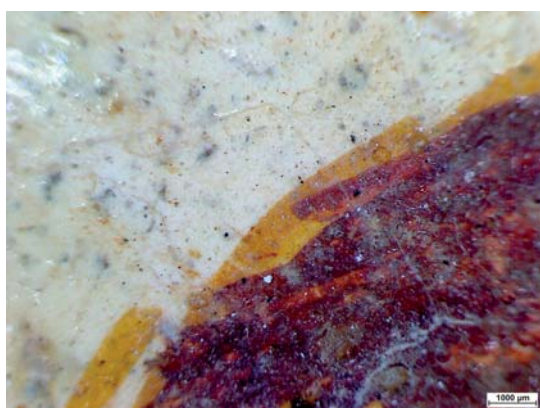
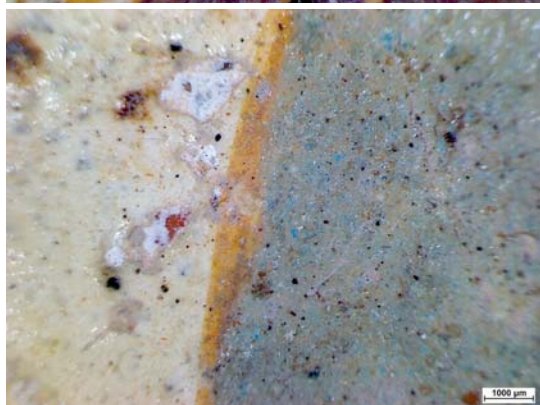
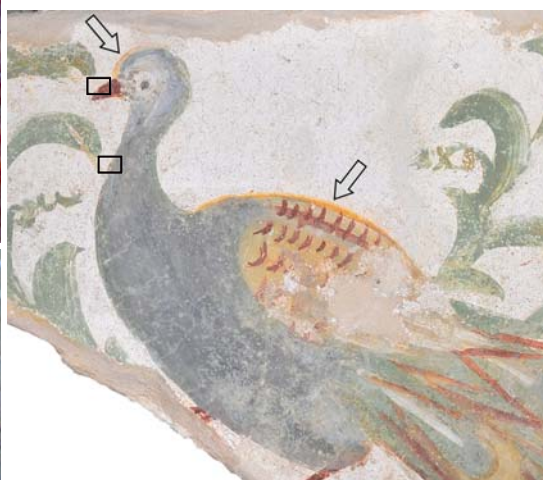
Fig. 3-19. Preliminary ocher underpainting: top, on the depiction of a partridge (*Cat. 97*); bottom, on the depiction of a peacock (*Cat. 94*); boxes indicate location of microphotographs on left; note that the paint of the red bill and the blue breast is applied on top of the ocher underpainting (the yellow tint of the microphotographs is caused by the presence of old yellowed varnish)

The neat representations of the peacock (*Cat. 94*), partridges, and inhabited scrolls contrast with some fragments of paintings executed in a rather unconstrained and freehand, perhaps even sloppy manner [see below, *Fig. 3-31*]. One is entitled to think that these parts were done without any preparatory outlines to guide the artist's brush. Coupled with a varying artistic quality of particular fragments of paintings, this inconsistent approach to planning out the designs of wall paintings at Porphyreon argues in favor of the decoration being executed by several (teams of) painters.

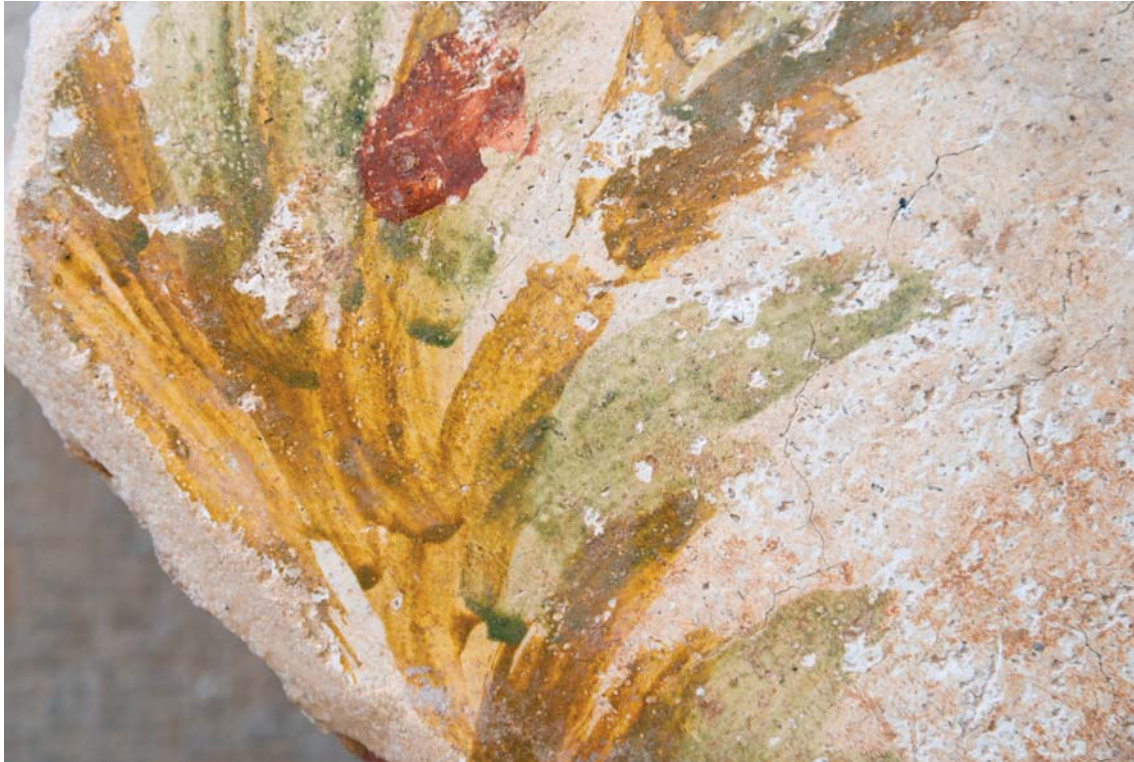
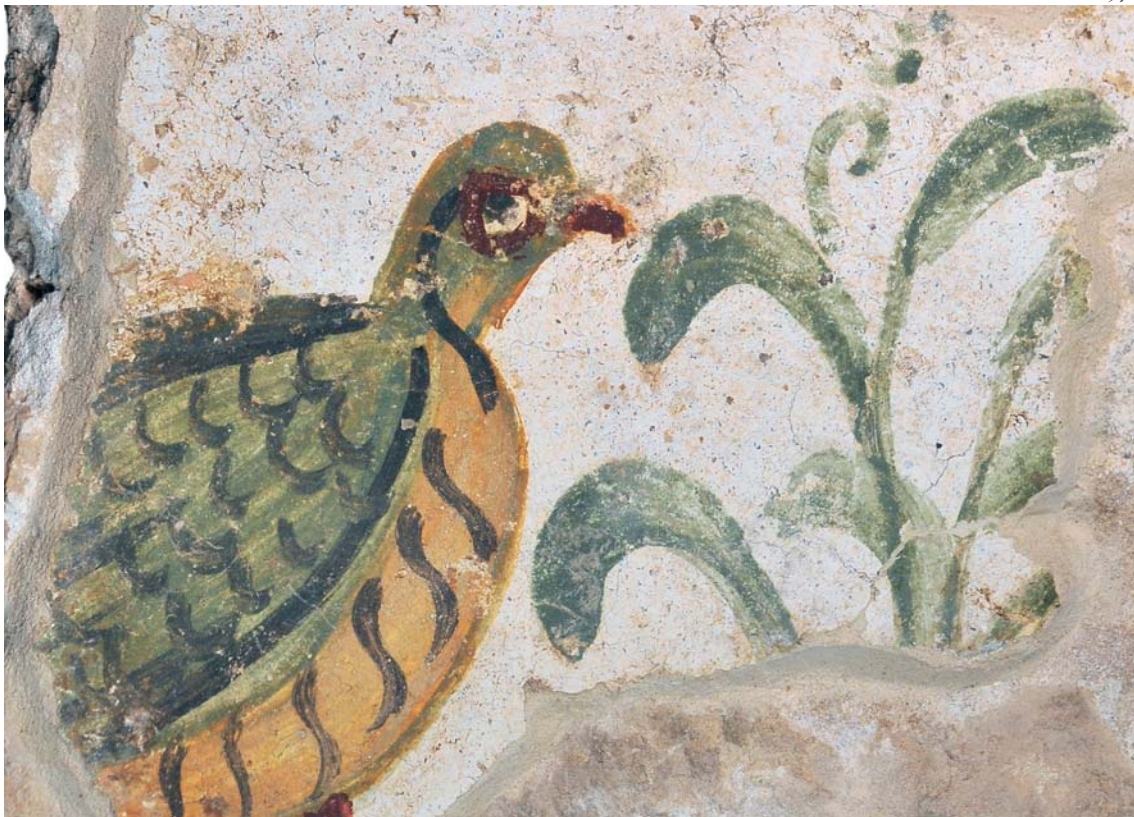
▲ *Cat. 152*▼ *Cat. 97*

Fig. 3-20. Watery, semi-translucent green and ocher paint used to render foliage (*Cat. 152*) and green leaves and tendrils (*Cat. 97*)

be an indication of the painter's skill and artistic sense. Also, some of the plant tendrils, marked with just a few strokes of watery, semi-translucent paint, display an elegant and effortless form [Fig. 3-20].

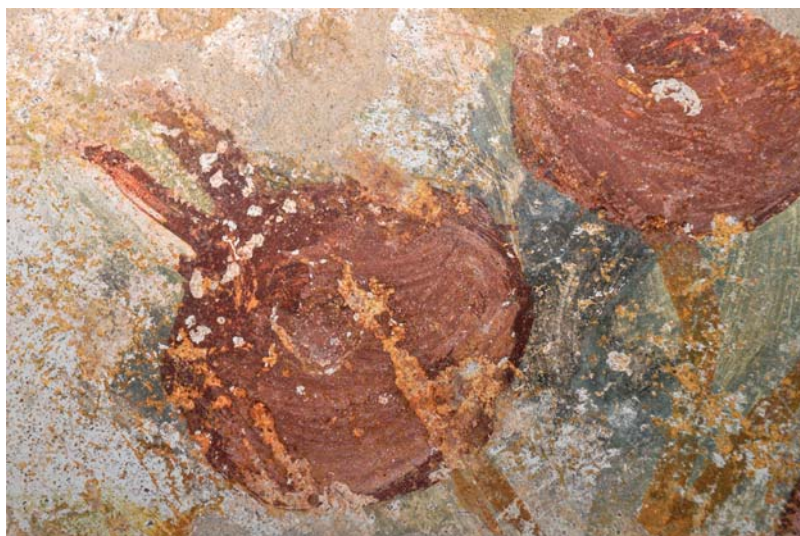
Fig. 3-22. Detail of pomegranate fruit set among foliage, painted with thick red paint and finished with dark pink opaque highlights on top of foliage painted with semi-translucent paint in various shades of green (*Cat. 154*)

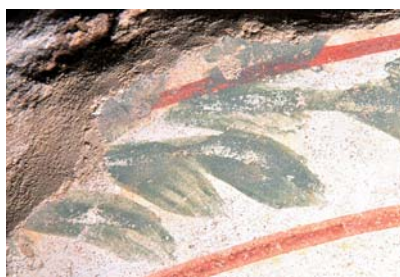
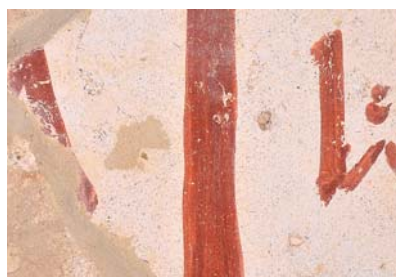
Fig. 3-23. Use of thick paint in one layer: *Cat. 45c* – leaves on the outer ring surrounding a medallion with a jeweled cross made with thick green paint applied with single brushstrokes; *Cat. 13* – thick, well-preserved red paint used to render a cross

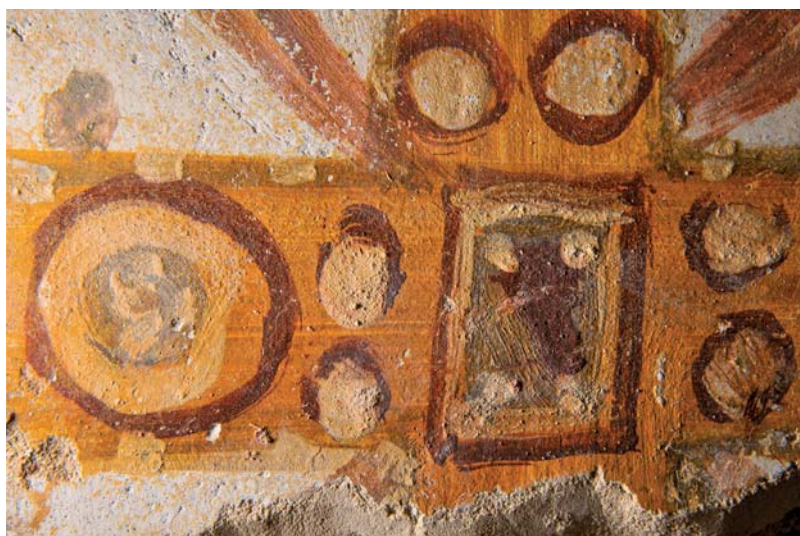
Fig. 3-24. Details executed in thick paint over underpaint: *Cat. 30a* – jeweled cross underpainted with dark yellow, with various details executed in thick paint on top of that

While painting with watery paint would have been cost-efficient, other fragments of wall paintings suggest that the artists working at Porphyreon were not necessarily compelled to use pigments sparingly. Depictions of jeweled crosses, medallions, animals, inhabited scrolls, and geometric designs display substantial, sometimes very thick, paint layers [see Figs 3-18, 3-21, 3-22]. This thickness is in some cases caused by abundant application of just one or two colors, while at other times it results from the presence of several superimposed layers of paint. The first case is illustrated by some fragments of simple red crosses or painted inscriptions which tend to be rendered with a single yet oftentimes thick layer of red paint. The same manner of painting may also be observed on some of the depictions of leaves [Fig. 3-23]. Paint layer buildup consisting of several superimposed layers is observed, for example, on depictions of medallions and on the edges of jeweled crosses that consist of an orange base color, a contour of a different color on top of it, followed by a series of dabs of paint imitating jewels or pearls [Figs 3-24, 3-25, 3-26].

The lowermost layers of paint of many fragments seem to have been executed using wide brushes, which allowed an even and ample application of the paint. Further details were executed on top of this base color. This painterly technique can be observed, for example, in depictions of jeweled crosses, where the orange base color was applied with the use of a wide brush, while the contours and details were finished with very thick paint applied with smaller paintbrushes [see Fig. 3-24]. Examples of such brushwork can be seen on a lamb's pelage and the plumage of a peacock [Fig. 3-29].

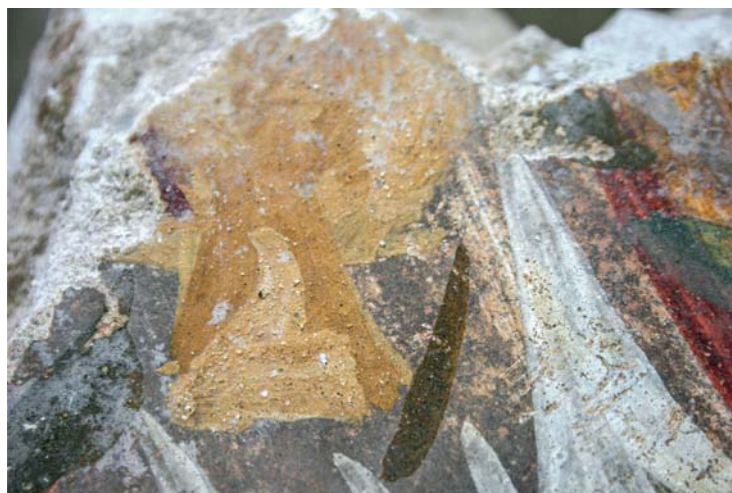
Fig. 3-25. Detail of a wreath around a jeweled cross (*Cat. 45b*): note the coarse grains of white pigment added to the yellow of the fruit. The fruit, lily-like white flowers, and green leaves were executed on top of greenish-gray base color (underpaint)

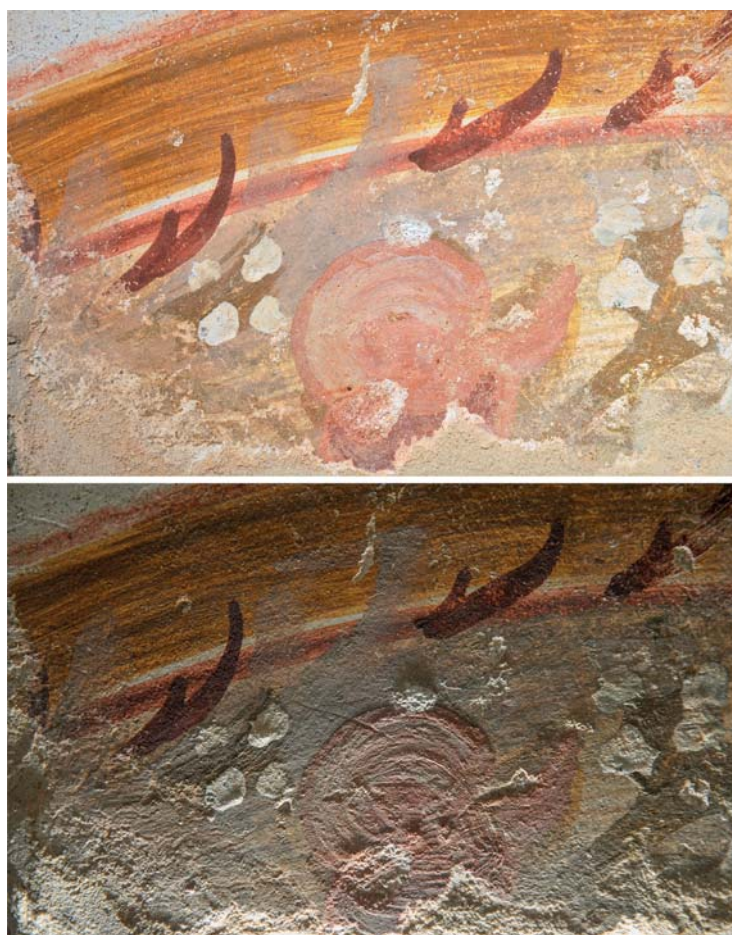
Fig. 3-26. Detail of a wreath around a jeweled cross (*Cat. 45c*) viewed in diffused and raking light (top and bottom, respectively). Note the thickness and brushstrokes of the fruit, as well as impastos marking the white details of the wreath

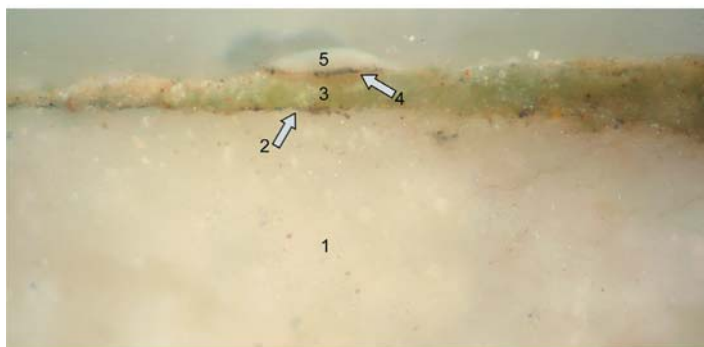
Jy020 (first part)

- 1) plaster
- 2) discontinuous reddish-brown layer measuring up to 4 μm
- 3) grayish-green layer measuring up to 64 μm
- 4) randomly appearing very thin brownish-black layer
- 5) randomly appearing dabs of white paint, measuring up to 20 μm

Fig. 3-27. Cross sections of samples of paint and plaster layers viewed under a stereoscopic microscope in reflected light

Microscopic examination of the stratigraphy of three samples of paint layers (Jy019, Jy020, Jy021) allowed their thickness to be estimated [Fig. 3-27]. For example, the four layers of paint from sample Jy019 have a total thickness of 72 μm . The buildup of Jy021, consisting of just two layers of paint, was only slightly thinner, measuring 64 μm , whereas a two-layered portion of sample Jy020 reached a thickness of nearly 90 μm . A portion of the same sample, which consisted of four layers, measured 124 μm .
