LATE ANTIQUE WALL PAINTINGS FROM PORPHYREON IN THE SIDON HINTERLAND

Julia M. BURDAJEWICZ

PEETERS
LEUVEN – PARIS – BRISTOL, CT.
2022

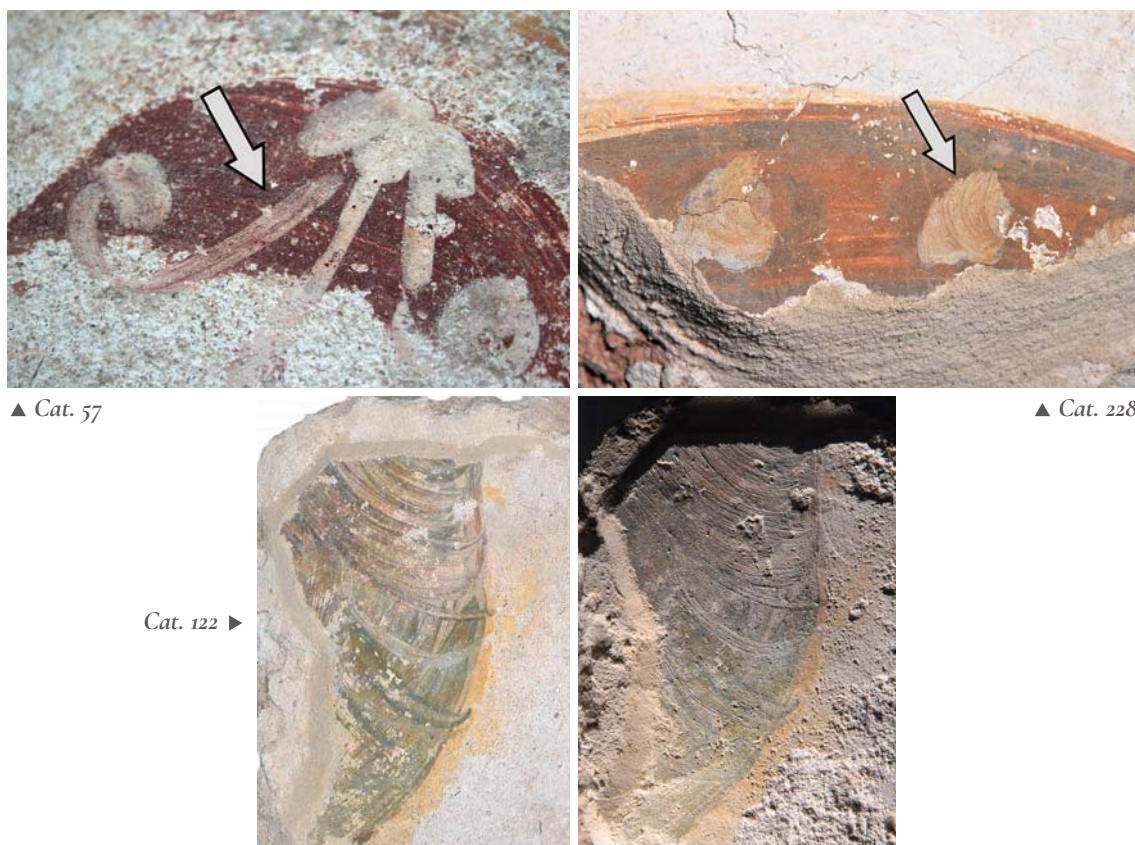
Fig. 3-28. Evidence of “wet-into-wet” painting: *Cat. 57* – detail of the lotus-band decoration on a medallion around a jeweled cross; note how the red paint of the lotus flower is mixed with the white detail painted on top of it; *Cat. 228* – detail of an unidentified motif; the white paint used to execute the rotund details is mixed with the dark orange base color; *Cat. 122* – breast of a bird(?), viewed in diffused and raking light (left and right, respectively); note how the transversal, curved brushstrokes cut through the previously applied paint

Examination of fragments of wall paintings with more than just one layer of color suggests that they were generally painted "wet-into-wet". This is attested, for example, by contamination of the color of the upper layers of paint with pigments of the base color [Fig. 3-28 top]. The "wet-into-wet" technique can also be observed in the brushwork, as some of the brushstrokes plowed through the already applied, yet still wet paint. This can be seen on the "gemstone" motif, where the outlines of particular gems wiped away the brushwork of the interior of the gems [see Fig. 3-18]. A similar manner of painting can be seen on a fragment where the bottle-green breast of a bird(?) was executed "wet-into-wet" with a relatively thin (0.5–1 cm) rigid brush that left groove-like marks [Fig. 3-28 bottom].

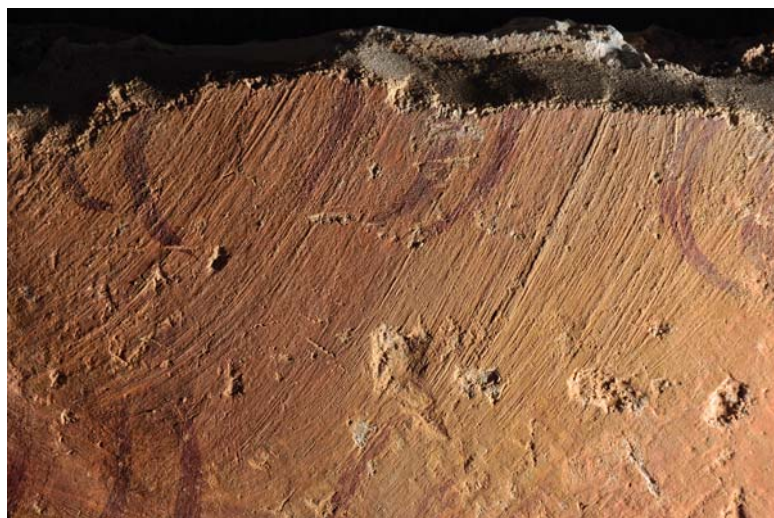
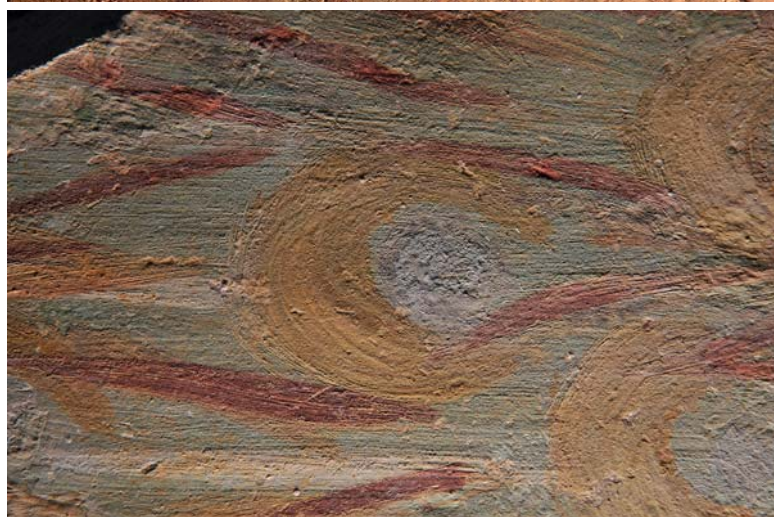
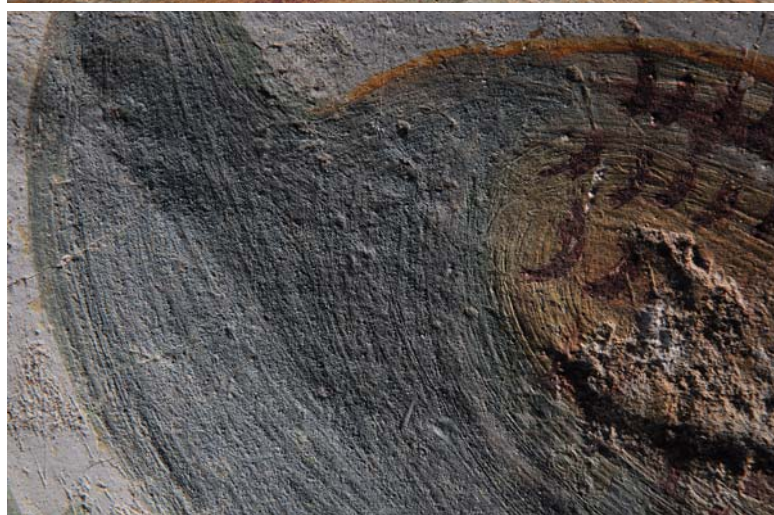
Fig. 3-29. Examples of brushwork, viewed in raking light: top, detail of a lamb's pelage (*Cat. 110b*) – note the wide brushstrokes of the ochre base color and slight color transitions within the pelage, and sets of crescent-shaped dark red details, possibly imitating fleece, on top of the base color; center, detail of a peacock's train (*Cat. 94*) – note superimposed layers of various colors of paint used to render the feathers and eyelets of the train; bottom, detail of a peacock's breast and flank (*Cat. 94*) – note broad brushstrokes and thick paint used to execute the painting

The lowermost layers of paint of many fragments seem to have been executed using wide brushes, which allowed an even and ample application of the paint. Further details were executed on top of this base color. This painterly technique can be observed, for example, in depictions of jeweled crosses, where the orange base color was applied with the use of a wide brush, while the contours and details were finished with very thick paint applied with smaller paintbrushes [see Fig. 3-24]. Examples of such brushwork can be seen on a lamb's pelage and the plumage of a peacock [Fig. 3-29].

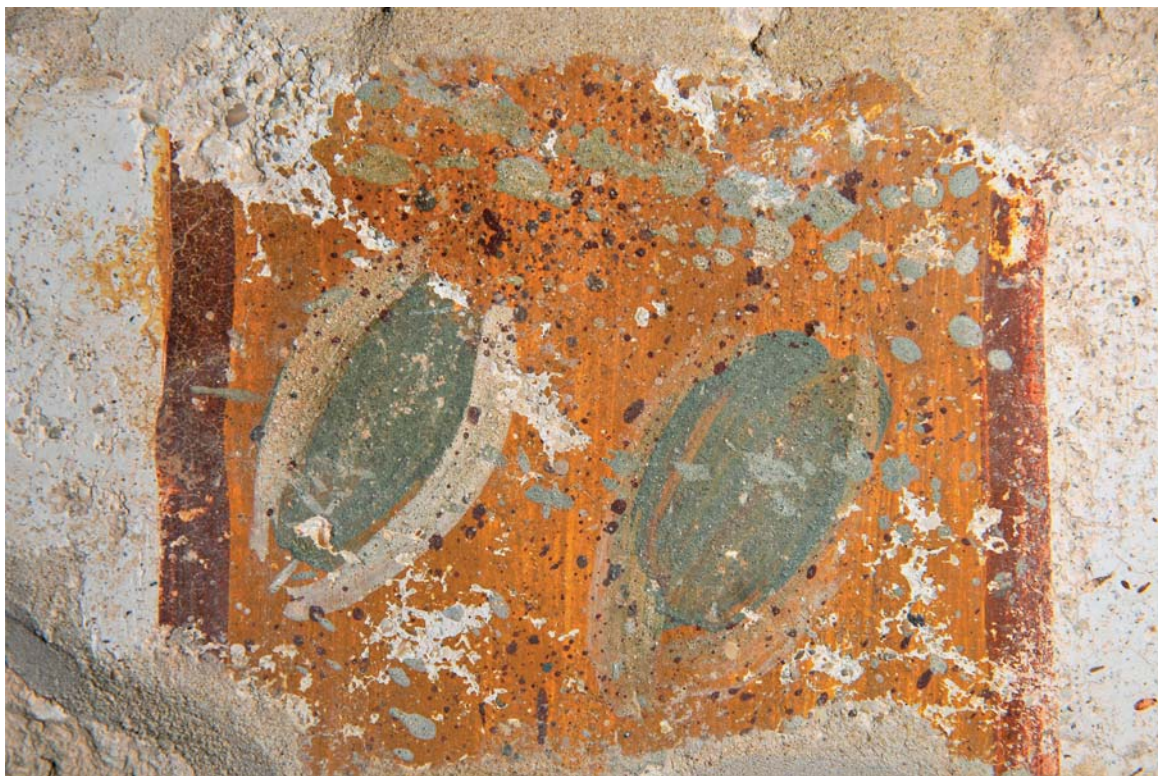
Fig. 3-30. Colorful, intentionally made paint splashes: detail of an unidentified depiction (*Cat. 81*)

Fragment *Cat. 81* reveals a unique painting technique, the artist apparently splashing paint deliberately across the depicted item [Fig. 3-30]. The effect must have been intended, because the splashes do not appear on the white background. Such splashes may have been meant to imitate marble (see below, § 5.3.4).

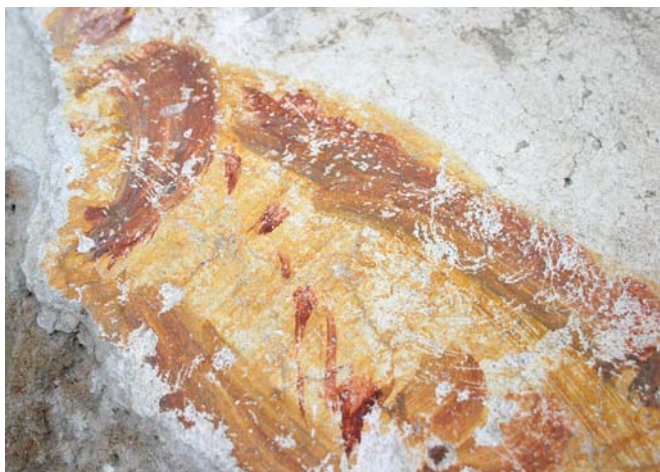
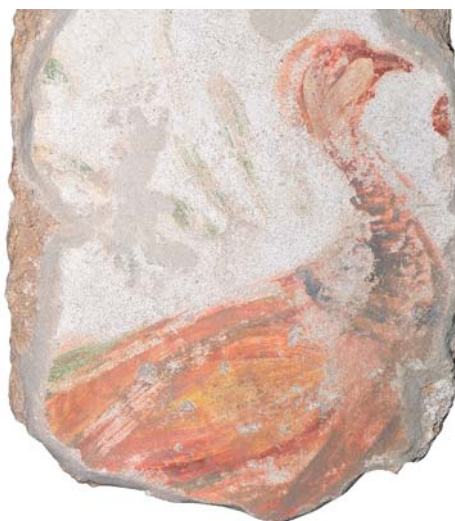
Fig. 3-31. Examples of disorganized paint handling: left, detail of an animal's neck (*Cat. 120*) and, right, depiction of a peacock(?) (*Cat. 96*); note the randomly applied colors, "dirty" paints, and quick, somewhat disorganized brushwork

The neat representations of the peacock (*Cat. 94*), partridges, and inhabited scrolls contrast with some fragments of paintings executed in a rather unconstrained and freehand, perhaps even sloppy manner [see below, *Fig. 3-31*]. One is entitled to think that these parts were done without any preparatory outlines to guide the artist's brush. Coupled with a varying artistic quality of particular fragments of paintings, this inconsistent approach to planning out the designs of wall paintings at Porphyreon argues in favor of the decoration being executed by several (teams of) painters.

Some depictions, however, appear to have been painted very spontaneously; there is no apparent organized structure of superimposed layers of paint nor any sign of intentional artistic effects. The colors are mixed, somewhat randomly applied, the details sloppy, the brushwork disorganized [*Fig. 3-31*]. These features indicate lesser artistic quality of the paintings in question, which may be ascribed to work of (a) less-skilled artist(s).

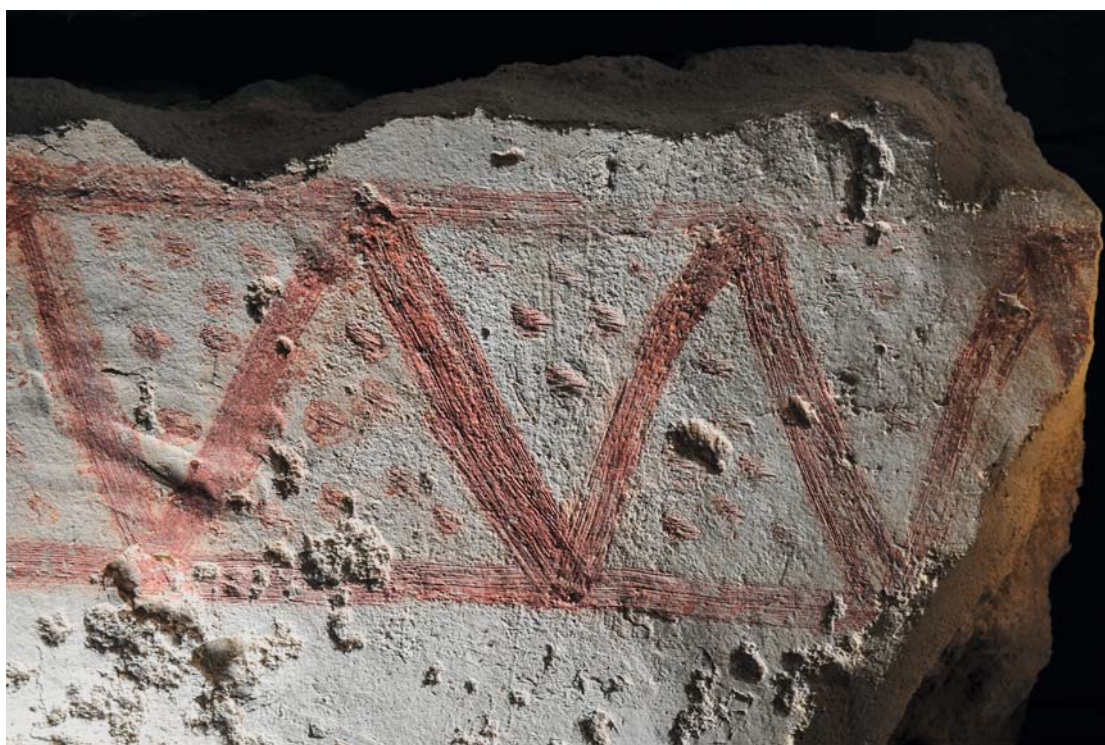
Fig. 3-38. Surface detail of *Cat. 80a* viewed in raking light;
note brush marks clearly made when the plaster was still wet

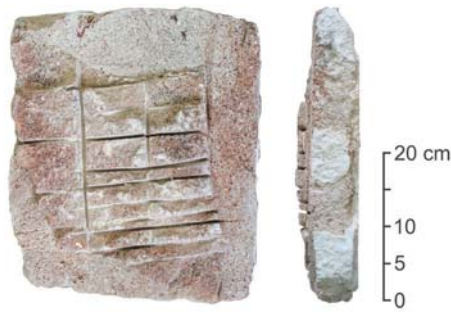
Fig. 4-2. The back (left) and one of the sides (right) of ashlar *Cat. 30d* showing deep cuts made with an angle grinder

Nearly half of the fragments (72) had their back (and in some cases also the sides) trimmed with an angle grinder, in order to reduce the weight and volume of the blocks [*Figs 4-2, 4-3*]. This action rendered the stone prone to cracking and breaking. Eight of the ashlar blocks with more than one surface painted were cut into pieces, each piece retaining plaster from a different side of the ashlar (*Cat. 78, 171–177*). This proved especially damaging for the six voussoirs from an arch. As result of this action, the painted face of the arch was separated from the painted intrados surface [*Fig. 4-4*]. The correlation between the six slightly trapezoidal dressed stones and the five rectangular ashlar blocks (one is missing now) with slightly concave plastered surfaces was not immediately apparent. The feature that betrayed a possible connection between them was an otherwise unexplainable diagonal cut at one of the edges of each of these elements.

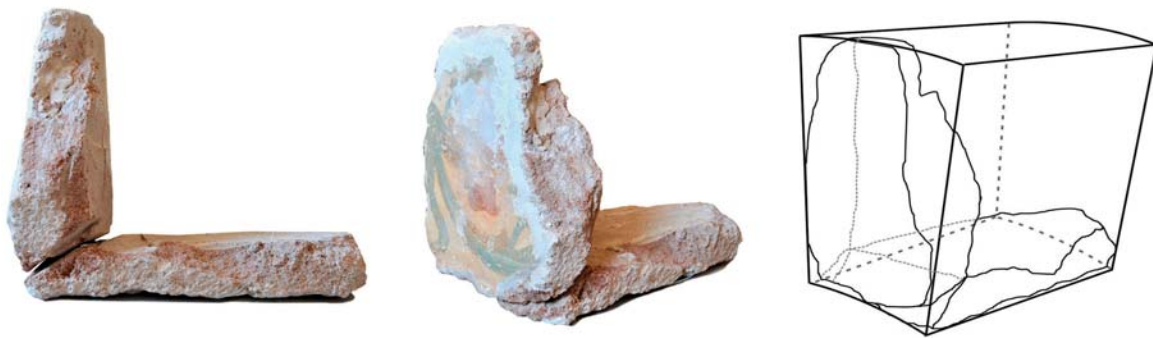
Fig. 4-3. Two fragments of voussoir *Cat. 174* recomposed: left, seen from the side; center, three-quarter view; right, reconstruction of voussoir shape

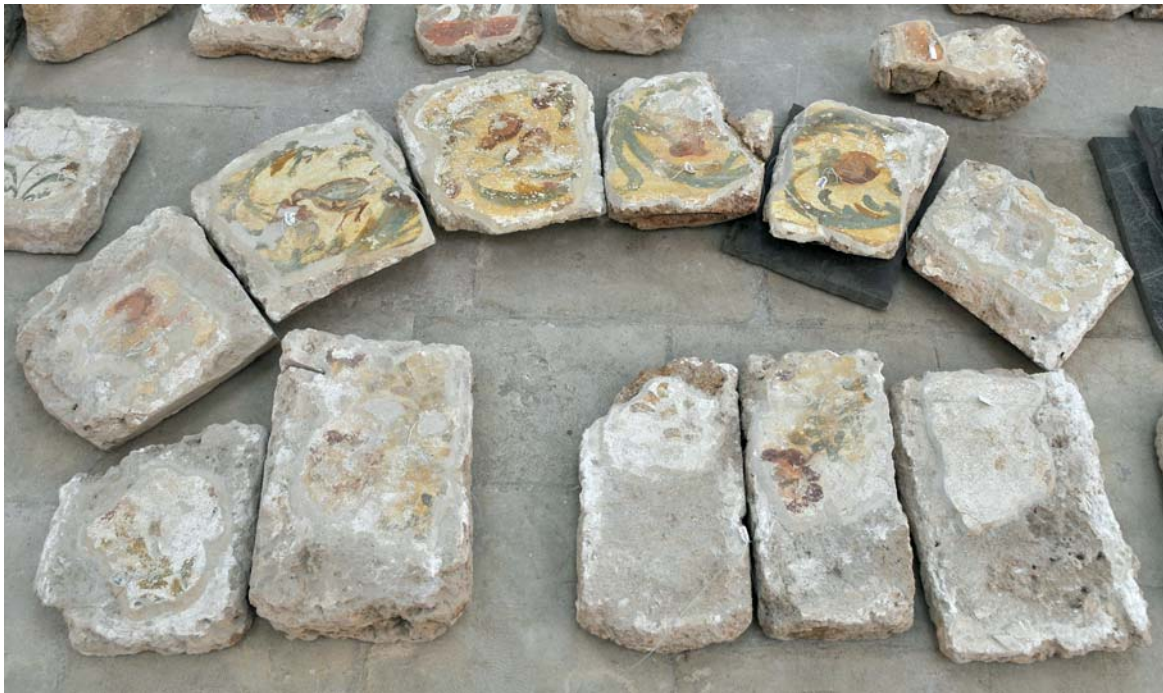
Fig. 4-4. Six trapezoidal faces of voussoirs and five matching, slightly concave elements from the intrados side of the voussoirs (one is missing; *Cat. 171–176*)

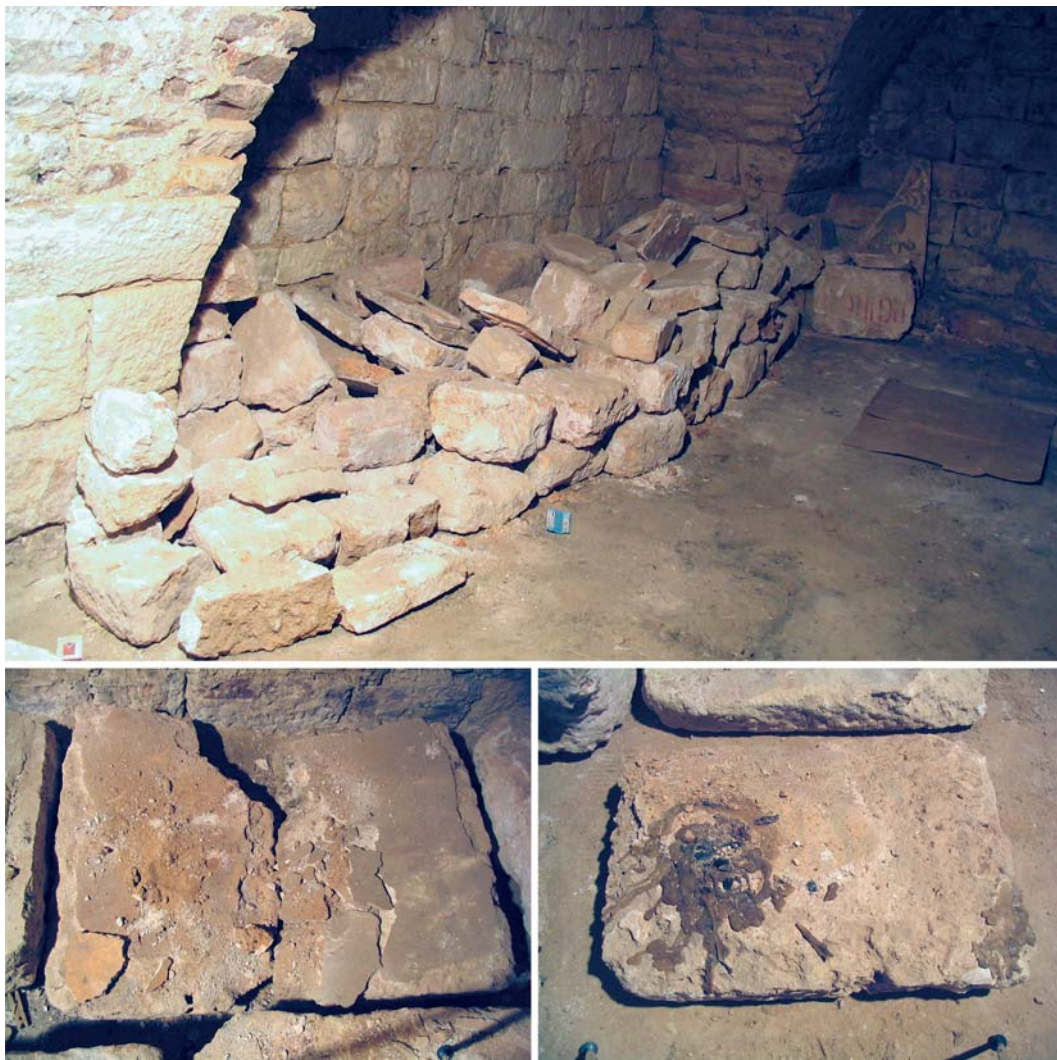
Fig. 4-6. Wall paintings from Porphyreon in the vaults of the Beiteddine Palace (2004); top, carelessly stacked blocks; note a fresh-looking break of the ashlar in the foreground; bottom left, broken and crumbled painted plaster; bottom right, remains of a burnt candle (on *Cat. 92*)

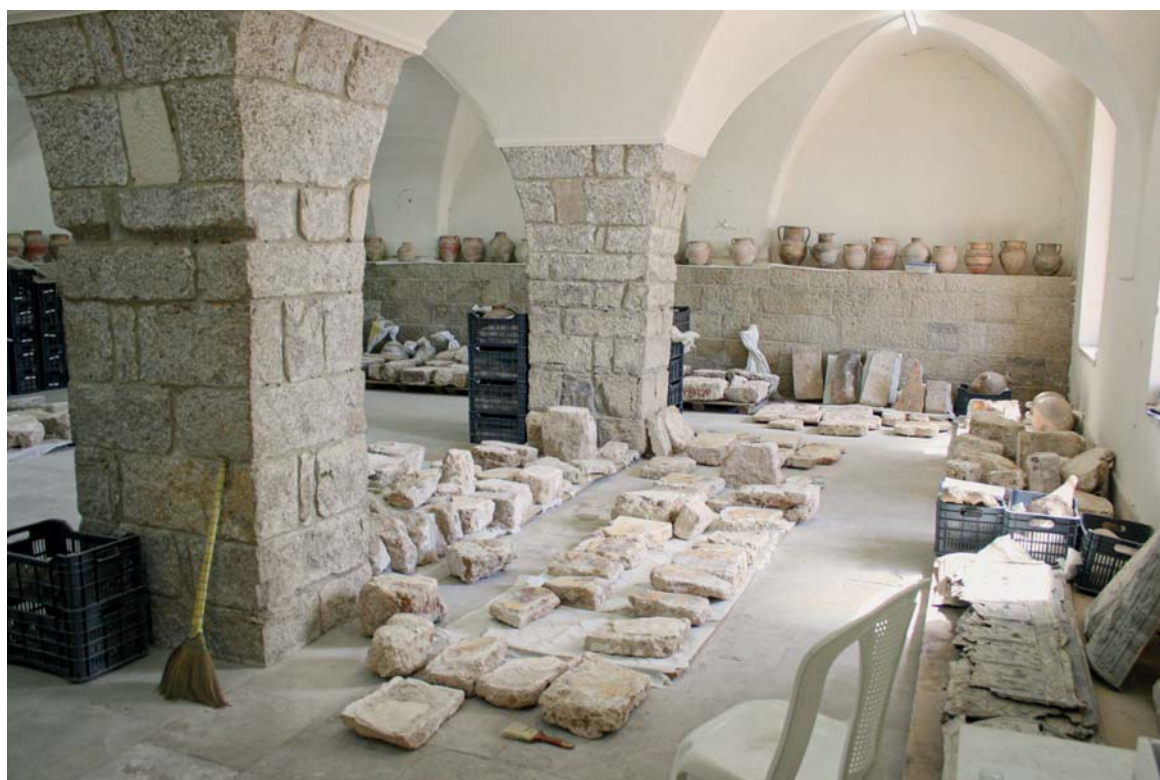
Fig. 4-7. Storage room for the wall paintings from Porphyreon and the archaeological collection of the Beiteddine Museum in 2014. View from the entrance. In the foreground, ashlar with wall paintings arranged on top of plywood boards covered with tissue

The paintings are kept in a spacious ground-level storage room with a high vaulted ceiling and stone floor [Fig. 4-7]. The walls, except for the pillars, are plastered and painted. Two large windows located in the south wall of the room have wooden shutters, usually closed. Access to the storage facility is restricted to DGA employees. The temperature inside the room changes slowly due to the considerable thickness of the stone walls. For example, the average temperature registered inside the facility during work seasons in September, when the outside daytime temperature ranged from 26°C to 32°C, was usually around 21°C.

appropriate insulation in that part of the palace. Water leakage is evident in the northeastern corner of the room; the entire east wall is damp. The storage room is equipped with an old yet functioning dehumidifier (Wood's Frostguard, model ED28-GD). Unfortunately, owing to frequent and prolonged power shortages in the museum, the instrument is rarely switched on. During the course of the Conservation Project, a hygrometer was installed in the storage room and monitored four times a day (at 9:00 and 11:00 AM, 2:00 and 5:30 PM). It showed relative humidity levels at about 85% in the mornings, right after the storage room was opened, dropping to about 45–50% by early afternoon. This drop was achieved simply by keeping the door and the two large windows open for the day. The museum staff received instructions to regularly ventilate the storage room throughout the year.

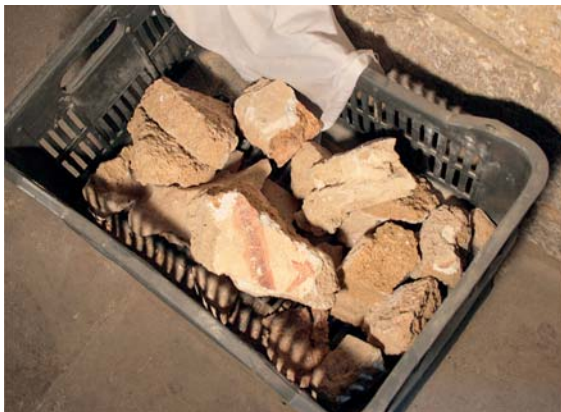
Fig. 4-9. Unregistered small fragments of broken blocks collected when the wall paintings were transferred from the vaults to the current storage room

pairs of stones with fresh breaks that had individual inventory numbers, reducing the number of registered ashlar to 158 (see below, § 4.6.6). Additionally, it was possible to match the broken ashlars and stones with a number of unregistered small fragments of stones collected when the paintings were transferred from the vaults of the palace [Fig. 4-9].

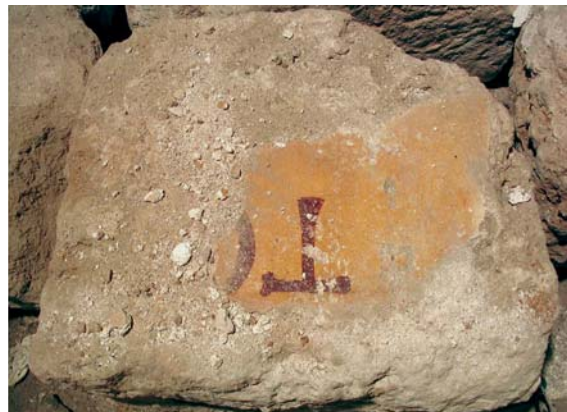
Fig. 4-10. Disintegration and crumbling of the painted plaster, leading to loss of painted areas (*Cat.* 207)

Loss of cohesion of the plasters and their granular disintegration was one of the most urgent issues, one which put the entire collection of wall paintings from Porphyreon in danger and necessitated immediate conservation attention. Loss of cohesion occurs when the binder does not hold the grains of the aggregates together and they begin to fall out. This process is especially evident on the jagged edges of surviving plaster [Fig. 4-10]. As the edges of the plaster disintegrate, the painted area shrinks as well. This process also concerns losses and abrasions of the plaster surfaces, which expand as the disintegration proceeds. Such decomposition of the binder, leading to disintegration of the plaster, can be caused, for example, by high humidity, unfavorable environmental conditions during deposition in the ground or after unearthing (characterized by an aggressive pH or containing pollutants and water-soluble salts), or by penetration of fungal mycelia into the render's structure.

The wall paintings from Porphyreon suffered from disintegration of the plasters, both painted and plain, but not of the preparatory mortars (Types 1 and 2), which generally remained coherent, suggesting that the preparation technology of the plasters was responsible for their poor condition to a far greater extent than any external factors. The quality of materials and mistakes made in

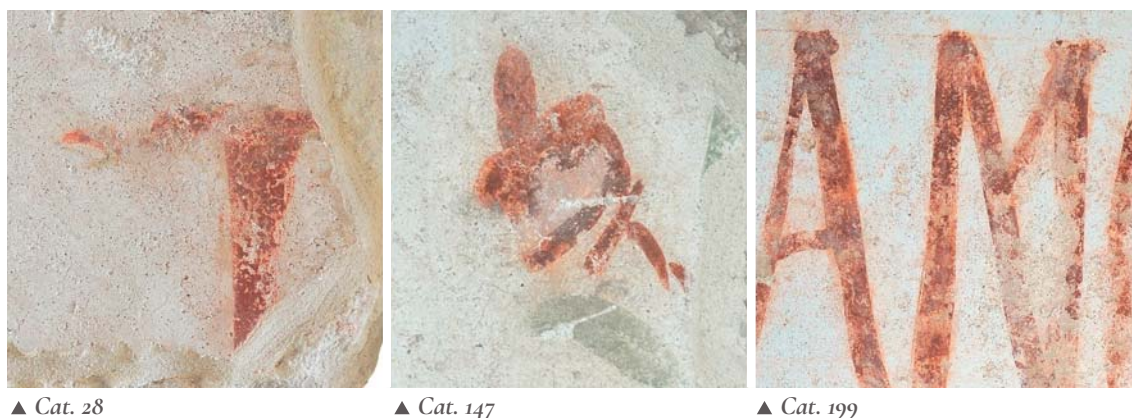
Fig. 4-12. Suffusion of red pigment on the surface of wall paintings, testifying to loss of cohesion of the paint layer

Of the 236 fragments from Porphyreon retaining painted plaster, 158 exhibited a powdery paint layer. The powdering concerned chiefly areas painted with red and dark red paint, and it could be explained by an insufficient amount of binder in these paint layers [*Fig. 4-12*].

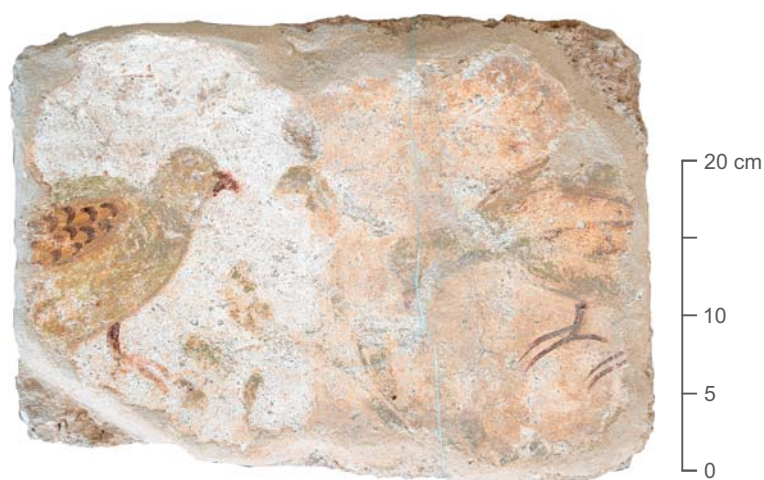
Fig. 4-13. Removal of surface grime (*Cat. 100*): the right side of the painting before cleaning, the left side after cleaning

Wall paintings from Porphyreon were covered with various kinds of secondary, unaesthetic residues, of either natural or artificial origin. Obscuring the plaster were deposits of dirt firmly adhering to the surface and by dust accumulating in the storage area over the years [Fig. 4-13]. Furthermore, soil and vegetal remains were caught in the cavities and interstices of the stones and plasters. No salt efflorescence was observed.

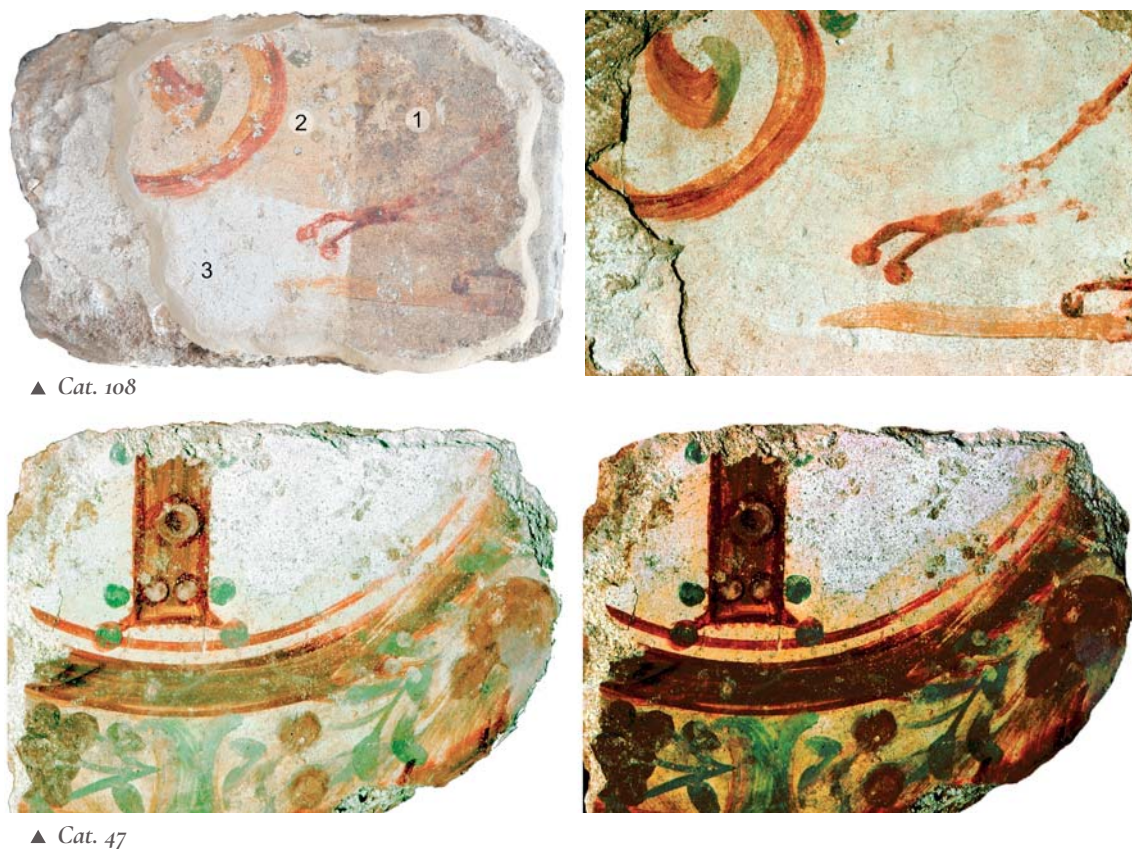
Fig. 4-16. Artificial coatings: top, fragment during cleaning, showing the uncleaned surface (1), a dull, grayish, synthetic varnish revealed after removal of surface grime (2), and the surface after removal of the varnish (3); at right, the painting as documented in 1975; bottom, condition documented in a photo from 1975; at right, the same photo after adjusting contrast and saturation levels in graphic software – note yellow veil over the painted areas indicating an artificial coat of varnish

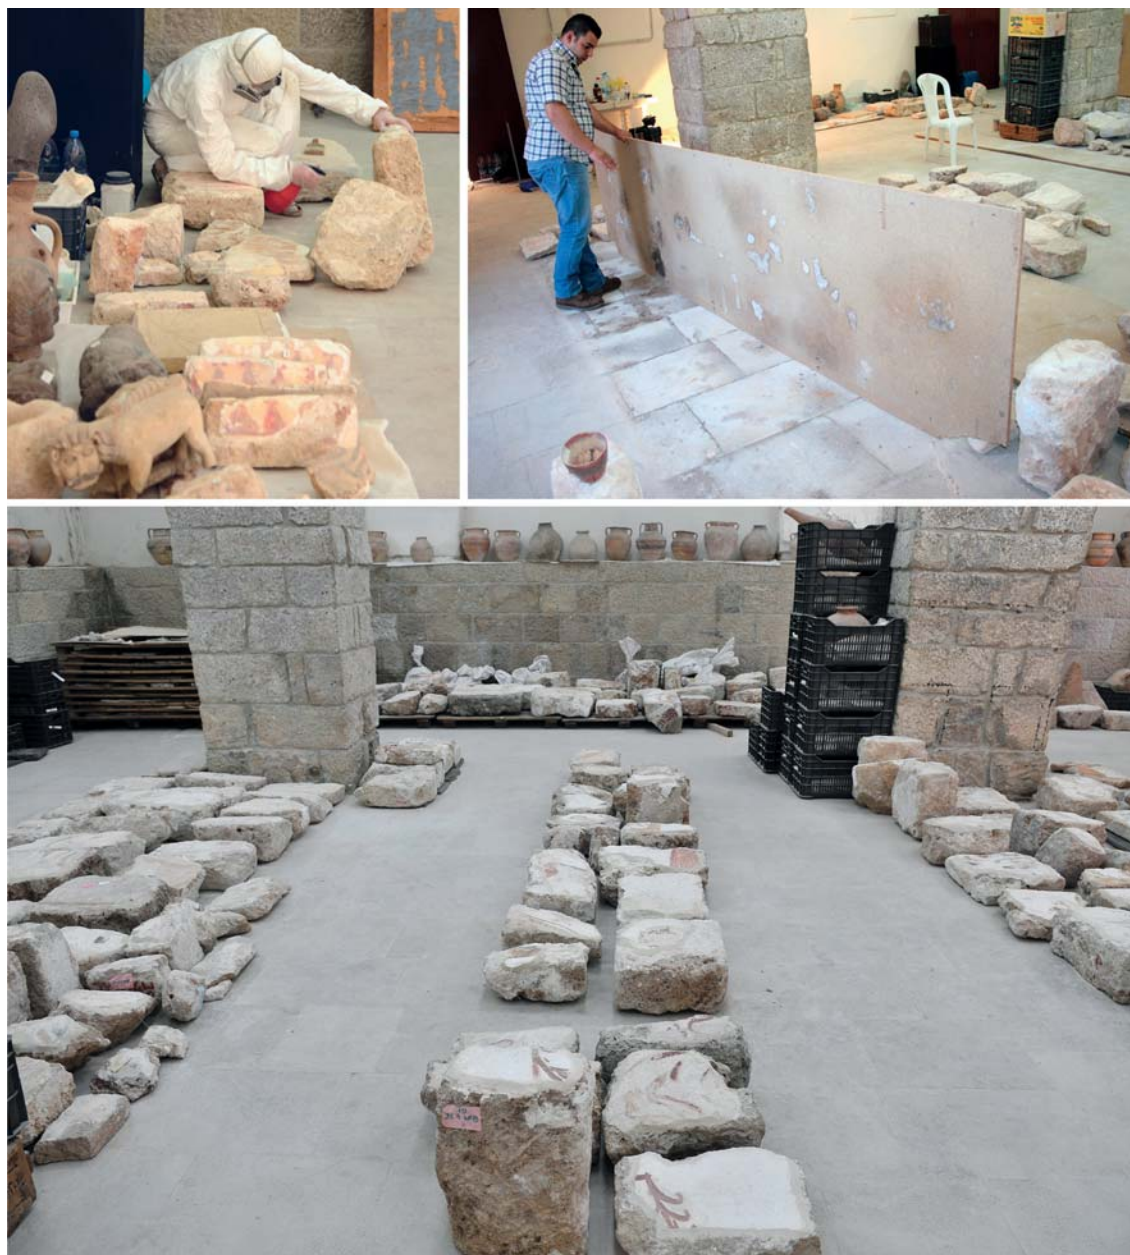
Fig. 4-19. Disinfection and improvement of storage conditions: top left, disinfection of the entire collection of paintings carried out at the beginning and end of each work season; top right, removal of one of the plywood boards on which the paintings were stored prior to 2014 – note the moist stains produced by fungi on the board and floor; bottom, current arrangement of stones and ashlars directly on the floor of the storage facility

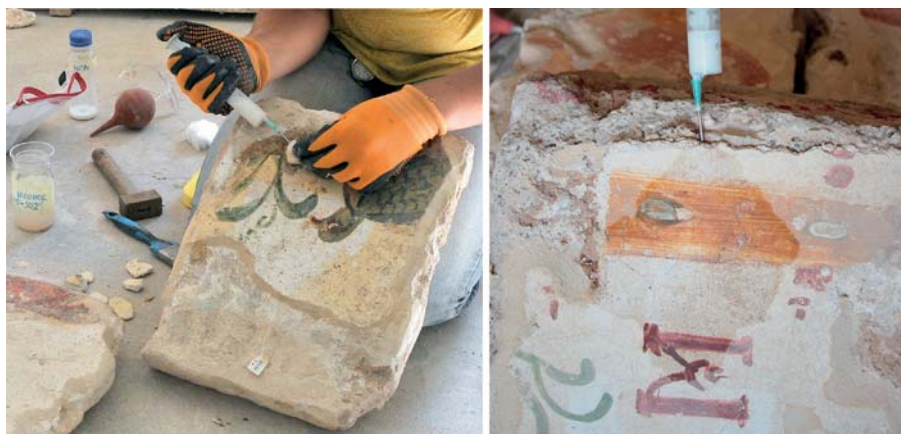
Fig. 4-20. Reattachment of detached plaster by means of injections: left, *Cat. 97*; right, *Cat. 37b*; note the moist stain on the surface of the plaster indicating migration of the adhesive inside the cleavage

Reattachment of detached plasters was achieved by applying an adhesive (7–10% water dispersion of Primal AC-33), introduced underneath the plaster with a syringe through existing cracks or at the edges of the plaster [Fig. 4-20]. It was preceded by the application of ethanol (45%) used to reduce surface tension inside the cleavages and to facilitate penetration of the adhesive. In the case of extensive detachments, the procedure was carried out in stages, with breaks between subsequent applications in order to allow the adhesive to fill the cleavages and set. None of the detachments were deep enough to require the employment of liquid injection mortar such as Ledan TB. No injections were carried out on fragments where the adhesion was only slightly weakened along the perimeter of the extant plaster. It was assumed that the application of mortar bands to the

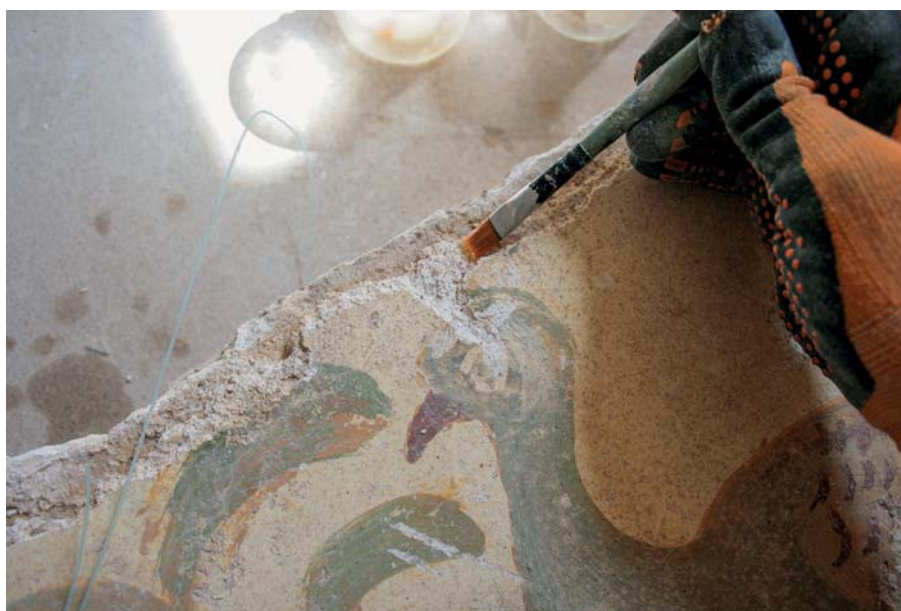
Fig. 4-21. Consolidation of disintegrated edges of plaster using Primal WS-24 (*Cat. 94*)

The granular disintegration of the plaster edges was in urgent need of attention. In order to halt this rapidly progressing deterioration process, a 2% water dispersion of Primal WS-24 acrylic resin was applied to the edges and abraded surfaces of the plasters. This kind of adhesive is characterized by excellent properties of penetration into porous structures, so it can bind grains together and prevent the mortar from disintegrating.

The resin was brushed onto the edges and abraded surfaces of plasters, following application of ethanol (45%) used to reduce surface tension and to facilitate penetration by the adhesive [Fig. 4-21]. Consolidation with Primal WS-24 was carried out on all stones and ashlars which had retained plaster on their faces, whether painted or plain.

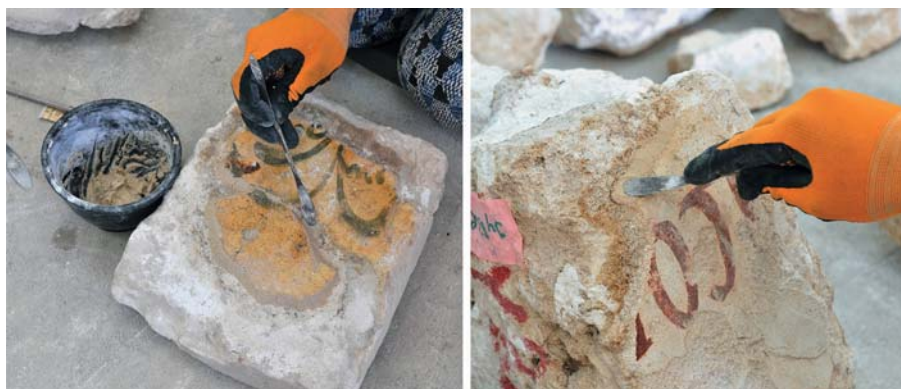
Fig. 4-22. Application of mortar bands: left, *Cat. 98*; right, *Cat. 211*

The bands were applied around the edges of all plasters, including plain fragments [Fig. 4-22].⁶ Large losses were infilled with the same type of mortar. The fills were applied *sotto livello*, about 1 mm below the surface of the original plaster; their surfaces were left slightly rough.

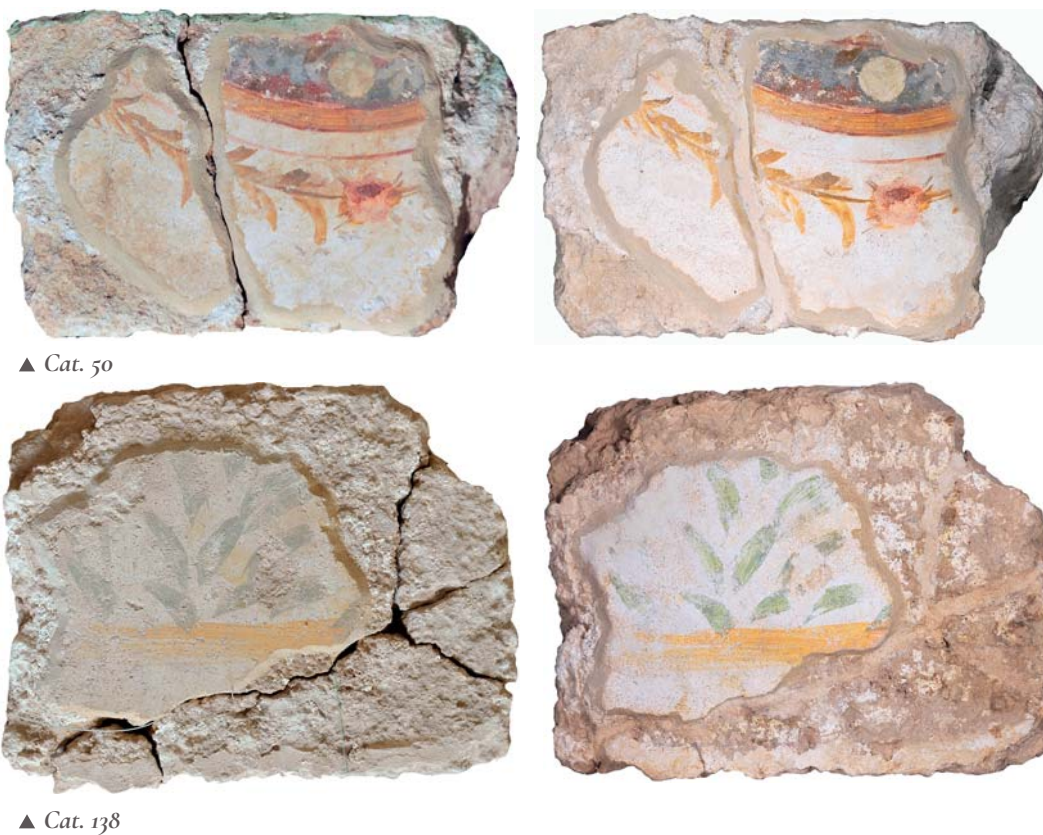
Fig. 4-23. Ashlars *Cat. 50* and *Cat. 138* before (left) and after reassembly, application of new mortar bands, and filling the joints with mortar (right)

- *Cat. 4* reassembled with three small pieces without inventory numbers;
- *Cat. 50* reassembled from two elements with separate inventory numbers [*Fig. 4-23 top*];

- *Cat. 127* reassembled from two elements with separate inventory numbers;
- *Cat. 138* reassembled from two elements with separate inventory numbers and three small pieces without inventory numbers [*Fig. 4-23 bottom*];

The surfaces of the breaks were carefully cleaned of dust. Next, holes were drilled in matching elements to accommodate fiberglass rods intended as a means to reinforce the bond [Fig. 4-24 top left and right]. The number, length, and diameter of the rods depended on the volume and weight of the matching elements. A two-component epoxy resin for stone conservation was used as an adhesive (Akepox 2040 by Akemi). The resin was inserted into the drilled holes and applied to the rods and the surface of the breaks [Fig. 4-24 bottom left]. The matching elements were rejoined and put under pressure for 24 hours [Fig. 4-24 bottom right]. Any excess of epoxy resin oozing from the joints was immediately cleaned with acetone. For the stone elements that could be reassembled from several pieces, this procedure was carried out in stages. Joints visible on the face of a reassembled ashlar were filled with mortar tinted with pigments to match the color of the stones. Where necessary, new mortar bands or fills were applied to the plasters [Fig. 4-23 top and bottom right].

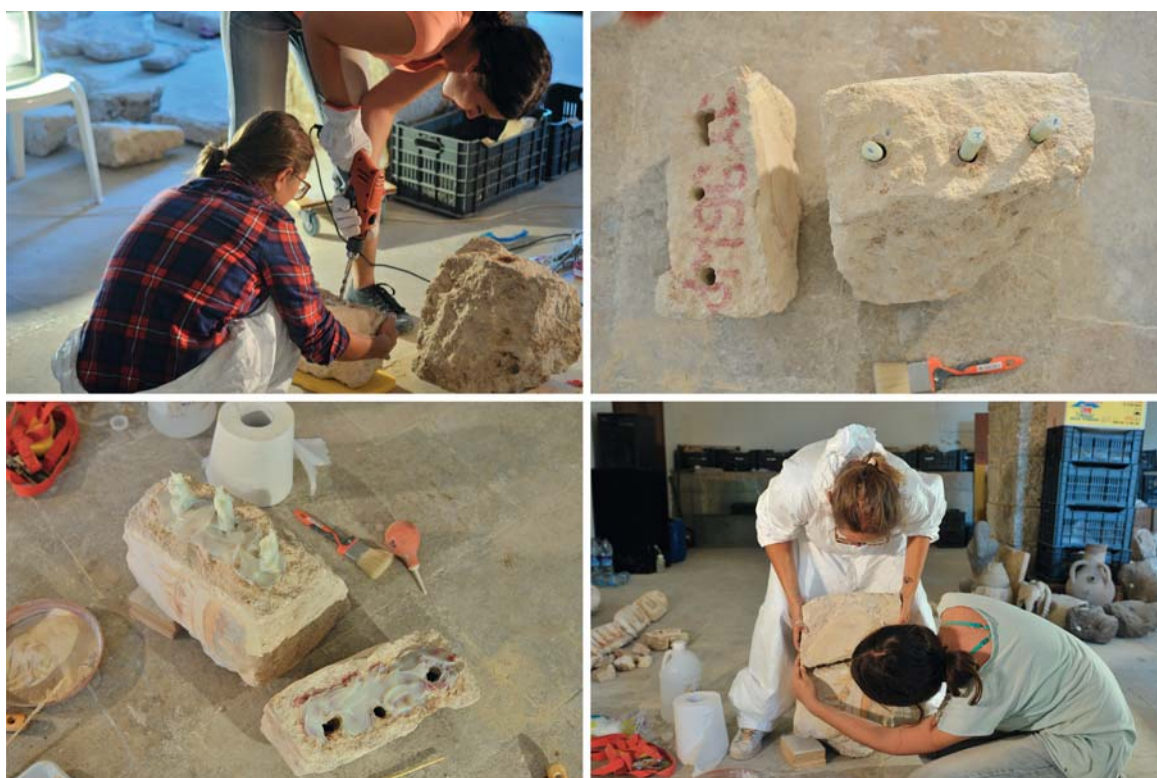
Fig. 4-24. Reassembling broken stones (*Cat. 50*): top left, drilling holes in one of the two fragments of the ashlar; top right, fiberglass rods inserted in the holes; bottom left, application of epoxy resin to the fiberglass rods, drilled holes, and surfaces of the breaks of the two fragments of ashlar; bottom right, rejoining the two fragments

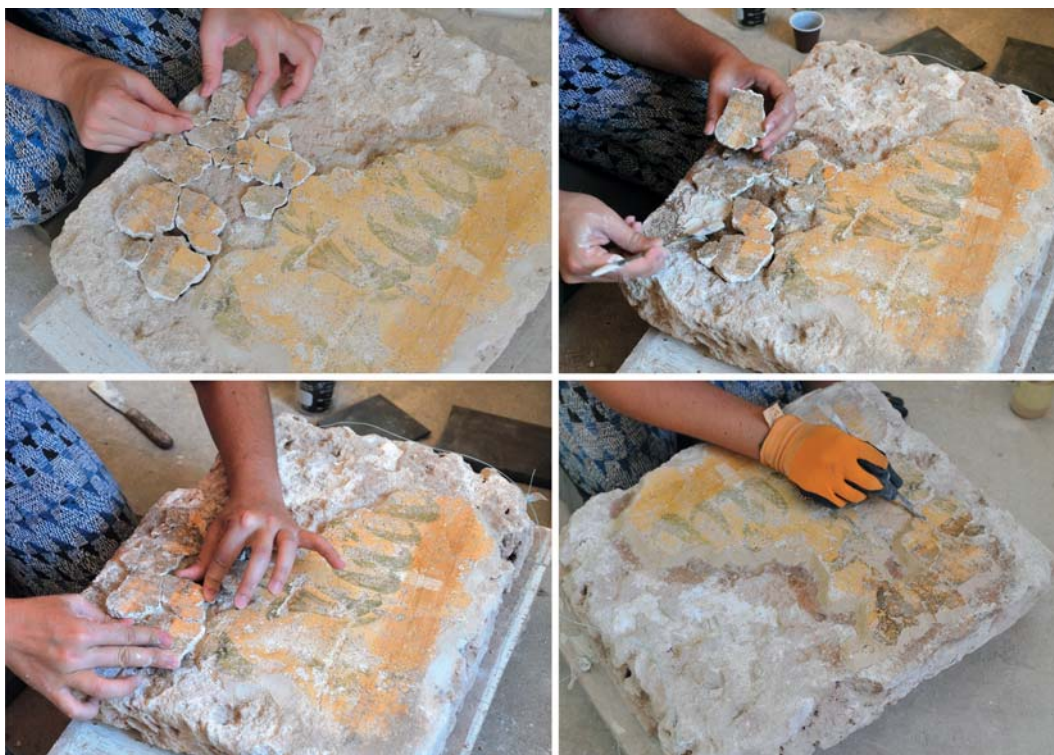
Fig. 4-25. Successive stages of matching and reintegrating fragments of broken plaster (*Cat. 137*): top left, matching fragments; top right, applying a thin layer of mortar to the stone; bottom left, setting fragments in mortar; bottom right, applying mortar bands around reintegrated plaster

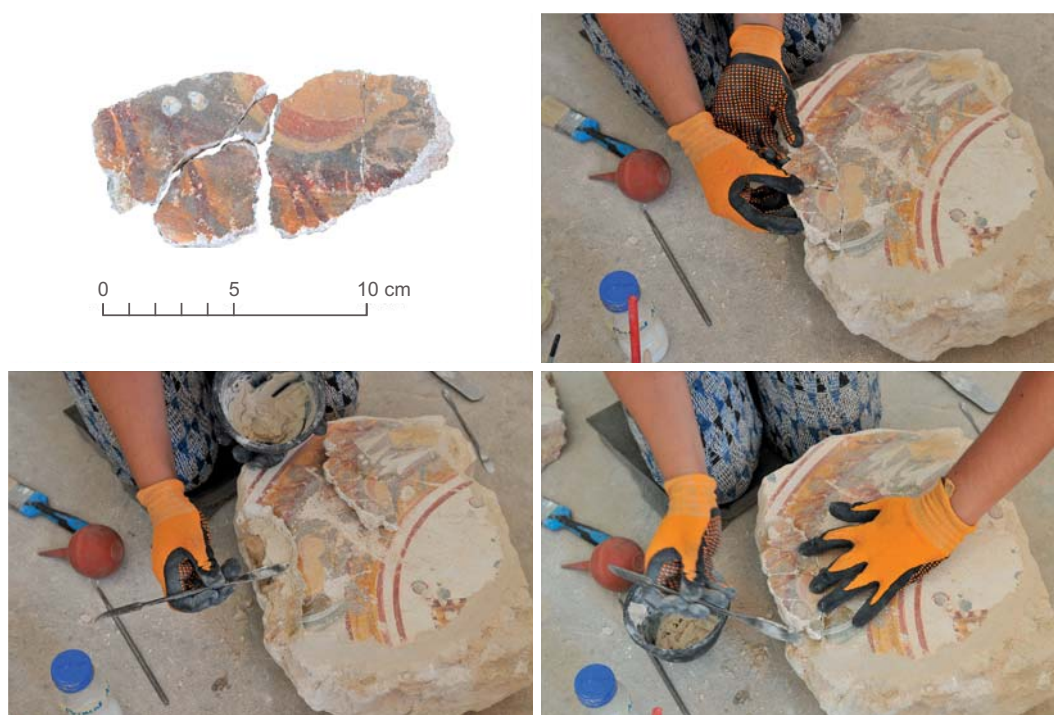
Fig. 4-26. Successive stages of matching and reintegrating fragments of broken plaster (*Cat. 45b*): top left, the fragments; top right, matching the fragments; bottom left, applying a thin layer of mortar to the stone; bottom right, setting the fragments in the mortar and applying mortar bands

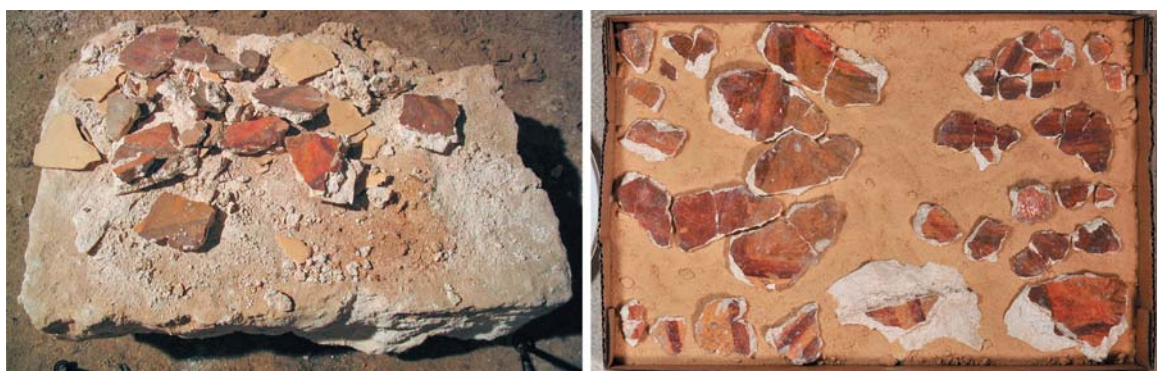
Fig. 4-27. Painted plaster from *Cat. 213*: left, condition in 2004, during storage in the vaults of the Beiteddine Palace; right, partly reassembled fragments

An effort was made to reassemble the numerous loose fragments of painted plaster belonging to *Cat. 213*. Photographic documentation made in the vaults of the Beiteddine Palace in 2004 shows this ashlar with broken fragments of plaster lying on top of it [Fig. 4-27 left]. The loose fragments were distinctive due to their maroon-khaki color palette and a thick layer of varnish. Some were reassembled, but since many were missing, it proved impossible to restore the composition or to position the reassembled, larger fragments on the ashlar.

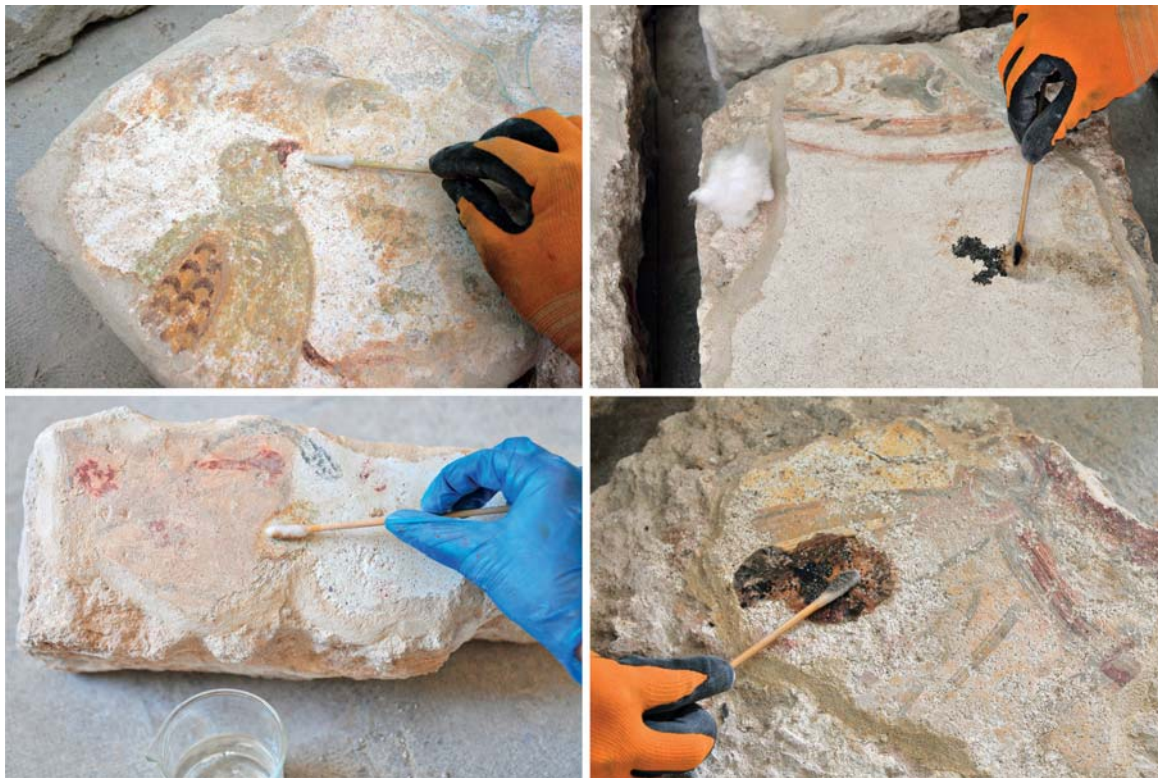
Fig. 4-28. Surface cleaning: left top and bottom, removal of surface grime using cotton swabs dipped in distilled water (*Cat. 100* and *Cat. 149*); top right, removal of an ink stain from *Cat. 52*; bottom right, removal of wax from *Cat. 92*
