LATE ANTIQUE WALL PAINTINGS FROM PORPHYREON IN THE SIDON HINTERLAND

Julia M. BURDAJEWICZ

PEETERS
LEUVEN – PARIS – BRISTOL, CT.
2022

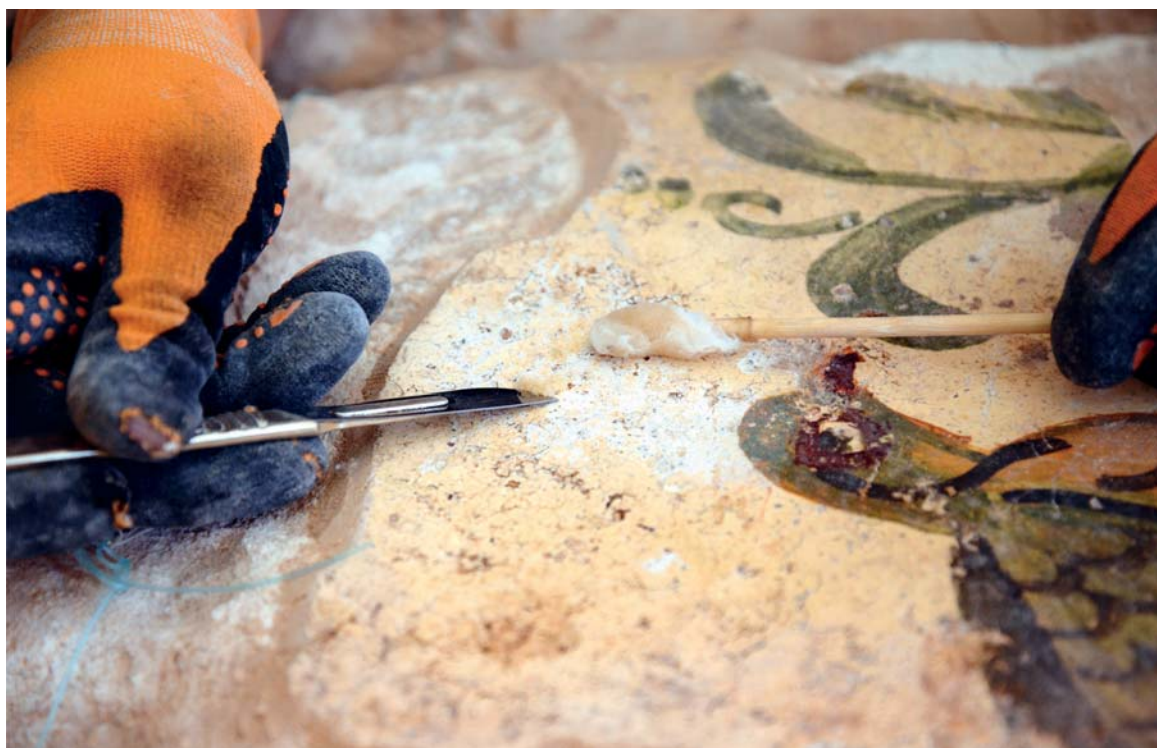
Fig. 4-29 Using a scalpel to scrape off from the surface alkyd varnish turned to gel after prolonged exposure to toluene (*Cat.* 97)

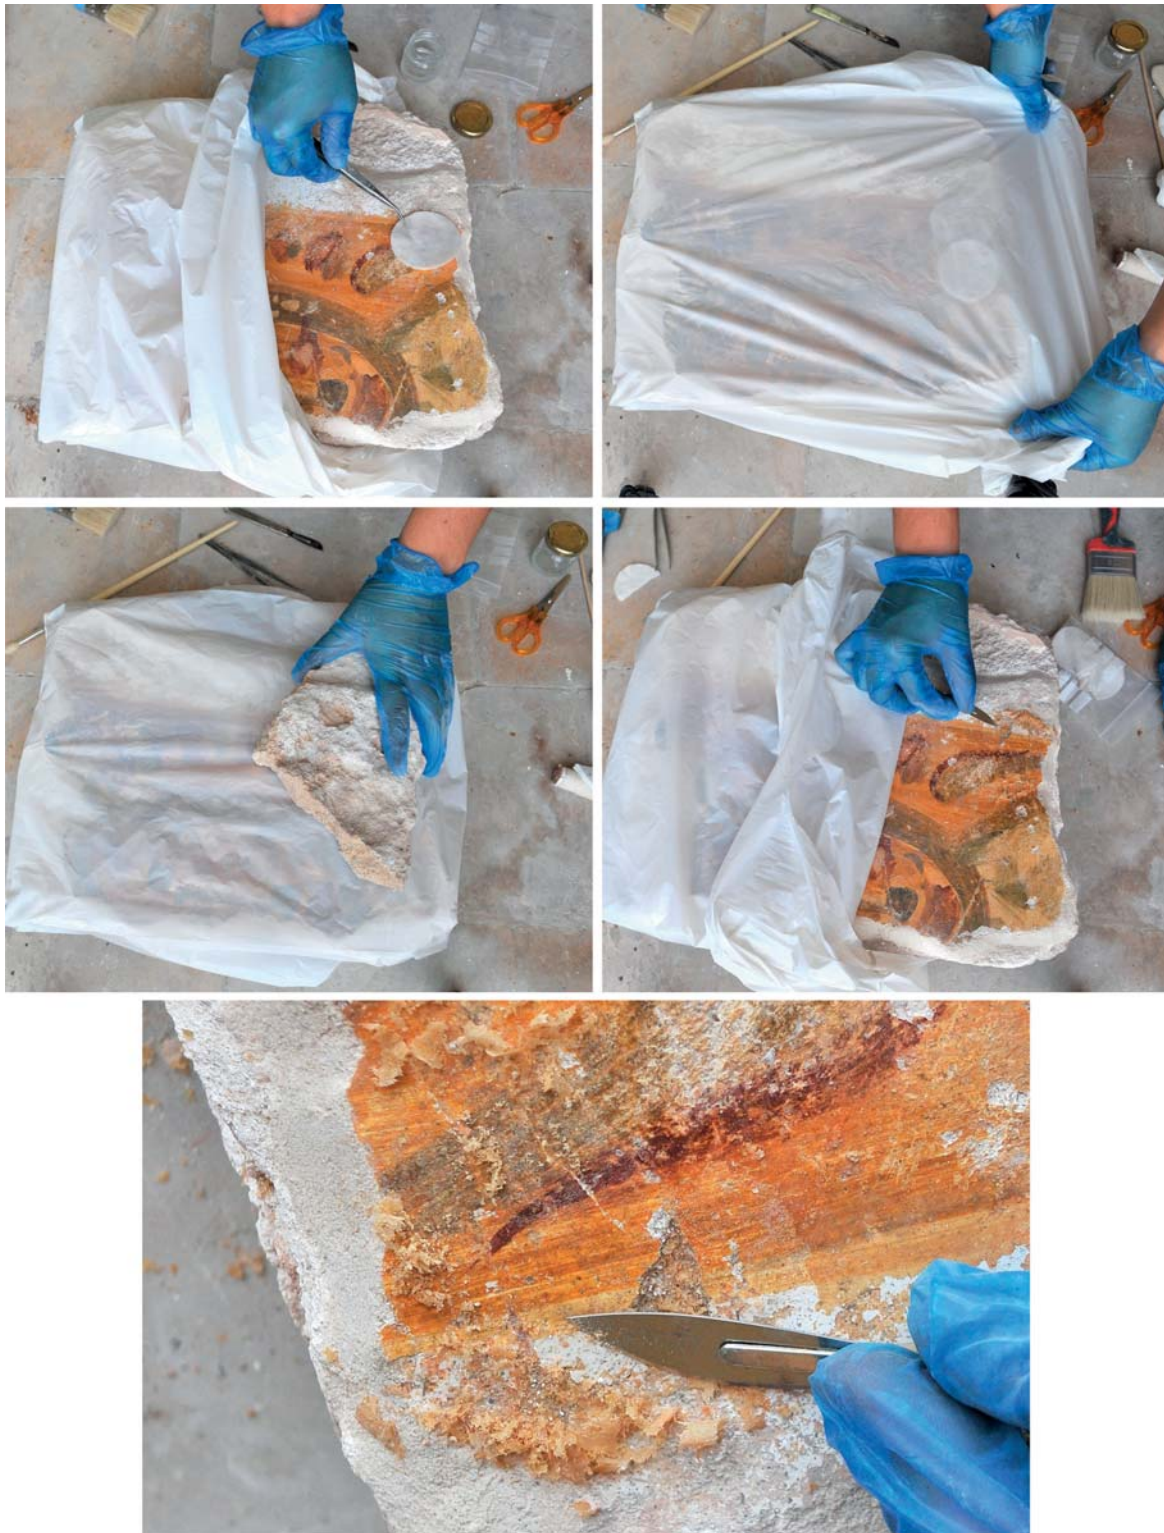
Fig. 4-30. Successive stages of removal of alkyd varnish from the surface of *Cat. 30d*: top left, application of cotton pads soaked in the solvent; top right, wrapping the ashlar in polyethylene foil; center left, putting pressure on the compresses; center right, unwrapping the ashlar and scraping off the varnish with a scalpel; bottom, close-up of the painting surface during the removal of the alkyd varnish

The varnish removal procedure involved application of cotton compresses soaked in solvent to the painting surface, wrapping the stone tightly in polyethylene foil to slow down evaporation, pressing the compress down with a heavy object and leaving it for about 15–45 minutes.⁷ After that time the varnish would become considerably softened and form a gel that could be gently removed with a scalpel blade [Fig. 4-30]. In some cases, the varnish would peel off so easily and thoroughly that it was enough to swipe the peels off with a brush [Fig. 4-31]. For especially thick coatings, the procedure was repeated once or twice. Because the organic solvent could not affect the mineral binder of the paint layer, the cleaning procedure was safe for the paintings. Varnish was completely removed from a total of 62 fragments: *Cat.* 8, 14, 19–21, 30, 36, 59a, 60, 66, 74, 78, 79, 81, 92, 94, 97, 98, 104, 107, 110, 121, 122, 124, 126, 127, 129, 137, 138, 140, 141, 143, 144, 150, 153, 154, 168, 170, 171, 172, 173b, 174a, 175, 177, 178, 196, 198, 203, 207, 217, 254.

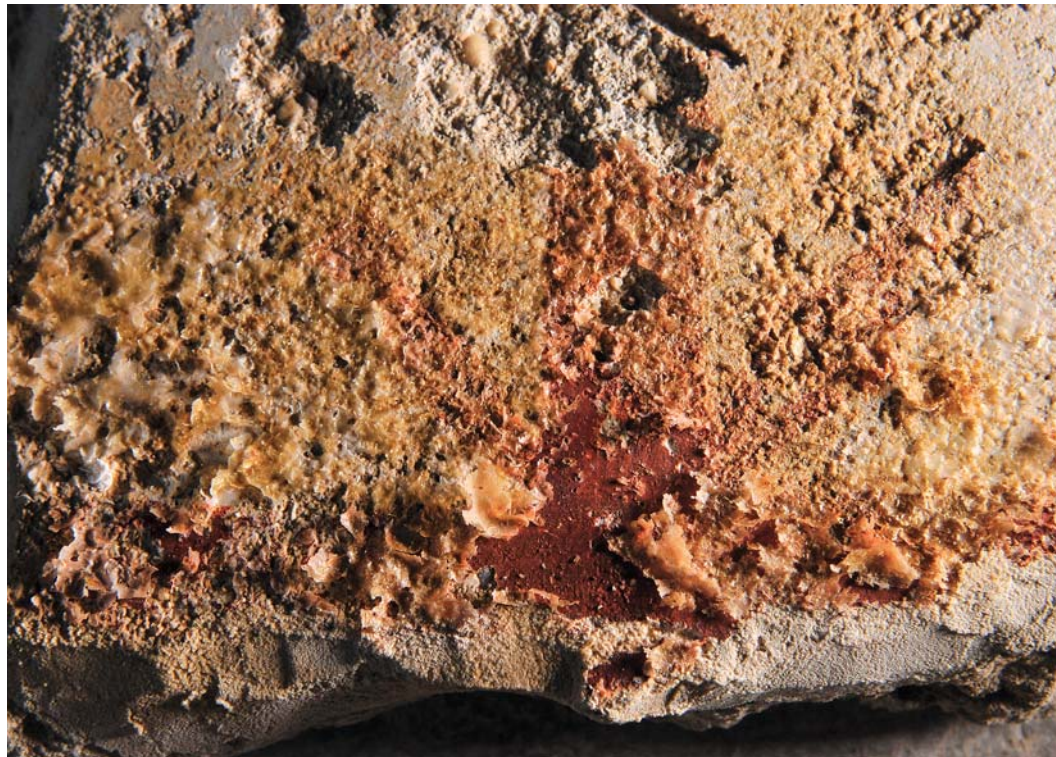
Fig. 4-31. Close-up of the painting surface of two fragments showing delamination of the alkyd varnish after treatment with the solvent; bottom, view in raking light

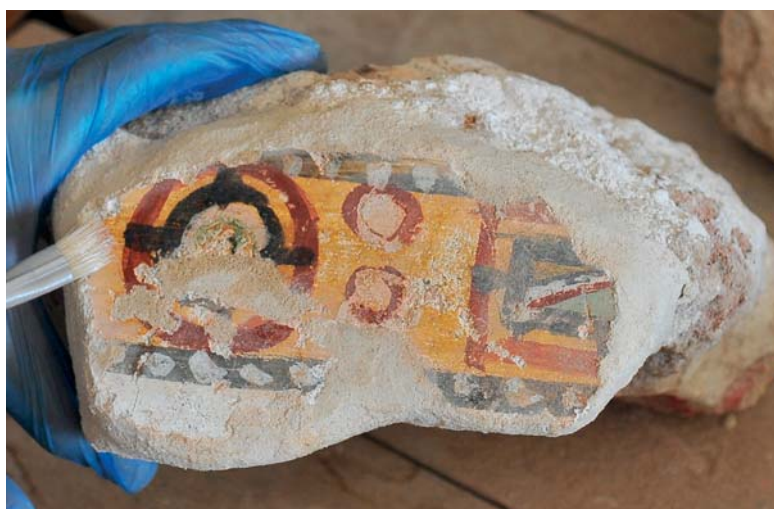
Fig. 4-33. Consolidation of powdery paint (*Cat. 35*)

Areas of powdery paint layers were consolidated with a 2% solution of Paraloid B-72 in toluene applied with a brush [Fig. 4-33]. On the most powdery parts of the paintings, the consolidant was applied 2–3 times to achieve proper cohesion. Altogether, 158 fragments required consolidation of the paint layer, chiefly in the red parts.

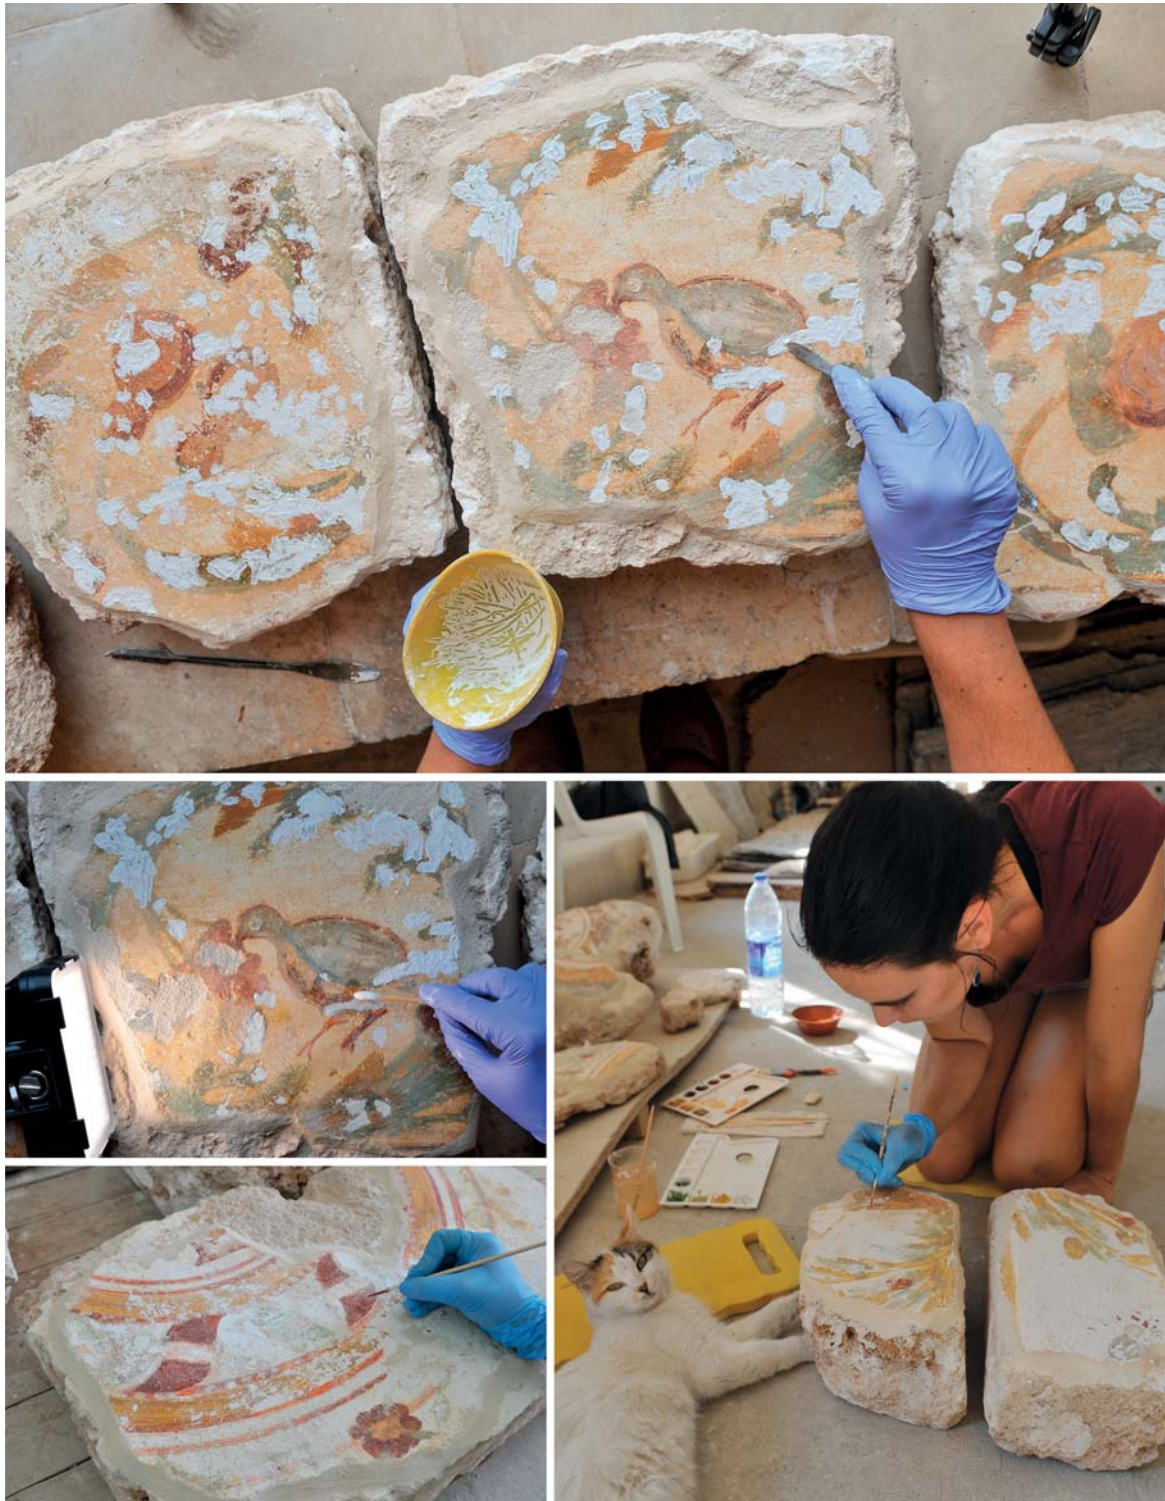
Fig. 4-34. Infilling losses: top, application of gesso (*Cat. 171a*); center left, removal of excess gesso and adjusting the surface of the fill to match the texture of the surrounding original (*Cat. 171a*); bottom left and right, inpainting fragments *Cat. 60, 151, and 152*

First, shallow losses in the plaster were infilled with gesso made of chalk and a 10% water dispersion of Primal AC-33 [Fig. 4-34 top]. The texture of the fills was adjusted to match the texture of the surrounding original surface [Fig. 4-34 center left]. Next, the most visually displeasing losses in the paint layer were inpainted with paints prepared from 7% water dispersion of Primal AC-33 and dry pigments to ensure full reversibility [Fig. 4-34 bottom left and right].

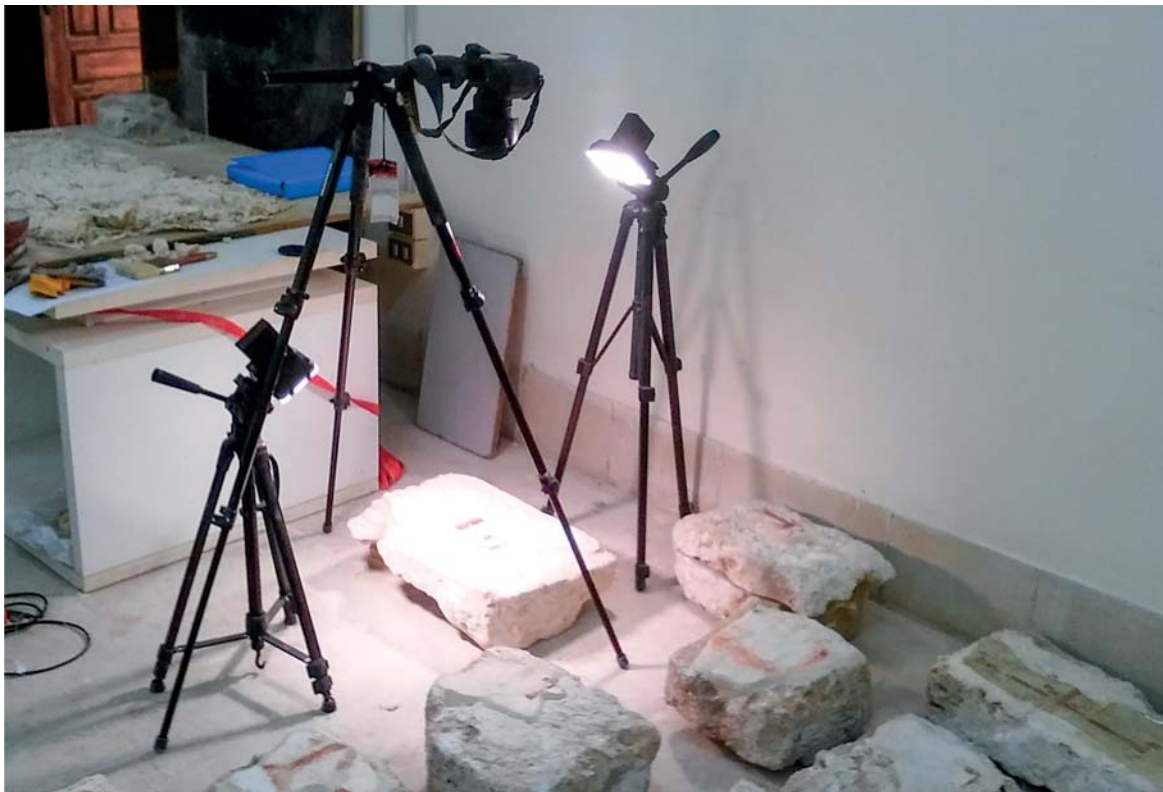
Fig. 4-35. Setup used to photograph fragments of wall paintings

All stages of the treatment were documented descriptively and photographed with a Nikon D300s reflex digital camera equipped with Nikkor 17-55 mm, f/2.8 AF-S ED lenses. Frequent power shortages in the Museum necessitated the purchase of two battery-powered XT-160 II LED lamps for the final photographic documentation of the paintings. The lamps and the camera were mounted on photographic tripods, ensuring mobility [Fig. 4-35]. The LED lamps also allowed creating photographic documentation of the paintings in raking light, which was particularly useful for the examination of execution technique and paint handling.

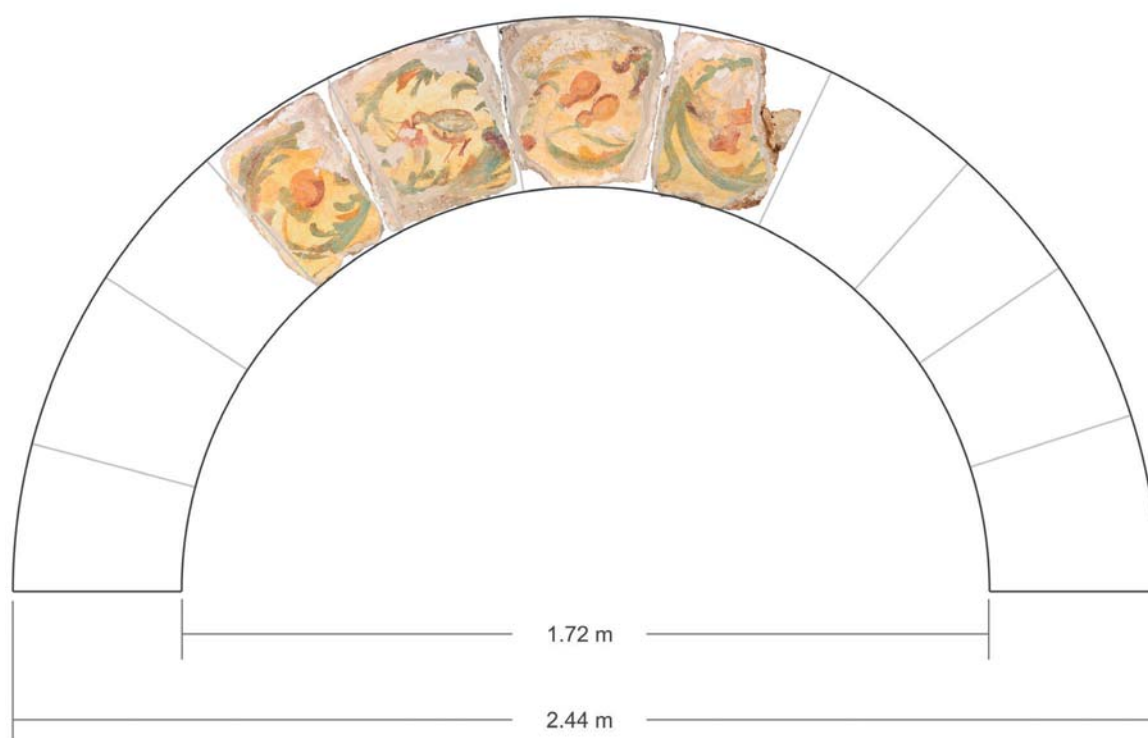
Fig. 6-1. Hypothetical reconstruction of the setting of *Cat. 94* on top of an arch and the estimated span of the arch

fragment (*Cat. 94*), is about 0.84 m, which indicates that the arch had a diameter of about 1.68 m.³ Furthermore, the fragment in question had to be placed on top of a set of voussoirs responsible for the load-bearing capacity of the arch [*Fig. 6-1*]. Therefore, in order to estimate the width of the passage in question, the span of 1.68 m should be further reduced by double the height of the voussoirs. Although the dimensions of these voussoirs are not known, the arched aperture must have been relatively small, probably less than 1.5 m wide. Thus, we could be dealing with a small arched passage.

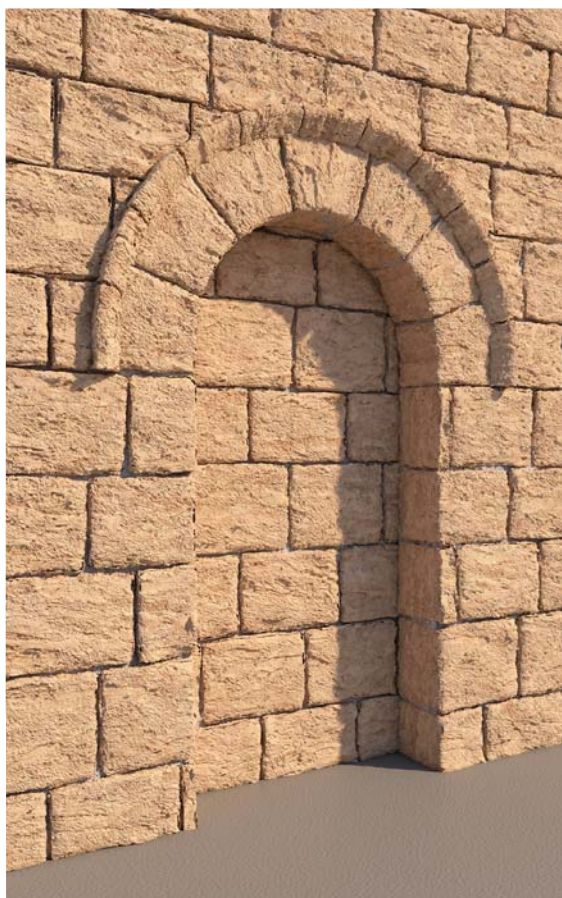
Fig. 6-4. Visualization of the elements of a hoodmold above a niche

radius in proportion to their flat shape. Such an arch could not have had a high load-bearing capacity, so the elements in question most likely topped an arch made of “true” voussoirs. They could have constituted a hoodmold (also referred to as “label” among others), that is, a projecting molding running along the top of an arch [*Fig. 6-4*]. Similar hoodmolds can be seen, for example, above a niche, an arched entrance, and a small apsis inside the northern apse of the Southern Church at Shivta/Sobota (Segal 1988: 110–115) [*Fig. 6-5*]. The last example has remains of a series of red triangles, painted directly on the stones. The hoodmold above the entrance to Tomb 4112C at the necropolis of Tyre also provides a parallel for this kind of projecting and painted element (Chéhab 1985: 630).

As with the representation of a peacock (*Cat. 94*) and the voussoirs discussed above, the place of the hoodmold decorated with red triangles in the basilica cannot be established. The calculated span of the inner curve of the molding measures about 1.77 m. As with *Cat. 94*, this dimension should be further reduced by double the height of the voussoirs that supported the molding [*Fig. 6-6*]. Therefore, the width of this archway was probably only about 1 m. Thus, it is possible that the hoodmold topped a small opening or a niche like the one at Shivta/Sobota.

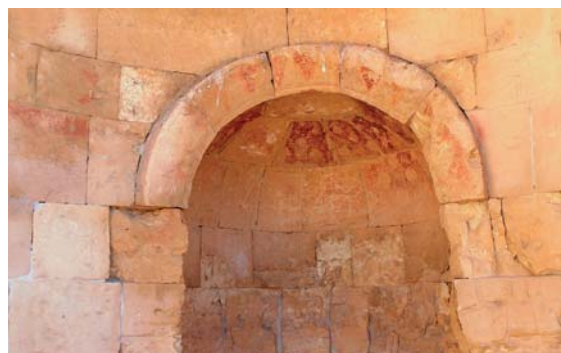
Fig. 6-5. Hoodmold with painted red triangles above a small apsis in the northern apse of the Southern Church at Shivta/Sobota

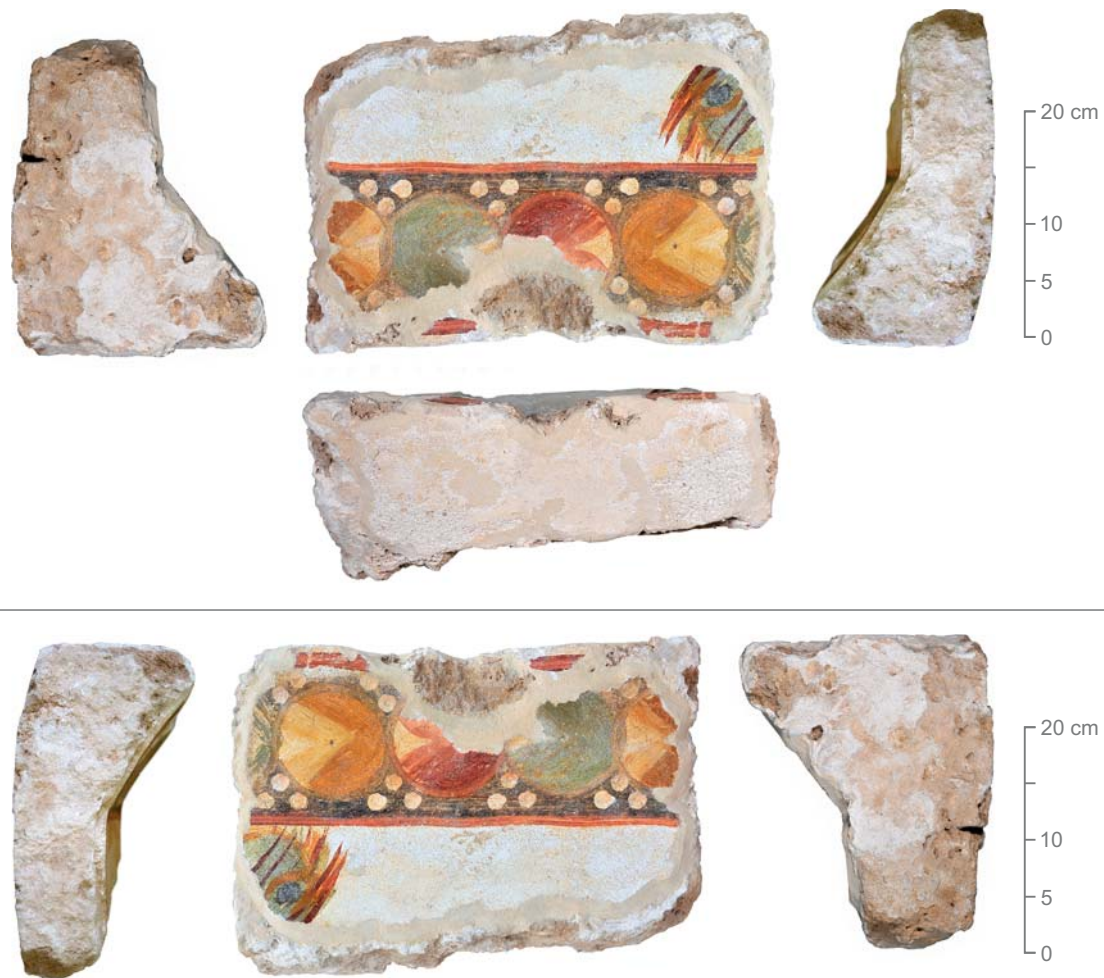
Fig. 6-7. The different sides of *Cat. 77*: top, front face in the center, flanked by the two lateral surfaces on either side, and the plastered but unpainted bottom surface below; bottom, the same element oriented with the gemmed band running along its top edge

The most curious of all the masonry members dressed to a particular, non-standard shape is *Cat. 77*. Like all the fragments discussed thus far, it also had the back trimmed in the past, so its original dimensions are lost. It has a projecting profile, the front of which is decorated with a band of “gemstones” bordering a plain white background; the feathers of a peacock’s train touch the edge of the gemmed band [*Fig. 6-7 top*]. It is not obvious how the fragment should be viewed, and so, the interpretation of its architectural setting is ambiguous. One possibility is that

the gemmed band constituted a horizontal frieze and the projecting profile acted as a cornice. Let us first consider the situation when the gemmed band runs along the upper edge of the fragment [Fig. 6-7 bottom]. A painted frieze of this kind with a downwards tilted profile could easily be seen from the ground even if the cornice was placed above the viewer's eye level. At the same time, the opposite side of the profile, which was covered with plain plaster, would not have been seen. However, the direction of the feathers of the peacock's train does not support such an interpretation. When the train is folded, the feathers should be directed downwards, as can be seen on *Cat. 94*. In the assumed orientation of *Cat. 77*, they seem to be awkwardly pointing upwards. However, if the fragment is rotated so that the gemmed band runs along its bottom edge, the train appears to be in its natural position [Fig. 6-7 top]. But then the gemmed band is not well visible assuming the cornice was set above eye level, and instead the viewer would see the undecorated white plaster covering the opposite side of the profile. The third option, perhaps the least feasible, assumes a vertical orientation of the fragment. The gemmed band would have to run along its right edge in order to keep the peacock's feathers directed downwards. The projecting profile would then be part of the vertical section of a hoodmold framing or emphasizing an opening like a niche or apse. Since *Cat. 77* is the only surviving member dressed to such a shape

(although missing the back part) and bearing this kind of decoration, the question of its orientation and architectural setting cannot be resolved. Nevertheless, it can be said that the projecting profile with a gemmed band marked either a vertical or a horizontal architectural feature.

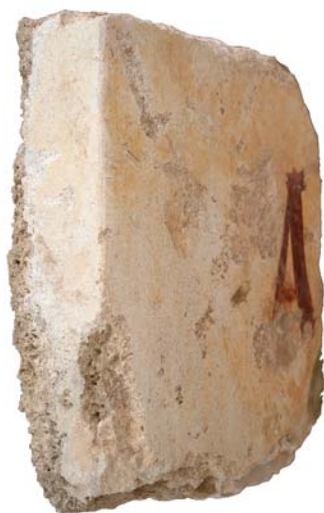
Fig. 6-8. Three-quarter view of *Cat. 14* showing the plaster extending over the side of the ashlar

Another group of fragments for consideration covers masonry members that are plastered not only on the face but also on one of the sides (*Cat. 14, 42, 81, 97, 98, 122, 132, 255*). The presence of plaster on one of the lateral surfaces indicates that the elements in question were placed next to an opening of some kind—a niche, doorway, apse, or window. In all of these cases, the plaster on the lateral surface is plain. All fragments, except for *Cat. 81*, had their back sides trimmed with an angle grinder. *Cat. 14* has the letter *alpha* painted on its face which, almost certainly, accompanied a depiction of a cross. The plaster is folded over the left edge of the ashlar and continues on its side, indicating that the painting was placed to the right of an opening [Fig. 6-8]. Also, *Cat. 42*, which depicts a schematic jeweled(?) cross, has one of the sides of the ashlar plastered. It is plausible that these fragments constituted compositions in which two crosses

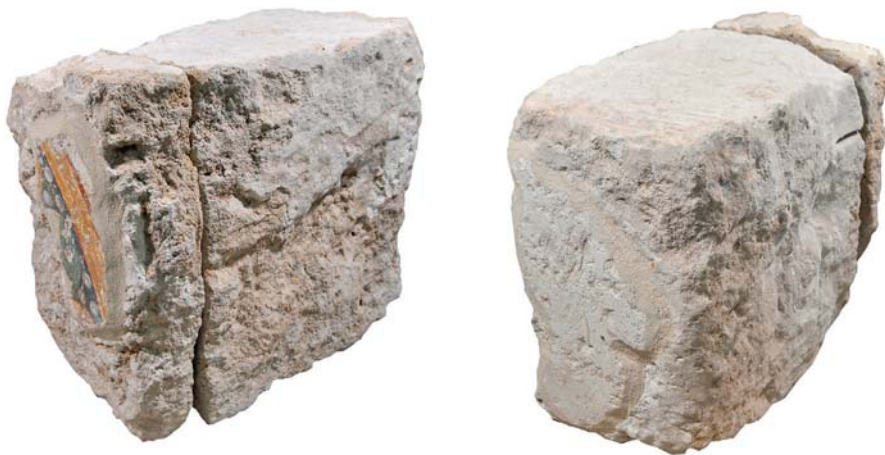
Fig. 6-10. Two opposite sides of *Cat. 78* in three-quarter view: left, the face with painted decoration; right, the face with plain white plaster. Note how the ashlar was cut into two pieces in order to separate the painted side from the bulk of the stone

Finally, *Cat. 45c, 78*, and *150* were plastered on two opposite sides, with one side painted and the other plain [*Fig. 6-10*]. The depth of ashlar *Cat. 45c* and *Cat. 78* is about 40 cm, suggesting that they could belong to either of the walls separating the presbytery from the aisle, also 40 cm thick.⁴ Nevertheless, as already noted, evidence of other internal divisions of the basilica is scarce, therefore it cannot be excluded that these fragments come from other, no longer extant walls that were also 40 cm thick. Ashlar *Cat. 150* is only 20 cm deep, so it is likely to have belonged to a light partition wall.

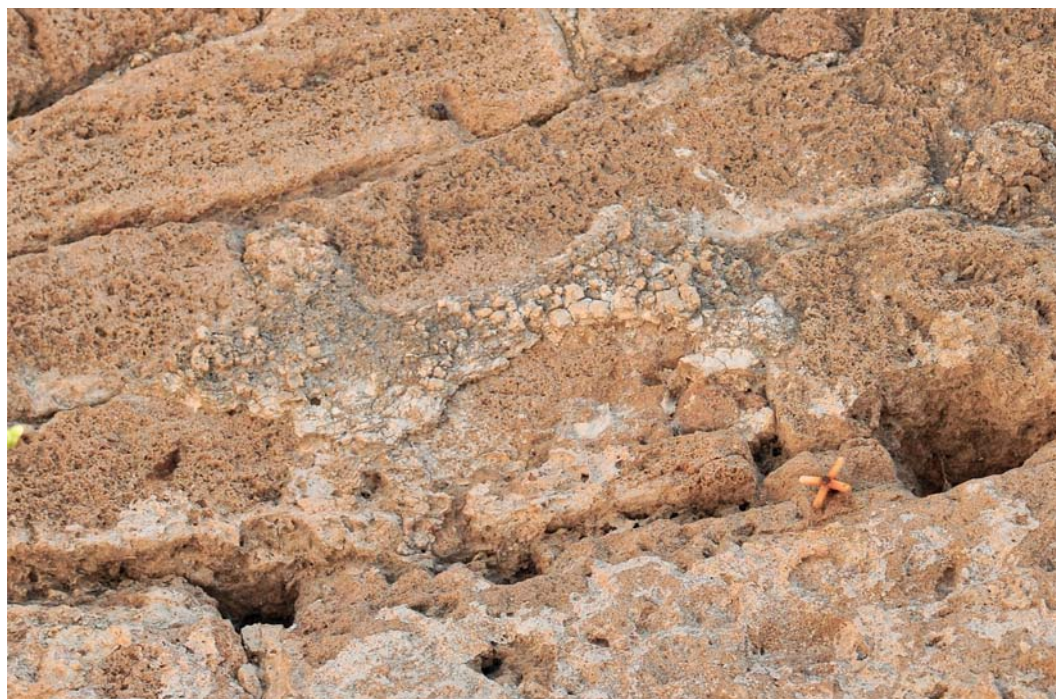
Fig. 6-17. Remains of mortar in the semi-dome of the apse with texture resembling imprints of tesserae

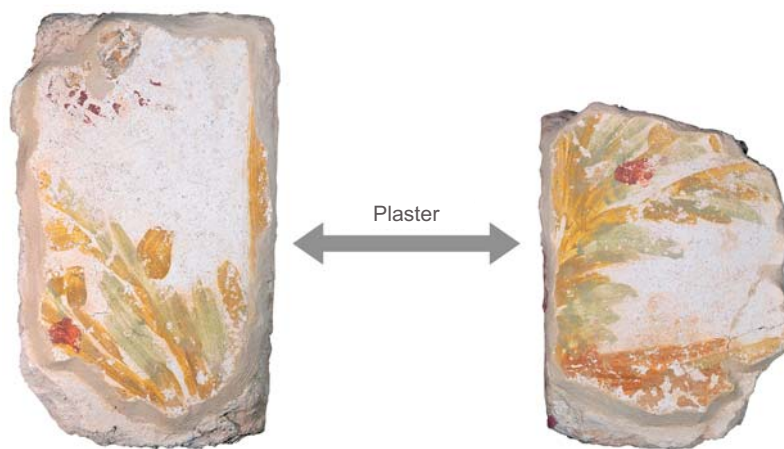
Fig. 6-20. Depictions of foliage with flowers or fruit, framing an opening in a wall (*Cat. 151 and 152*); plastered lateral surfaces indicated with arrows

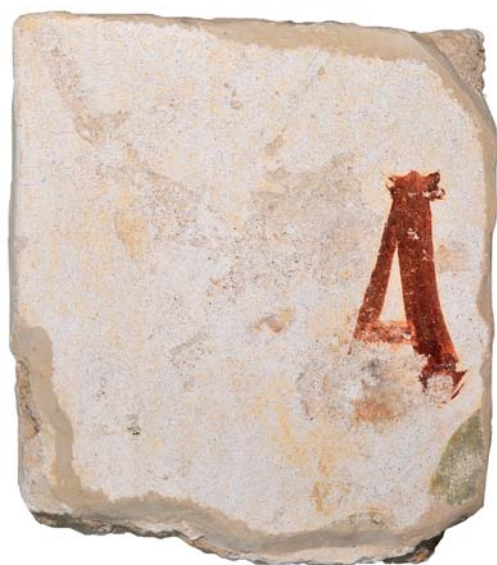
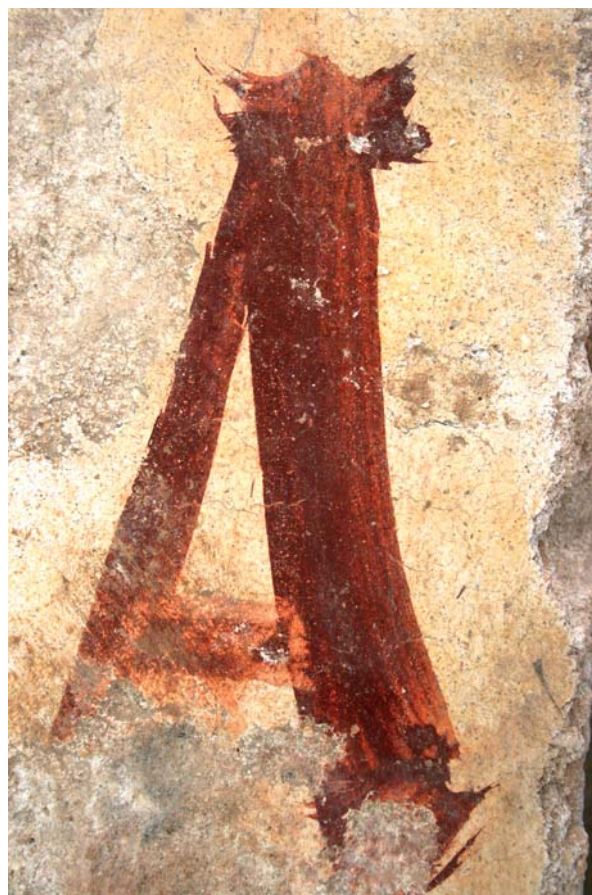
After treatment (2018); right, detail of brushwork before removal of yellowed varnish (2015) Cat. 14

Cat. 14	<i>Representation</i>	
<i>Inv. No.</i> 97105	Letter <i>alpha</i> , most likely accompanying a simple red cross; green leaf(?) below and to the right of the letter	
<i>Fig. 6-8</i>	<i>Provenance</i> Basilica	<i>Discovery / transport to Beiteddine</i> 1987 / about 1987
<i>Stone</i>	29 × 25 (face) × 7 cm; small, well-dressed ashlar. <i>Condition:</i> back side trimmed; otherwise good.	
<i>Mortar/plaster</i>	Type 2 mortar underneath the plaster and on the sides. Plaster 7–10 mm thick, even; present on the face and left side of the ashlar. <i>Condition:</i> good overall; granular disintegration of plaster, shallow losses, and abrasions.	
<i>Paint layer</i>	Thick red paint applied with broad, confident brushstrokes. <i>Condition:</i> good overall; surface grime; thin, yellowed varnish.	
<i>Treatment</i>	Disinfection; consolidation of plaster edges and abraded areas; application of mortar bands; removal of surface grime; removal of varnish.

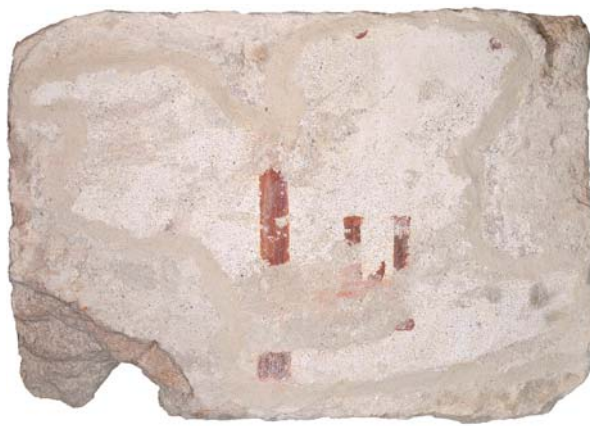
Cat. 19

After treatment (2018)

**Cat. 19**Inv. No.
98561*Representation*Letter *omega* right of the vertical member of a simple red cross*Provenance*
Basilica*Discovery / transport to Beiteddine*
1987 / about 1987*Stone*37 × 52 (face) × 14 cm; regular, well-dressed ashlar.
Condition: back side trimmed; lower left corner missing, fresh break.*Mortar/plaster*Type 2 mortar on most of the face and on the sides. Plaster 5–7 mm thick.
Condition: deep gouges and abrasions; granular disintegration of plaster.*Paint layer*Red paint applied in one thick layer.
Condition: yellowed varnish; sensitive and powdery where not coated with varnish; surface grime.*Treatment*

Disinfection; consolidation of plaster edges; application of mortar bands; partial removal of varnish (complete removal impossible in the rough, abraded areas).

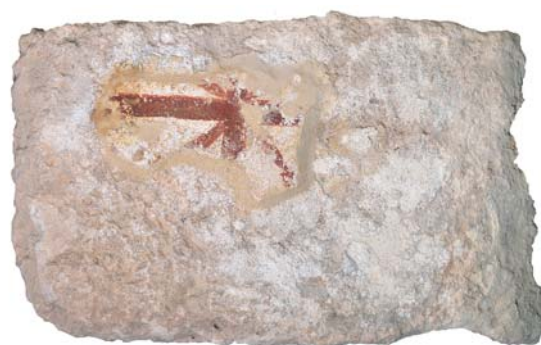
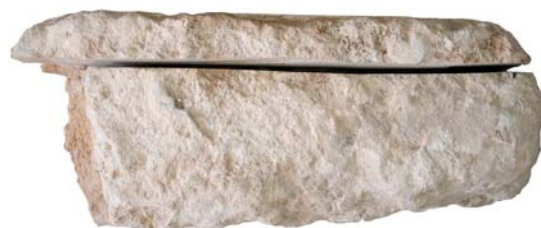
After treatment (2017) Cat. 21

Bottom, unfinished cut made on the bottom side, about 6 cm from the face of the ashlar (shown in photo at top)

30 × 47 (face) × 20 cm; large, relatively regular ashlar.
Condition: unfinished cut made with an angle grinder; fragment broken off at back during the cutting.

Type 2 mortar on the sides. Plaster 3–10 mm thick; directly on stone.
Condition: poorly preserved; numerous losses and abrasions; severe granular disintegration of plaster; remains of epoxy(?) resin.

Red paint applied in one thick layer.
Condition: relatively good; yellowed varnish; surface grime.

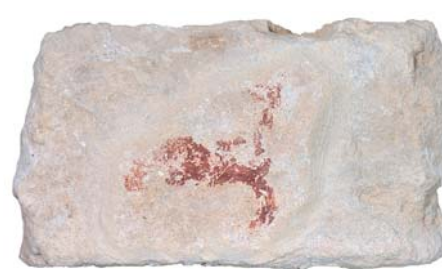
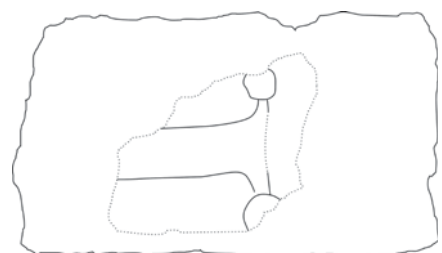
After treatment (2017) Cat. 22

16 × 28 (face) × 8 cm; well-dressed, small ashlar.
Condition: back side trimmed; otherwise in good condition.

Type 2 mortar on the sides, in the deepest interstices of the stone. Plaster 5–10 mm thick; directly on stone.
Condition: poor; surface severely abraded; edges jagged; severe granular disintegration of plaster.

Red paint applied in one, originally thick layer.
Condition: poor; abraded; powdery; affected by biodegradation noted in 2009; surface grime.

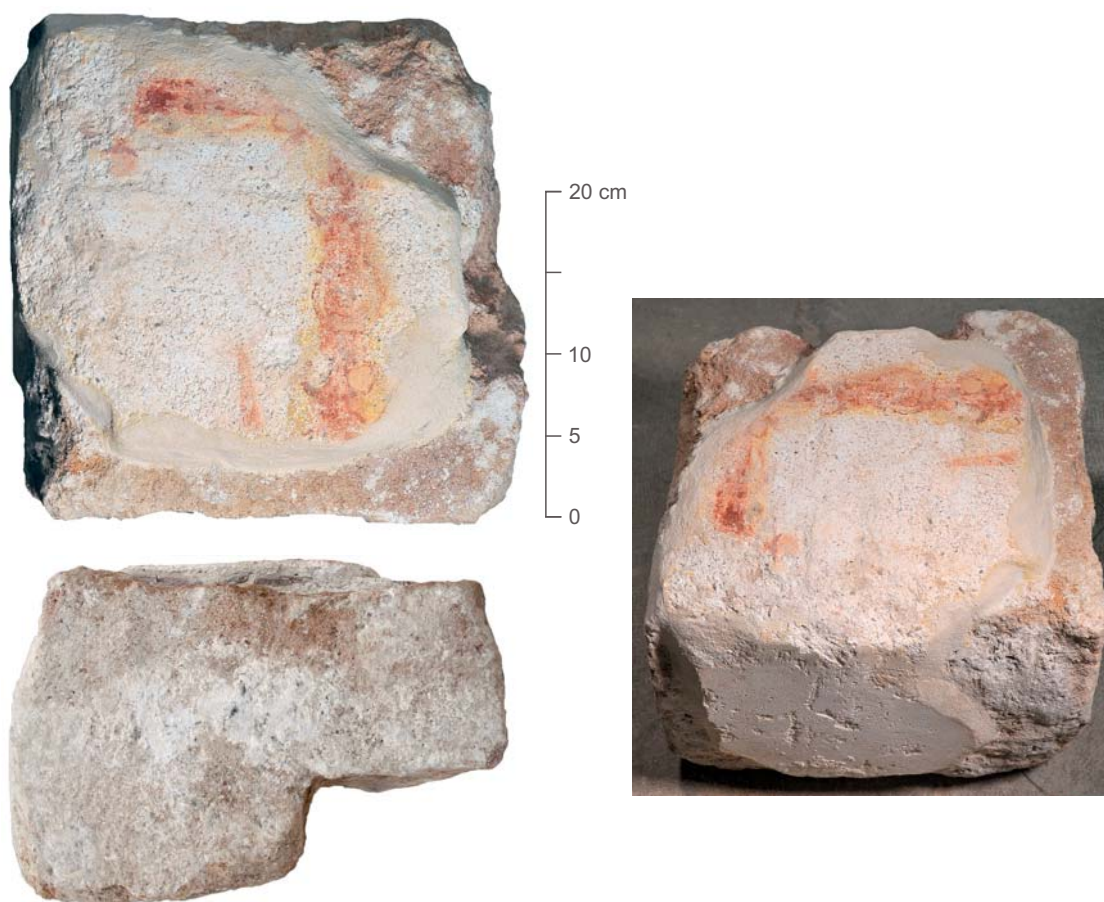
After treatment (2017): note plaster folded over the edge and continuing on the side of the ashlar; bottom left, section view

Cat. 42	<i>Representation</i> Jeweled(?) cross	
<i>Inv. No.</i> 98547		
<i>Fig. 3-7</i>	<i>Provenance</i> Basilica	<i>Discovery / transport to Beiteddine</i> 1987 / about 1987
<i>Stone</i>	30 × 28 (face) × 20 cm; well-dressed, L-shaped ashlar. <i>Condition:</i> good overall.	
<i>Mortar/plaster</i>	Type 1 mortar on the back side of the ashlar; Type 2 mortar on the face and sides; fragments of potsherds inserted in the mortar. Two sides plastered, the lateral side plain; plaster 8–10 mm thick. <i>Condition:</i> poor adhesion; granular disintegration of plaster.	
<i>Paint layer</i>	Simple buildup; treated schematically; color palette limited to two colors; remains of white impastos imitating pearls. <i>Condition:</i> poor; severely abraded and faded; powdery; surface grime.	
<i>Treatment</i>	Disinfection; consolidation of plaster edges; reattachment of plaster to stone support; application of mortar bands; removal of surface grime; consolidation of powdery paint layer.

Type 2 mortar was employed in an identical manner as the first type, to bind masonry members, seal the joints between them, and compensate for surface defects of particular elements [*Fig. 3-5*]. Thus, its thickness ranges from several millimeters to a few centimeters. Because it was applied to the joints between particular masonry members, but not always to their faces, it can be observed chiefly on the perimeter of the ashlar faces [*Fig. 3-6*]; only the very rough and irregular ashlar and stones have it also on their faces. In several instances, evidence of keying of the mortar is noted; this procedure is necessary to improve adhesion of the plaster. Judging by the appearance of the keying, it was done when the mortar had already set [*Fig. 3-7 top*]. Fragments of pottery

Fig. 3-7. Type 2 mortar: top, evidence of keying of the mortar before the application of plaster visible on the side of ashlar *Cat. 151*; bottom, potsherds pressed into the mortar; ashlar *Cat. 42* has a rough, irregular surface, hence the application of a thick levelling layer of mortar with potsherds

sherds are at times incorporated in the thick parts of the render [*Fig. 3-7* bottom].⁸ Also, small fragments of worn-out glass are present occasionally [*Fig. 3-8* bottom].

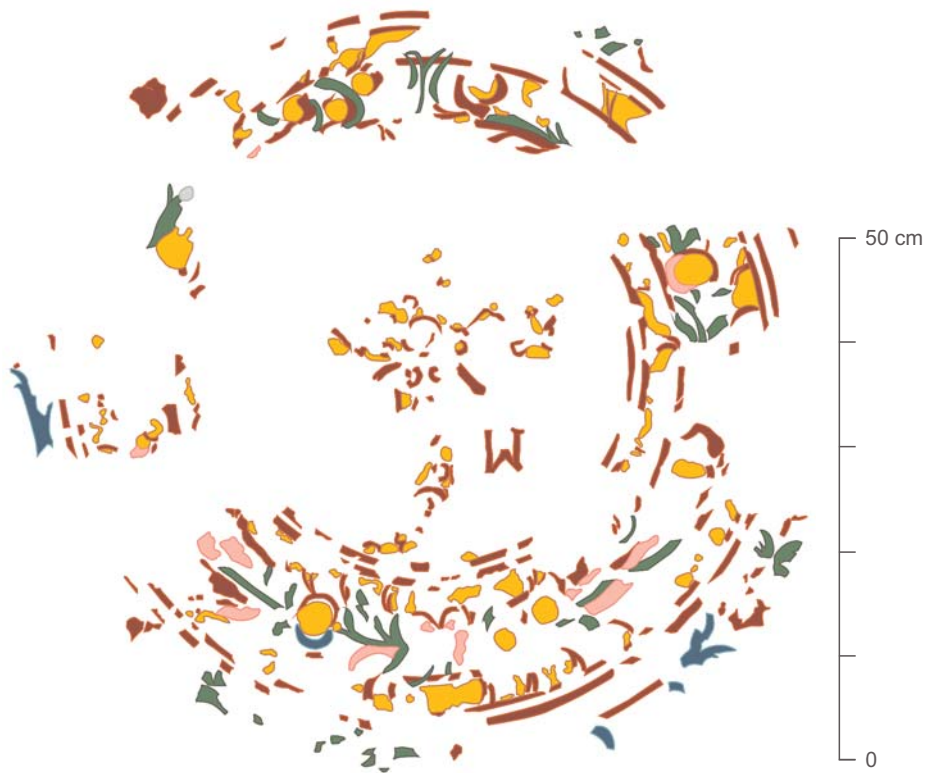
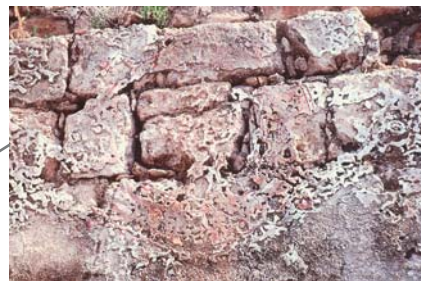
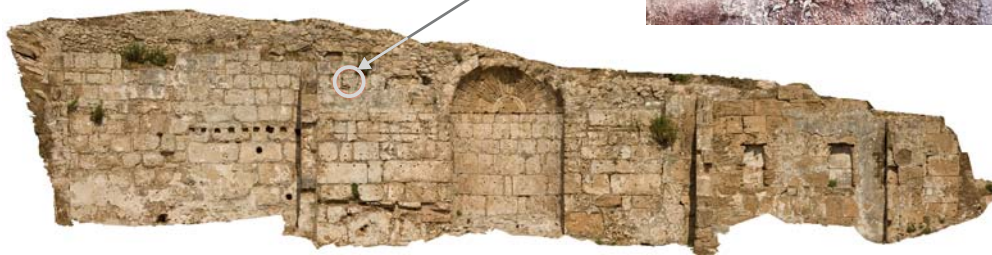
Location of the painting on the east wall of the basilica (circle)
and close-up of extant remains (about 2004); top, tracing of the remains

Disinfection; consolidation of plaster edges; application of mortar bands; removal of surface grime; removal of varnish; preventive consolidation of paint layer.

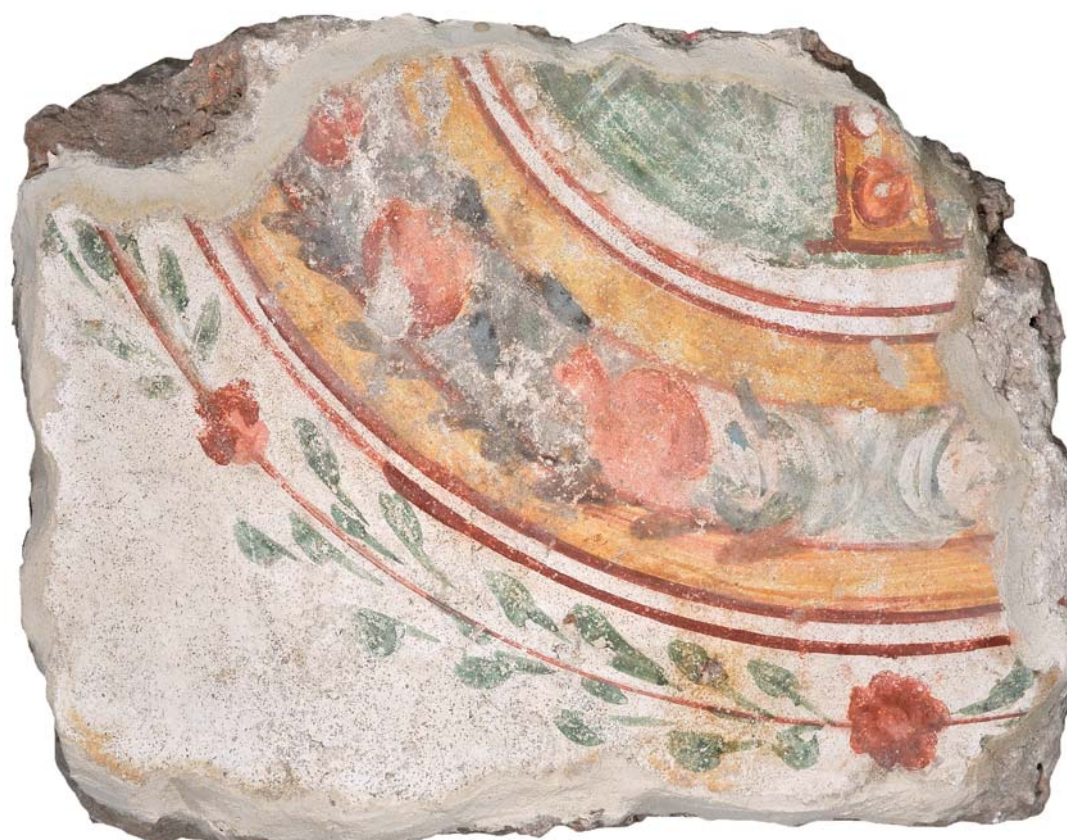
Cat. 46

After treatment (2017)

Disinfection; consolidation of plaster edges and abraded areas; reattachment of plaster to stone support (*a, b*); reintegration of broken fragments of plaster (*b*); application of mortar bands; removal of surface grime; consolidation of powdery paint layer.

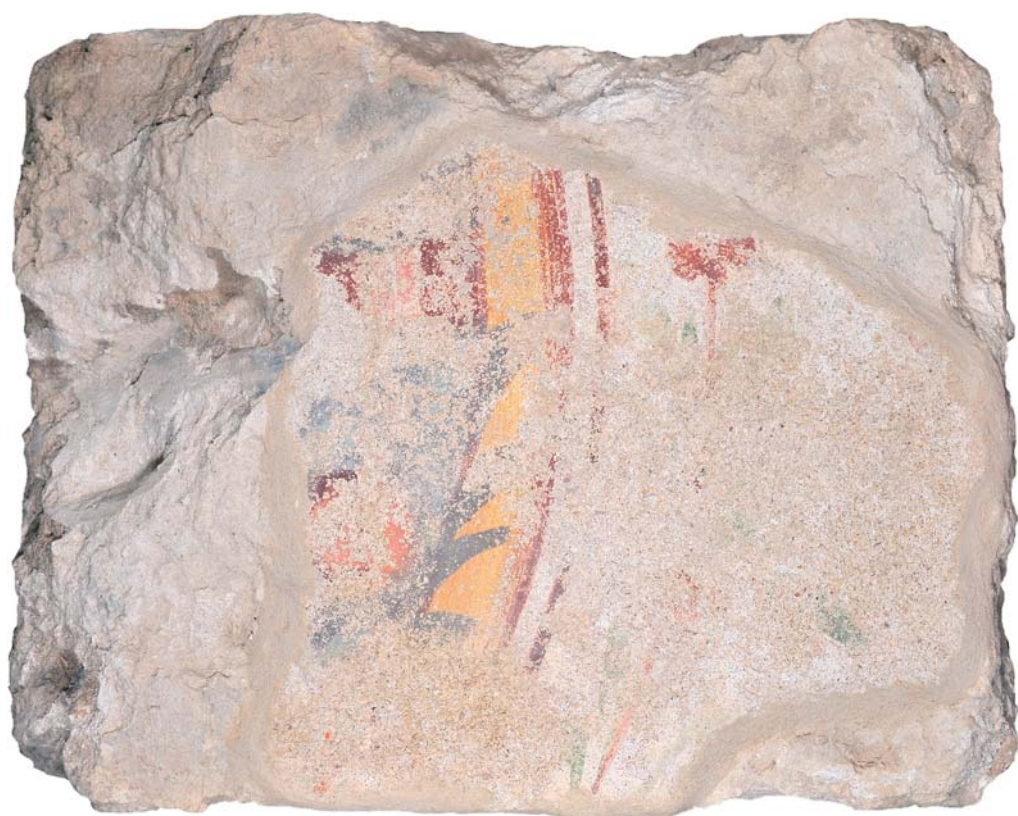
Cat. 49

Condition: good overall.*Mortar/plaster*

Condition: minor losses and abrasions, especially along the perimeter of the plaster; minor plaster detachment; granular disintegration of plaster.*Paint layer*

Condition: numerous small abrasions and losses; surface grime.*Treatment*

After treatment (2017)

Disinfection; consolidation of plaster edges; reattachment of plaster to stone support; application of mortar bands; removal of surface grime.

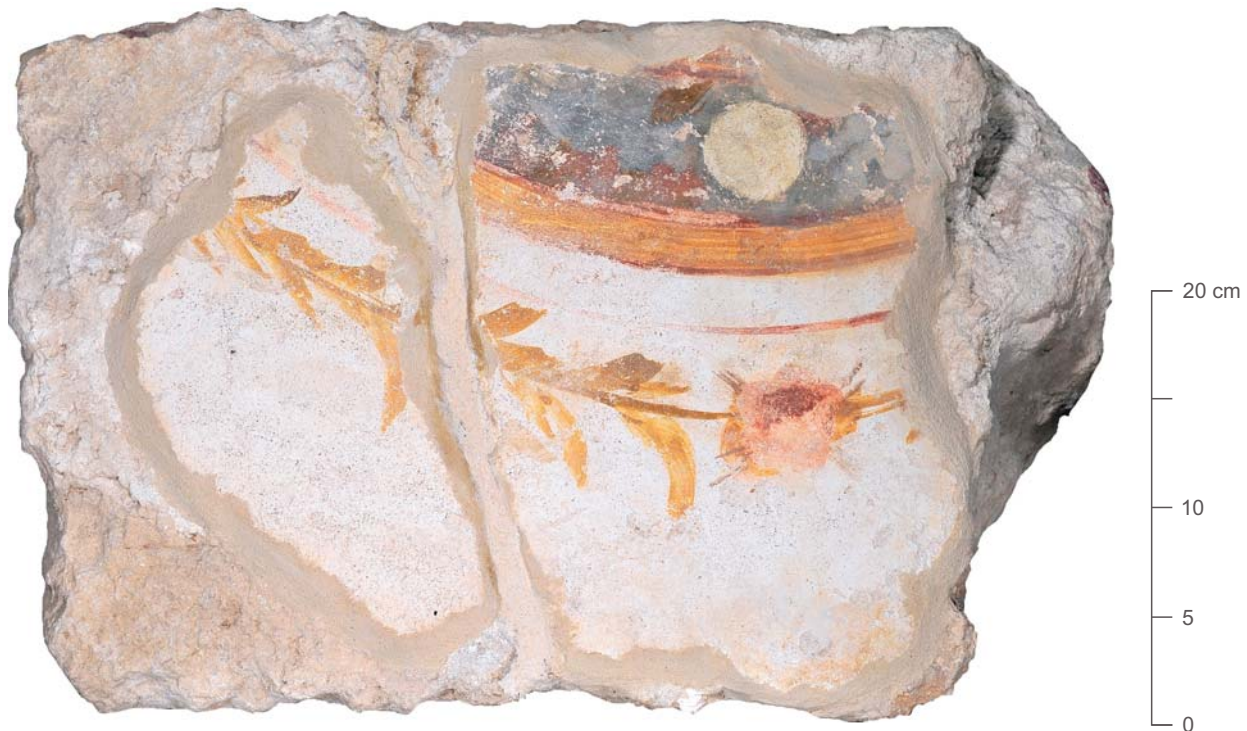
Condition: good overall.*Mortar/plaster*

Condition: adhesion weakened along the perimeter of the plaster; broad shallow abrasions; granular disintegration of plaster.*Paint layer*

Condition: poorly preserved due to plaster condition; powdery; surface grime firmly adhering to rough plaster surface.*Treatment*

After treatment (2017)

Disinfection; consolidation of plaster edges and abraded areas; reattachment of plaster to stone support; application of mortar bands; removal of surface grime; consolidation of powdery paint layer.
