LATE ANTIQUE WALL PAINTINGS FROM PORPHYREON IN THE SIDON HINTERLAND

Julia M. BURDAJEWICZ

PEETERS
LEUVEN – PARIS – BRISTOL, CT.
2022

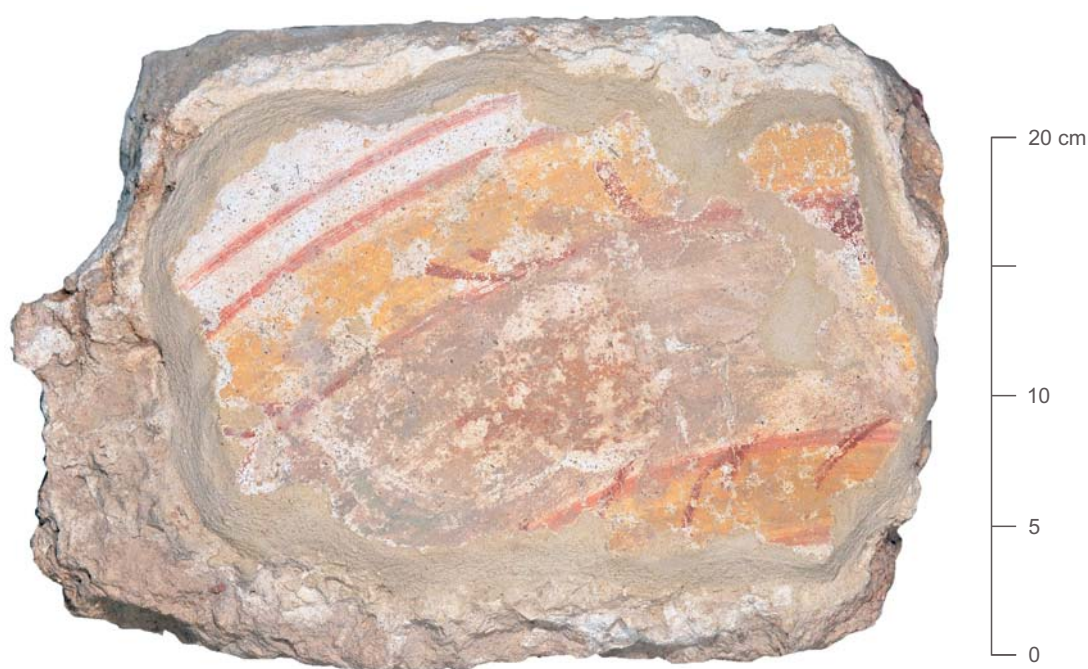
Cat. 51

Condition: broken in two, fresh break.

Type 2 mortar in the interstices and voids of the stone, partly under the plaster. Plaster 7–10 mm thick. *Condition:* poor adhesion of the plaster along the break line; surface abrasions, pits, and small losses; granular disintegration of plaster.

Condition: overall very good; minor losses and abrasions; surface grime.

After treatment (2017)

Disinfection; consolidation of plaster edges; reattachment of plaster to stone support; reassembling the two fragments; infilling joint between fragments; application of mortar bands; removal of surface grime; preventive consolidation of paint layer.

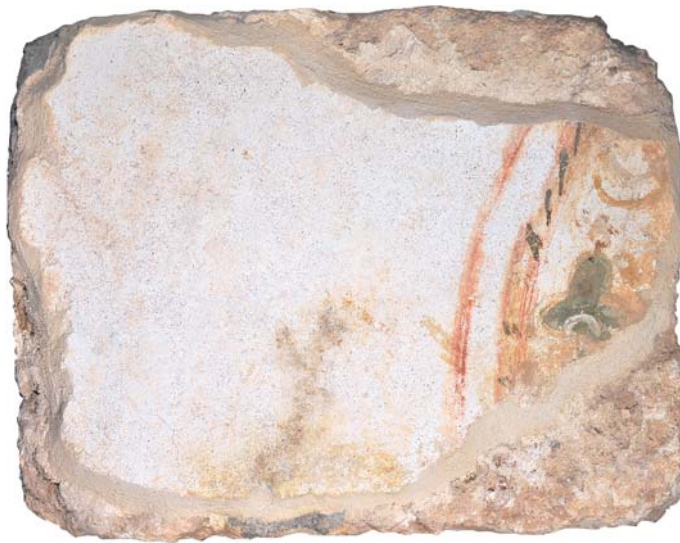
After treatment (2017) Cat. 52

Cat. 52	<i>Representation</i> Wreath, likely encircling a cross	
<i>Inv. No.</i> JY8WP12		
<i>Figs 4-14, 4-28</i>	<i>Provenance</i> Residential district	<i>Discovery / transport to Beiteddine</i> 2000s / 2012
<i>Stone</i>	33 × 42 (face) × 20 cm; well-dressed ashlar. <i>Condition:</i> good.	
<i>Mortar/plaster</i>	Type 1 mortar remains on the sides of the ashlar; Type 2 mortar visible in some places underneath the plaster. Plaster 7–10 mm thick. <i>Condition:</i> cracks; granular disintegration of plaster; large ink stain.	
<i>Paint layer</i>	Poor condition hinders assessment of the buildup. <i>Condition:</i> severely abraded and faint; slightly powdery; surface grime.	
<i>Treatment</i>	Disinfection; consolidation of plaster edges; application of mortar bands; removal of surface grime; removal of ink stain; consolidation of powdery paint layer.

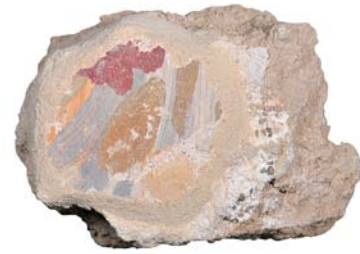
After treatment (2017) Cat. 53

Cat. 53	<i>Representation</i> Detail of a foliated wreath with fruit and/or flowers	
<i>Inv. No.</i> —		
	<i>Provenance</i> Basilica	<i>Discovery / transport to Beiteddine</i> 1987 / about 1987
<i>Stone</i>	10 × 14 (face) × 7 cm; fragment of a masonry element. <i>Condition:</i> fresh breaks on two sides; back side trimmed; possibly broken off during the trimming.	
<i>Mortar/plaster</i>	Type 2 mortar underneath the plaster. Plaster about 5 mm thick. <i>Condition:</i> good except for granular disintegration of plaster.	
<i>Paint layer</i>	Superimposed layers of thickly applied paint; evidence of painting wet-into-wet. <i>Condition:</i> very good save for minor losses; slightly dusty.	
<i>Treatment</i>	Disinfection; consolidation of plaster edges; application of mortar bands; dusting.

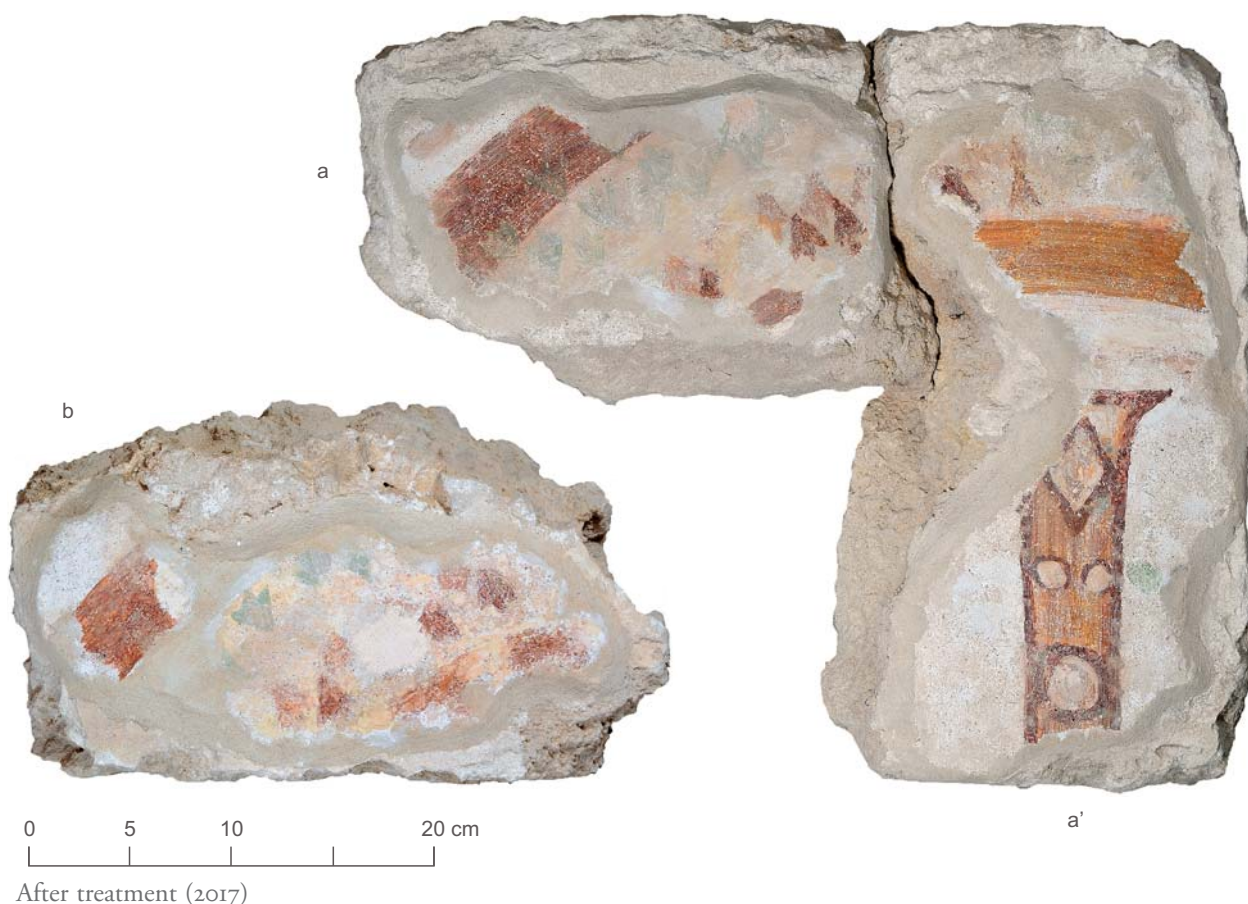
Cat. 54

*Stone**a* – 37 × 44 (face) × 11 cm; well-dressed ashlar; crumbly.*b* – 31 × 16 (face) × 20 cm; fragment of an ashlar; rough, porous stone.*Condition:* *a* – two restorable fragments, fresh breaks; back side trimmed; already broken prior to trimming considering the different thicknesses.*b* – broken on two sides, one of the breaks appears fresh; otherwise in good condition.*Mortar/plaster*Type 2 mortar locally along the edges of the ashlar. *b* – also in the cavities of the stone. Plaster 6–10 mm (*a*) and 8–10 mm (*b*) thick.*Condition:* losses, scuffs, and abrasions, especially on the perimeter of the plaster (*b*); granular disintegration of plaster.*Paint layer*

Medallion executed with thick, opaque, superimposed layers of paint; semi-transparent base color of the cross; details of the cross executed with relatively thick paint.

Condition: abrasion and losses scattered all over; colors of the medallion apparently faded; powdery and sensitive; surface grime.*Treatment*Disinfection; consolidation of plaster edges and abraded areas; application of mortar bands; removal of surface grime; consolidation of powdery paint layer; infilling losses of plaster; inpainting. The thinness of the two elements (*a*, *a'*), as well as missing third part of the ashlar made reassembling impossible, considering also the condition of the stone and the small contact surface between the two extant fragments.

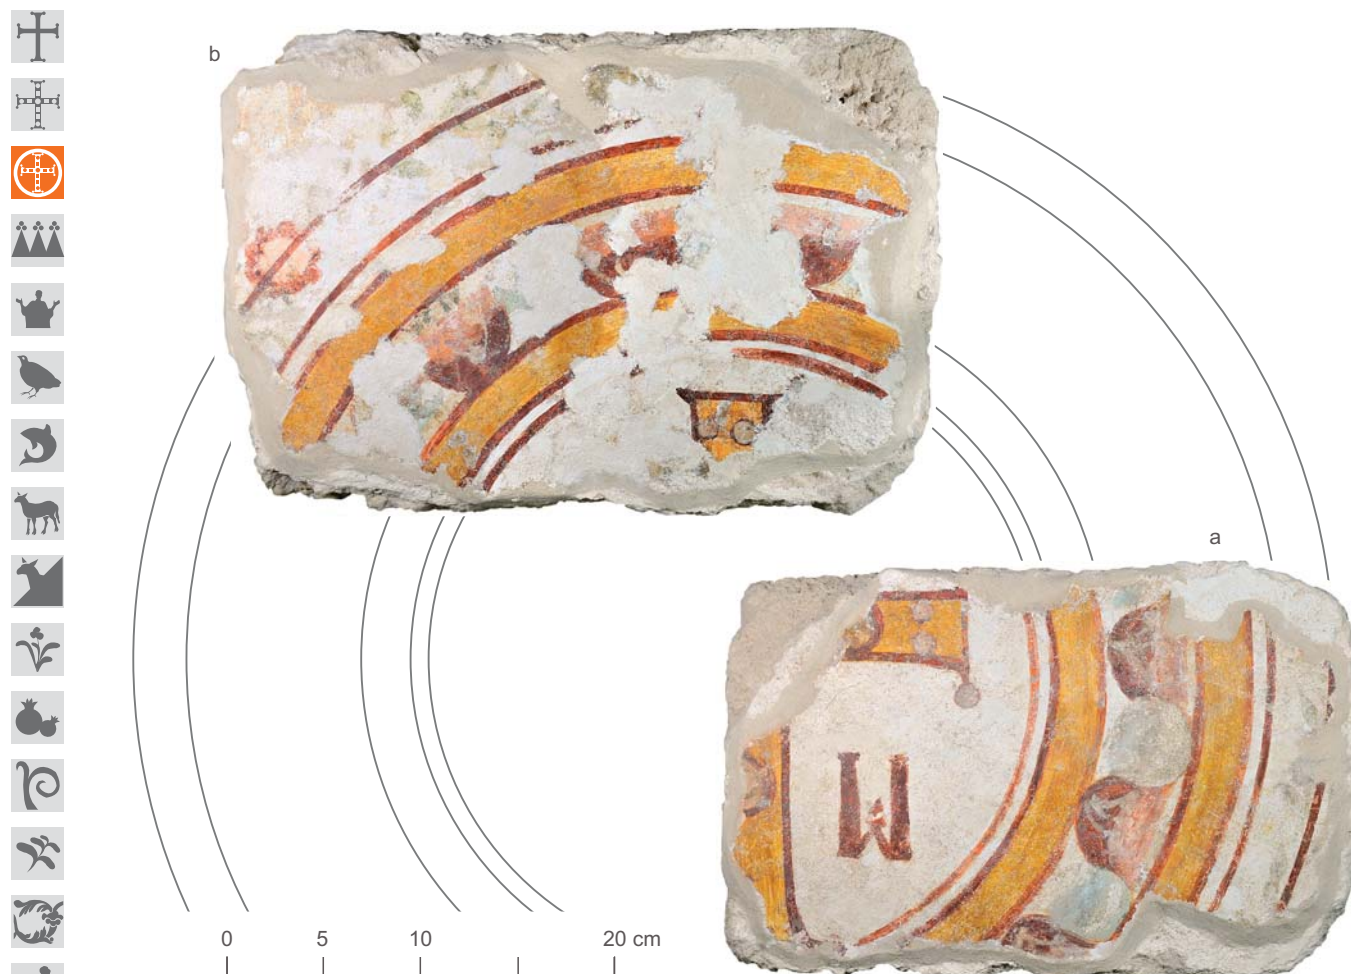
Cat. 59

20 × 30 (face) × 17 cm; well-dressed, originally rectangular ashlar.
Condition: concave loss along one of the bottom sides, break appears fresh.

Type 2 mortar in the cavities of the stone. Plaster 5–7 mm thick where applied on top of the mortar and about 10 mm thick where directly on stone.
Condition: many losses and abrasions of the plaster; root-like shallow channels in the surface; granular disintegration of plaster.

Layered buildup; red band and the green element retain considerable thickness.
Condition: deterioration of paint related to plaster condition; red parts powdery; red pigment suffused on the surface; surface grime.

After treatment (2018); tentative recomposition

Disinfection; consolidation of plaster edges; application of mortar bands; removal of surface grime; consolidation of powdery paint layer.

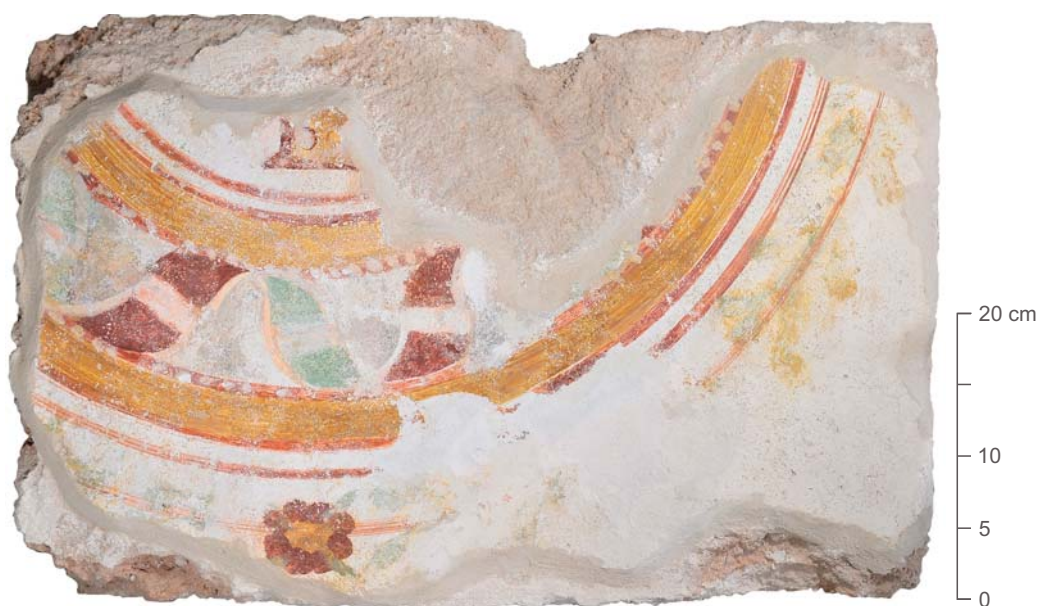
After treatment (2018)

Cat. 60	<i>Representation</i>	
<i>Inv. No.</i> 97089	Jeweled cross in a medallion decorated with twisted ribbon pattern	
<i>Figs 4-18A, 4-34, 5-19</i>	<i>Provenance</i> Basilica	<i>Discovery / transport to Beiteddine</i> 1987 / about 1987
<i>Stone</i>	41 × 61 (face) × 14 cm; large, well-dressed ashlar. <i>Condition:</i> back side trimmed; chipping along the edges.	
<i>Mortar/plaster</i>	Type 2 mortar along the edges. Plaster 8–10 mm thick; in the center directly on stone. <i>Condition:</i> deep, broad abrasions and losses; jagged plaster edges; granular disintegration of plaster.	
<i>Paint layer</i>	Layered buildup; details executed with thick, rather opaque paint on top of semi-transparent base colors; white impastos render pearls running on top of the inner red rings. <i>Condition:</i> poor due to plaster deterioration; numerous losses and abrasions of the paint; yellowed varnish; surface grime.

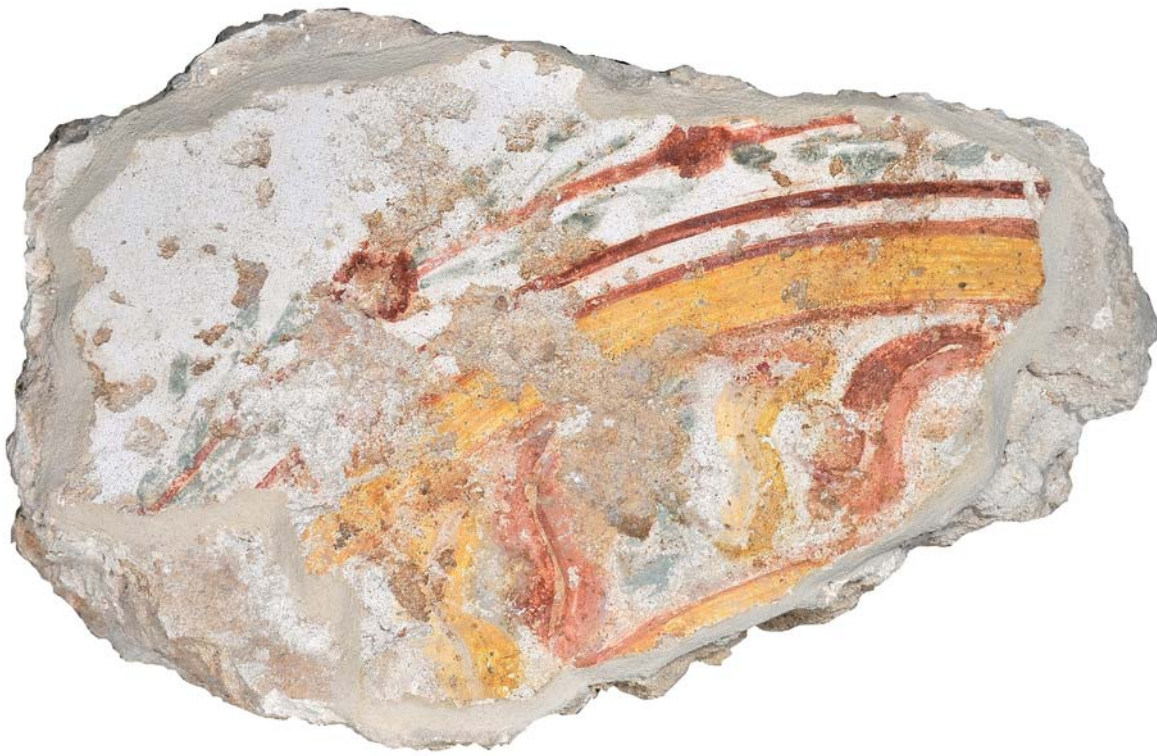
31 × 28 (face) × 16 cm; roughly dressed ashlar with rounded corners; rough, porous stone.
Condition: good.

Type 2 mortar underneath the plaster and on the sides, where it is applied thickly to compensate for the irregularities of the ashlar. Plaster 10–12 mm thick.
Condition: surface pitted and abraded; some cracks; granular disintegration of plaster.

Poor condition hinders evaluation of buildup; most likely the paint was applied thickly.
Condition: poor due to plaster deterioration; abraded, faint and powdery; surface grime.

After treatment (2017)

Disinfection; consolidation of plaster edges; application of mortar bands; removal of surface grime; consolidation of powdery paint layer.

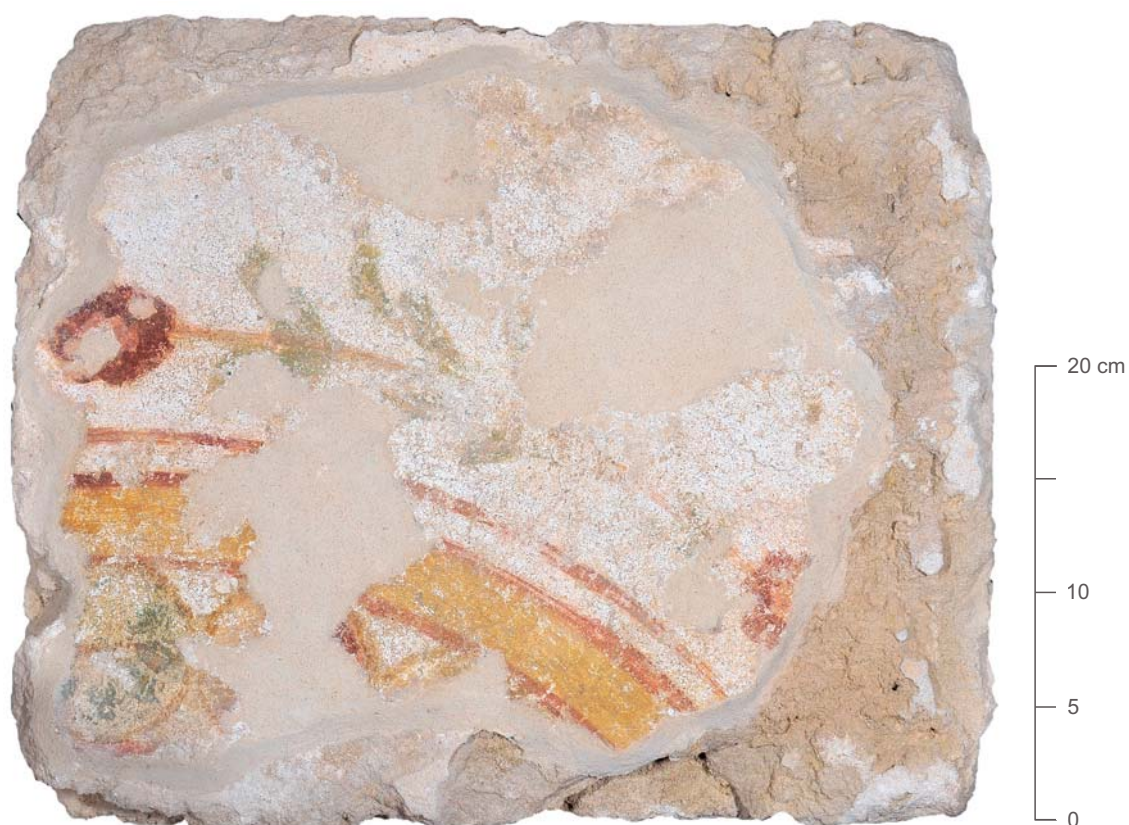
After treatment (2018)

Cat. 66	<i>Representation</i> Medallion decorated with rosette-like elements, likely encircling a cross	
<i>Inv. No.</i> 98509		
<i>Fig. 4-1&A</i>	<i>Provenance</i> Basilica	<i>Discovery / transport to Beiteddine</i> 1987 / about 1987
<i>Stone</i>	35 × 43 (face) × 9 cm; well-dressed ashlar. <i>Condition:</i> rounded corners; chipping along the edges; back side trimmed.	
<i>Mortar/plaster</i>	Type 2 mortar only on the top and bottom side. Plaster 6–9 mm thick; directly on stone. <i>Condition:</i> broad and shallow losses; surface abrasions; jagged plaster edges; granular disintegration of plaster.	
<i>Paint layer</i>	Buildup difficult to assess due to the condition of the painting. <i>Condition:</i> poor; abraded and faint; matte, yellowed varnish; surface grime.	
<i>Treatment</i>	Disinfection; consolidation of plaster edges and abraded areas; application of mortar bands; removal of surface grime; removal of varnish.

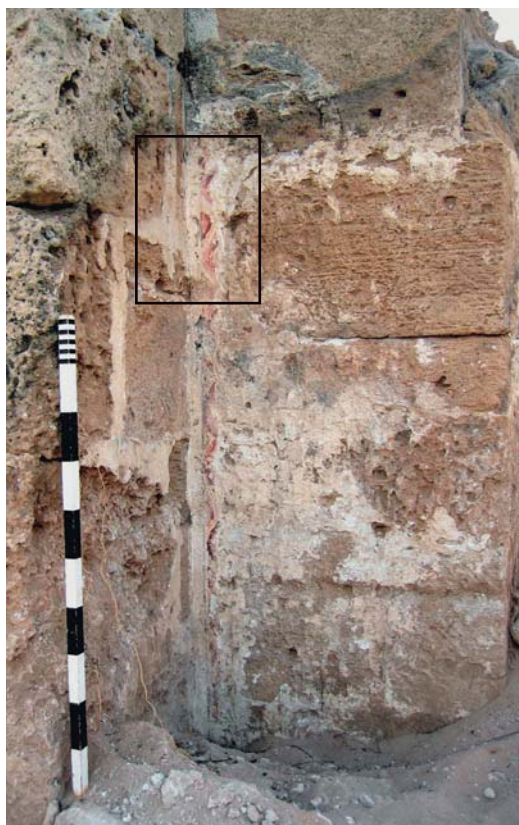
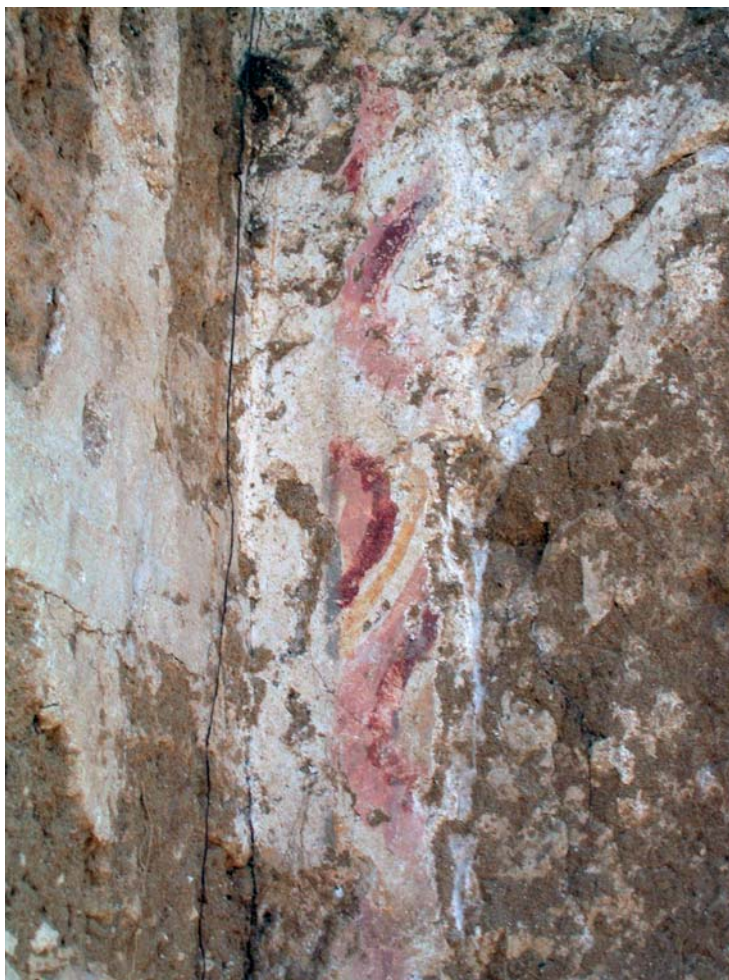
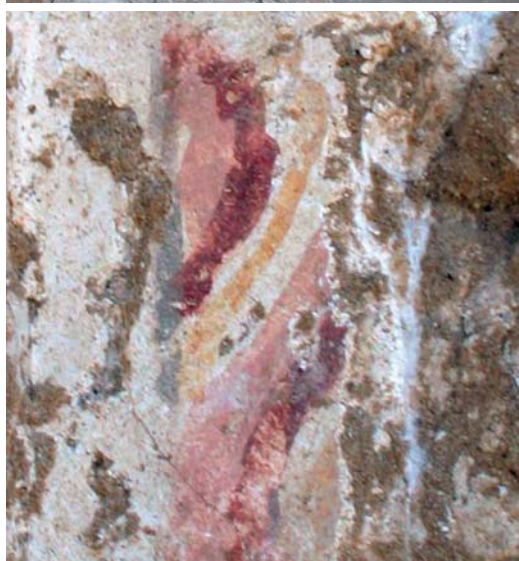
Cat. 76

After discovery (2005): top left, general view of the northeastern corner of a room (chapel?) adjoining the basilica on the south with preserved painted decoration; right, close-up of the tricolor ribbon on a narrow strip of painted plaster; bottom left, close-up of one of the wave-motifs

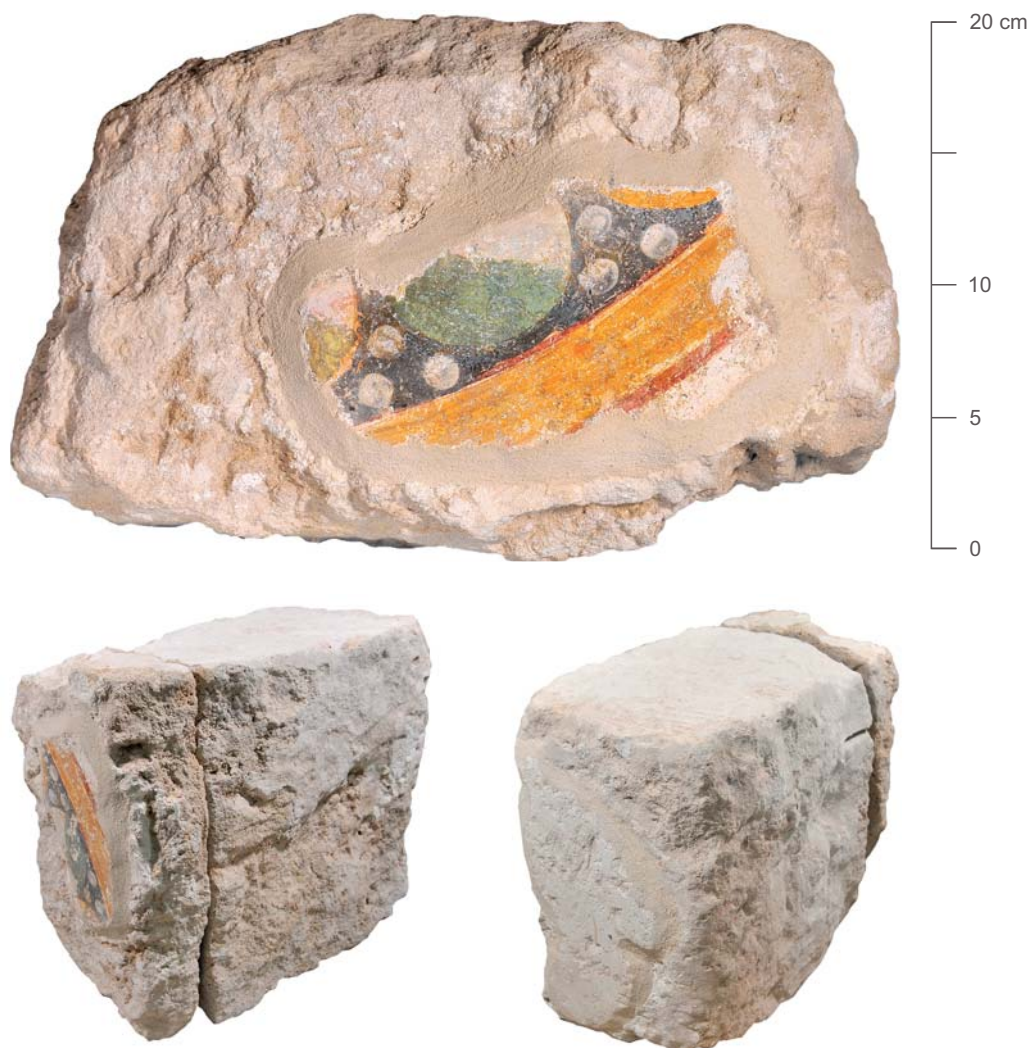
Cat. 78

After treatment (2018); bottom, ashlar face reassembled with the rest of the stone;
viewed from two angles (2018)

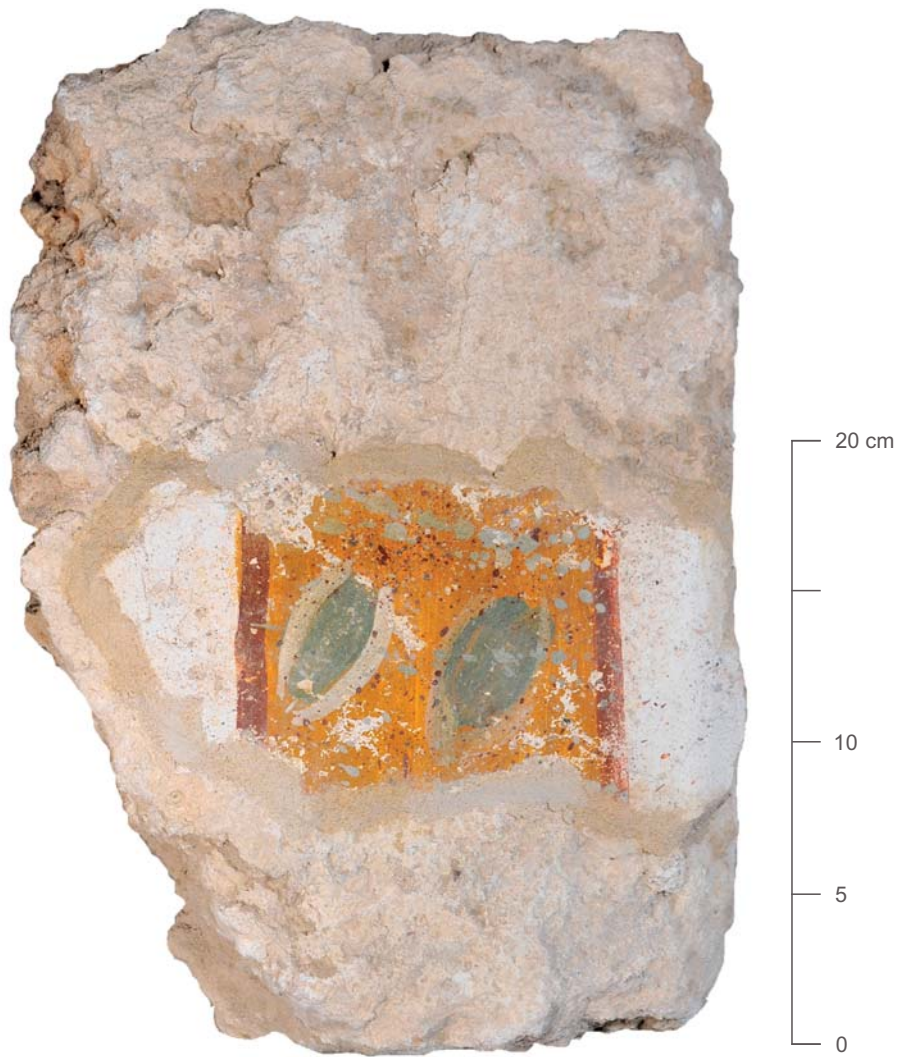
Fragment *Cat. 81* reveals a unique painting technique, the artist apparently splashing paint deliberately across the depicted item [Fig. 3-30]. The effect must have been intended, because the splashes do not appear on the white background. Such splashes may have been meant to imitate marble (see below, § 5.3.4).

After treatment (2018)

Cat. 81	<i>Representation</i>	
<i>Inv. No.</i> 97109	Pier-like element(?) decorated with laurel-shaped elements or imitation of marble(?)	
<i>Fig. 3-30</i>	<i>Provenance</i> Basilica	<i>Discovery / transport to Beiteddine</i> 1987 / about 1987
<i>Stone</i>	34 × 24 (face) × 15 cm; front dressed, back side shapeless. <i>Condition:</i> missing corner, likely old damage; some chipping.	
<i>Mortar/plaster</i>	Type 2 mortar underneath the plaster and on the sides. Plaster 5–7 mm thick; folded over the right-hand edge, continuing on the side of the ashlar. <i>Condition:</i> good overall; minor losses and abrasions; granular disintegration of plaster.	
<i>Paint layer</i>	Layered buildup; details executed on top of the ochre background pulled with a wide brush; intentional splashes of paint. <i>Condition:</i> good; minor losses and abrasions; small area coated with yellowed varnish; surface grime.	
<i>Treatment</i>	Disinfection; consolidation of plaster edges; application of mortar bands; removal of surface grime; removal of varnish.

Disinfection; *a* – consolidation of plaster edges and abraded areas; application of mortar bands; dusting; consolidation of powdery paint layer; *b* – consolidation of plaster edges; reintegration of broken plaster fragment; application of mortar bands; removal of surface grime; consolidation of powdery paint layer.

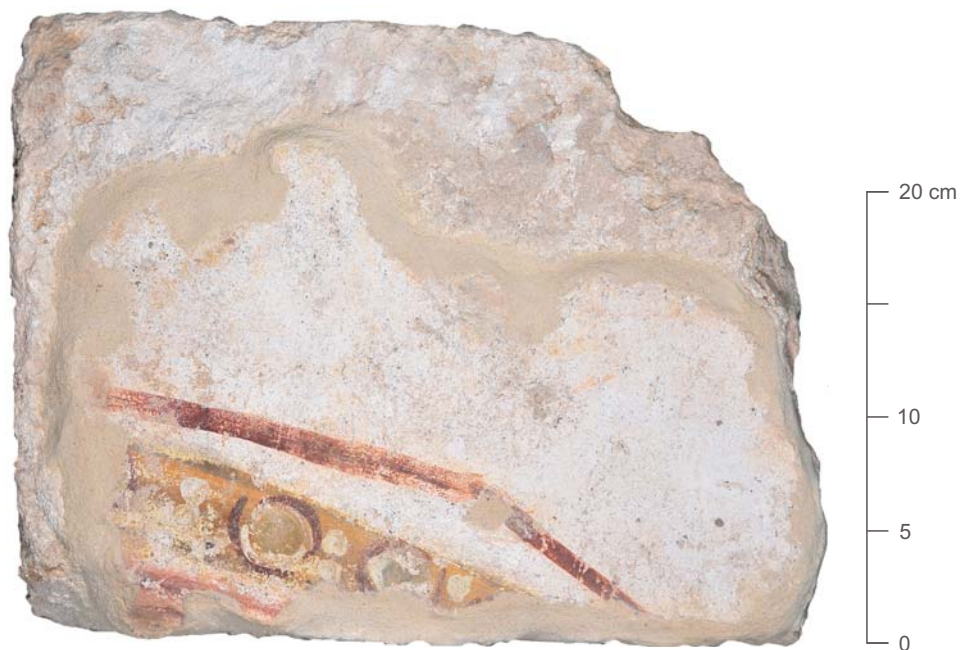
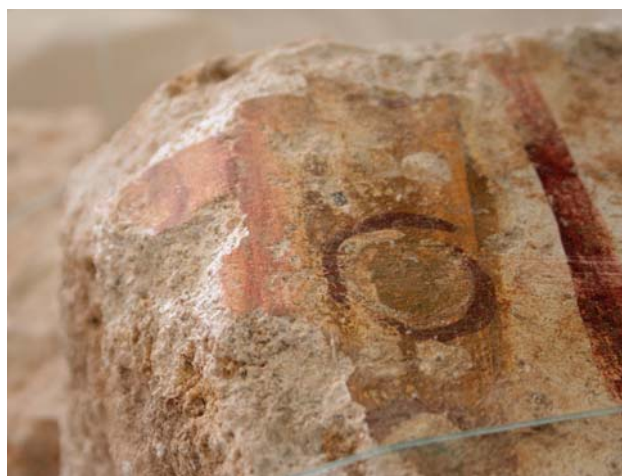
Cat. 82

After treatment (2017); bottom, plaster folded over the bottom left corner of the ashlar (2017)

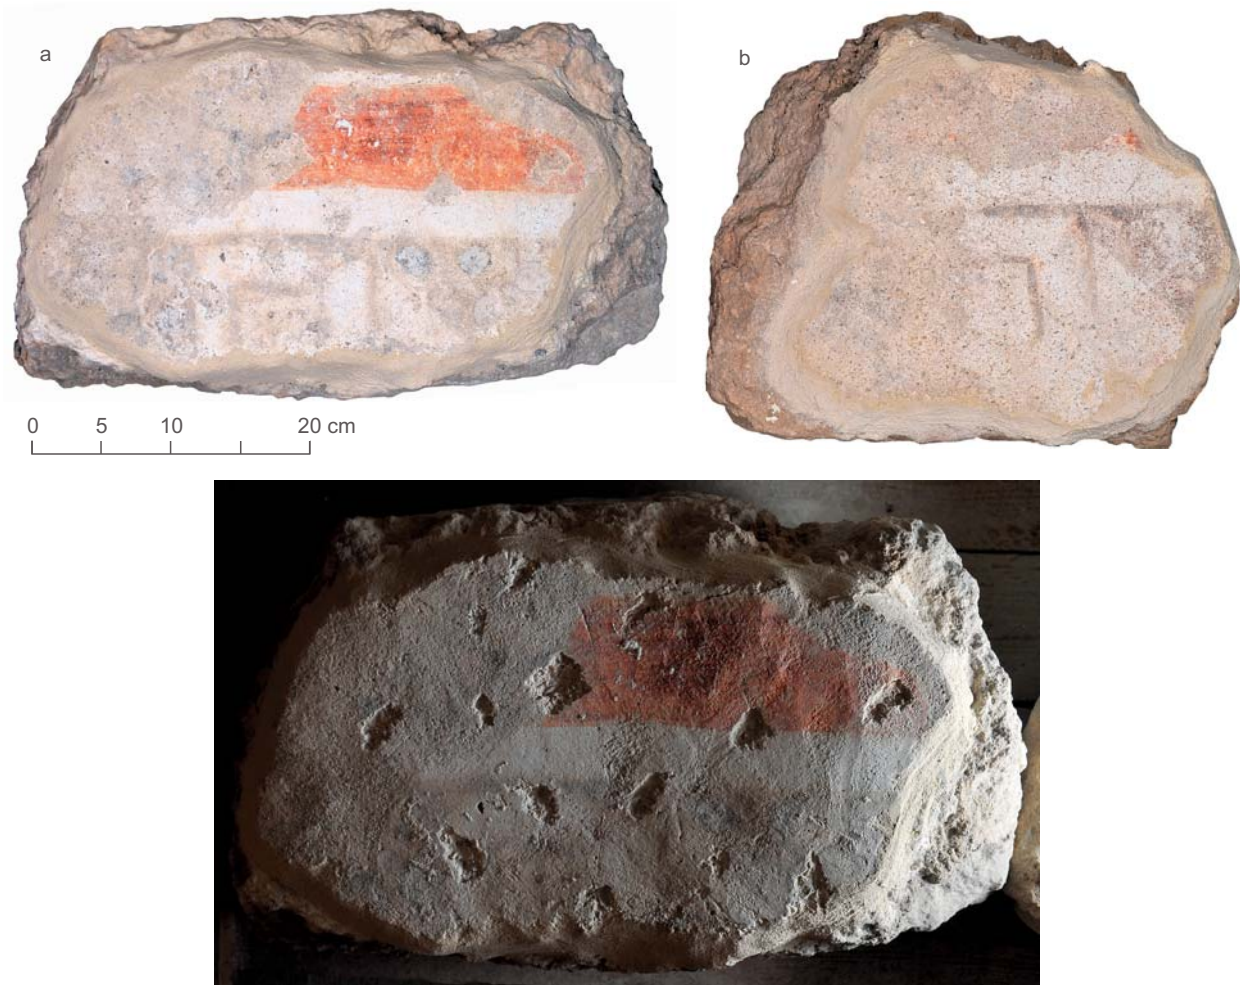
After treatment (2017); bottom, *Cat. 83a*: keying marks viewed in raking light

Disinfection; consolidation of plaster edges; application of mortar bands; removal of surface grime; consolidation of powdery paint layer.

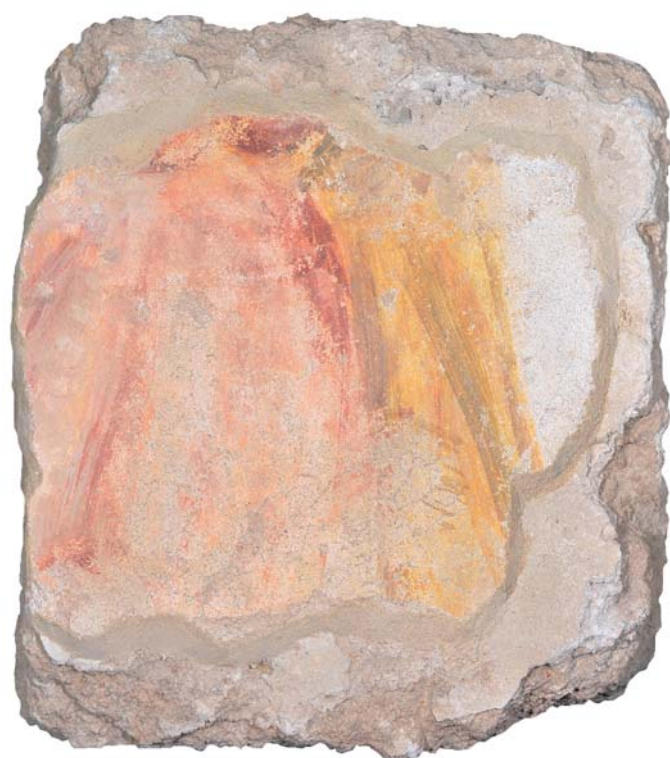
Cat. 91*Inv. No.*
98493*Representation*

*Stone*35 × 30 (face) × 19 cm; well-dressed ashlar.
Condition: fresh-looking damage to the back side.*Mortar/plaster*Type 1 mortar applied in an even layer. Plaster 7 mm thick.
Condition: adhesion slightly weakened along the perimeter of the plaster; abrasions and cracks; granular disintegration of plaster.*Paint layer*Painted wet-into-wet, with broad, quick brushstrokes.
Condition: abraded but legible; pink areas slightly powdery; candle-wax stain by the upper edge; surface grime.*Treatment*

Disinfection; consolidation of plaster edges; application of mortar bands; removal of surface grime; partial removal of wax; consolidation of powdery paint layer.

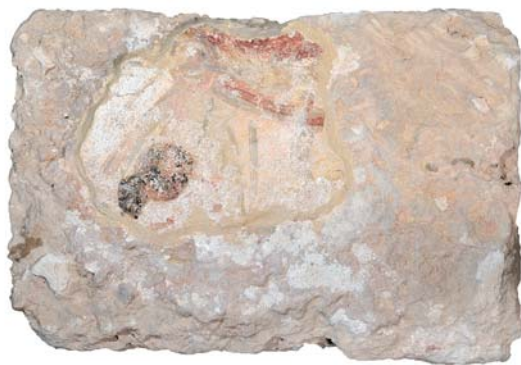
Cat. 92	<i>Representation</i> Draped garment(?)	
<i>Inv. No.</i> 98486		
<i>Figs 4-6, 4-14, 4-28</i>	<i>Provenance</i> Basilica	<i>Discovery / transport to Beiteddine</i> 1987 / about 1987
<i>Stone</i>	31 × 45 (face) × 8 cm; well-dressed ashlar; porous stone. <i>Condition:</i> back side trimmed, otherwise in good condition.	
<i>Mortar/plaster</i>	Type 2 mortar in a strip along the perimeter of the ashlar face. Plaster 7–9 mm thick. <i>Condition:</i> poor adhesion along the perimeter of the plaster; rough, abraded surface; some cracks; granular disintegration of plaster.	
<i>Paint layer</i>	Layered buildup; dark red lines applied with thick paint; well-preserved texture of brushstrokes. <i>Condition:</i> abraded and faded; red parts powdery; a large stain of melted candle wax spilled over the stone; some remains of yellowed varnish; surface grime.	
<i>Treatment</i>	Disinfection; consolidation of plaster edges; reattachment of plaster to stone support; application of mortar bands; removal of surface grime; removal of varnish; complete extraction of wax proved impossible; consolidation of powdery paint layer.

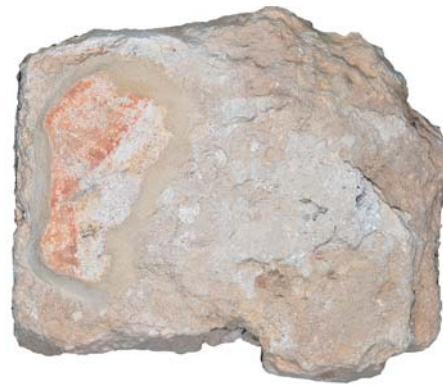
Cat. 93	<i>Representation</i> Human limb(?)	
<i>Inv. No.</i> 98528		
<i>Sample</i> Jy005 [Fig. 3-4]	<i>Provenance</i> Basilica	<i>Discovery / transport to Beiteddine</i> 1987 / about 1987
<i>Stone</i>	28 × 34 (face) × 17 cm; roughly dressed ashlar. <i>Condition:</i> good.	
<i>Mortar/plaster</i>	Type 1 mortar on the face of the ashlar; Type 2 mortar on the sides. Plaster 8–10 mm thick. <i>Condition:</i> poor; losses and abrasions; granular disintegration of plaster.	
<i>Paint layer</i>	Appears to be applied thickly, wet-into-wet. <i>Condition:</i> numerous small losses; powdery; surface grime.	
<i>Treatment</i>	Disinfection; consolidation of plaster edges; application of mortar bands; removal of surface grime; consolidation of powdery paint layer.

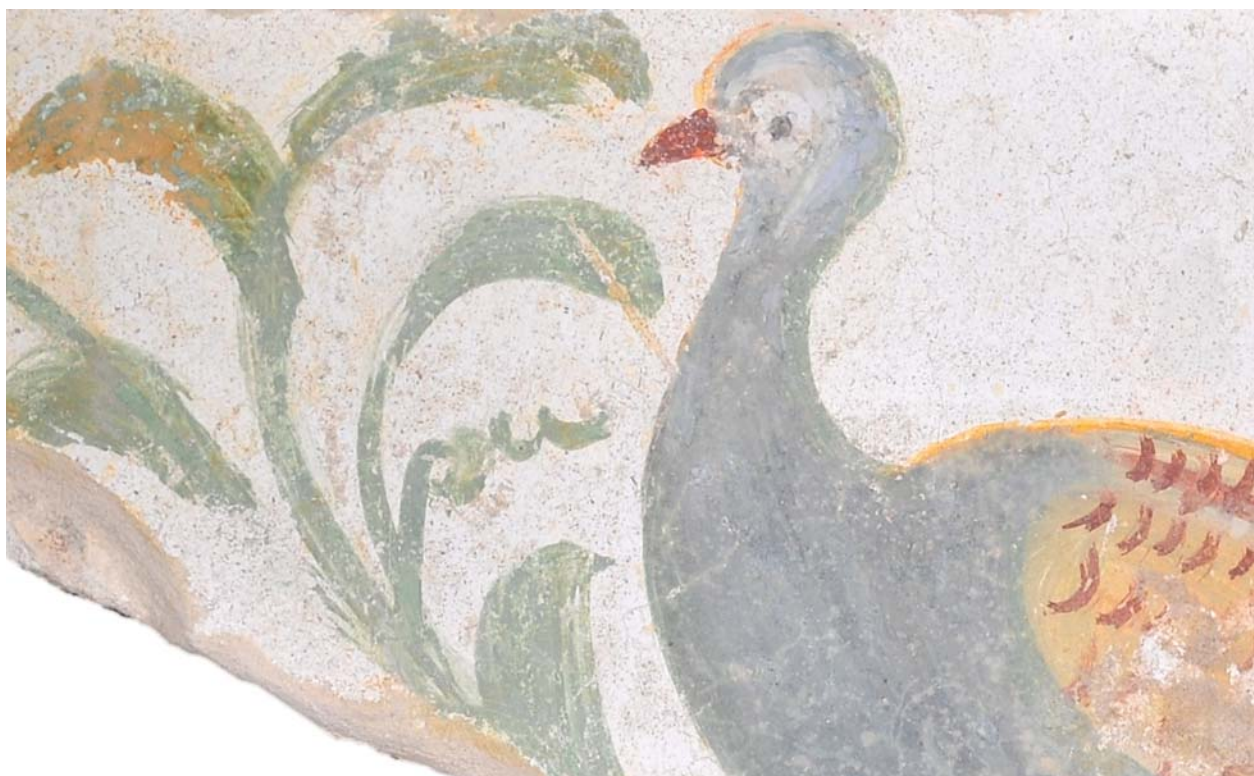
After treatment (2017); detail of *Cat. 94***Cat. 94***Inv. No.*

Condition: weak adhesion along the edges; remains of epoxy(?) resin along the bottom edge of plaster; minor, shallow losses concentrated on the head and flank; granular disintegration of plaster.*Paint layer*Layered buildup; evidence of preparatory sketch executed with ocher; thickly applied paint, especially blue and green; colors of the details do not mix with the base colors (e.g. on the train or flank); brush marks visible in raking light [see *Fig. 3-29*].*Condition:* minor, scattered losses and abrasions; moderately yellowed, glossy varnish; surface grime.*Treatment*

Disinfection; consolidation of plaster edges; reattachment of plaster to stone support; removal of epoxy(?) resin; application of mortar bands; removal of surface grime; removal of varnish; infilling losses of plaster; inpainting.

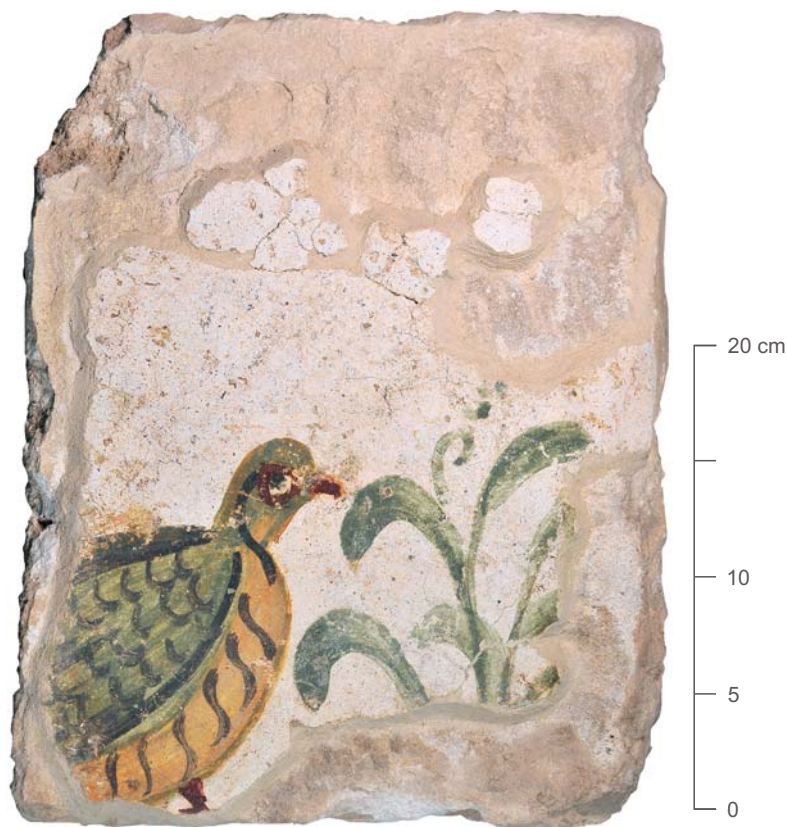
Cat. 97

Plaster 4–10 mm thick; directly on stone; folded over the right-hand edge and continuing on the side.
Condition: poor adhesion in the lower part of the representation; matching fragment of plaster was found detached in the storage room; cracks; granular disintegration of plaster.

Layered buildup; evidence of preparatory sketch with ocher; paints rather opaque and thick; easy and skillful execution of details of the plumage and of the plant tendril.
Condition: good overall; moderately yellowed, thick, glossy varnish; surface grime; mortar-like hard incrustations on the surface.

Disinfection; consolidation of plaster edges; reattachment of plaster to stone support; reintegration of broken plaster fragment; application of mortar bands; removal of surface grime; removal of varnish; preventive consolidation of red and black paint layer.

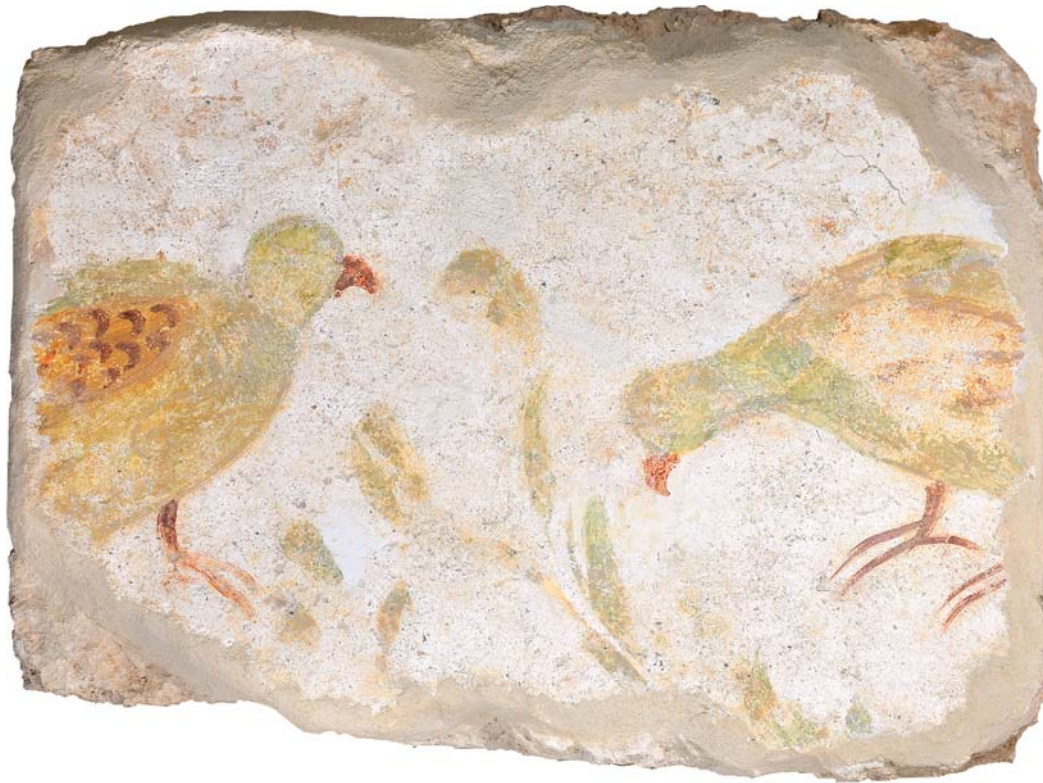
Cat. 99

Condition: good; large loss on the back, possibly prior to construction.*Mortar/plaster*

Condition: some deep losses and abrasions; cracked upper right corner; remains of epoxy(?) resin on the edges; granular disintegration of plaster.*Paint layer*

Condition: abraded, faded and sensitive; minor losses; thick surface grime; hard, sand incrustation in upper left corner.*Treatment*

Disinfection; consolidation of plaster edges; removal of epoxy(?) resin; application of mortar bands; removal of surface grime; preventive consolidation of paint layer; infilling losses of plaster; inpainting.

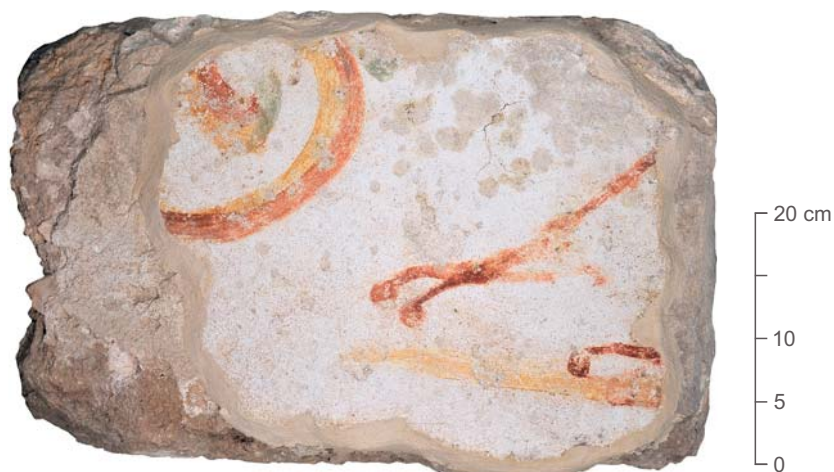
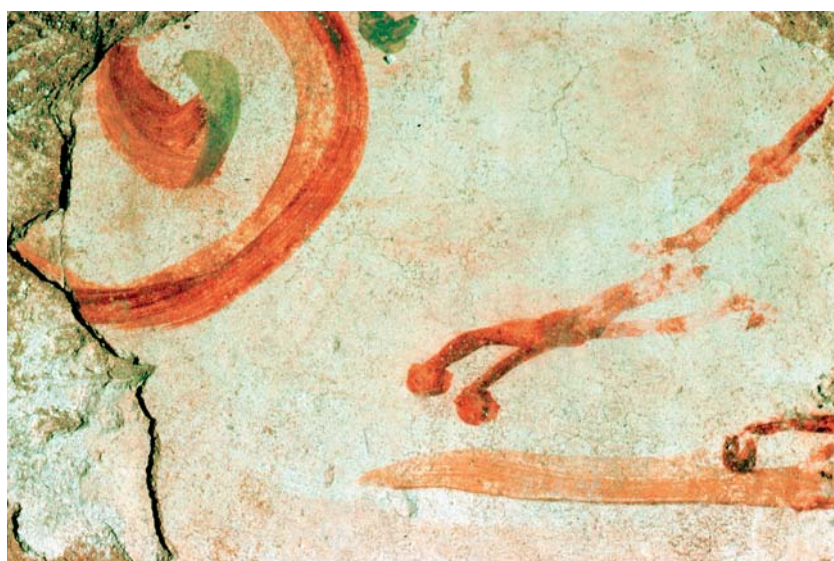
Cat. 108

36 × 52 (face) × 17 cm; well-dressed; old plaster on the right side of the ashlar suggesting secondary use.
Condition: good.

Type 2 mortar or old plaster on the face of the ashlar. Top plaster is 7–12 mm thick.
Condition: poor adhesion along the top edge; small losses of plaster and surface abrasion; granular disintegration of plaster.

Buildup difficult to assess due to the condition of the painting; possibly relatively thick at first.
Condition: many abrasions and minor losses; dull gray varnish; surface grime.

Disinfection; consolidation of plaster edges; reattachment of plaster to stone support; application of mortar bands; removal of surface grime; removal of varnish; preventive consolidation of paint layer.

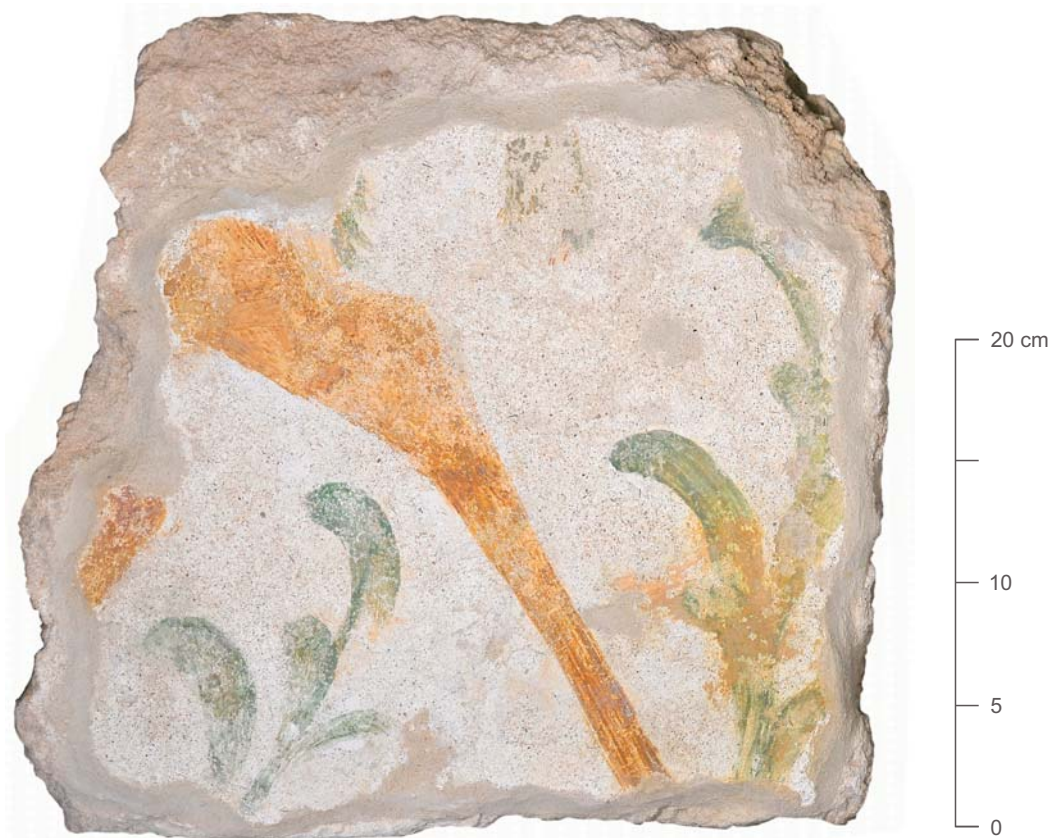
After treatment (2018) Cat. 115

Condition: upper left corner missing, break apparently fresh; back side trimmed.*Mortar/plaster*

Condition: a few deep losses; some abrasions and minor cracks; remains of epoxy(?) resin used in the past to reattach plaster; granular disintegration of plaster.*Paint layer*

Condition: numerous losses, scuffs, and abrasions; sensitive, especially the areas of buff color; surface grime.*Treatment*

Disinfection; consolidation of plaster edges; removal of epoxy(?) resin; application of mortar bands; removal of surface grime; consolidation of powdery paint layer; infilling losses of plaster; inpainting.

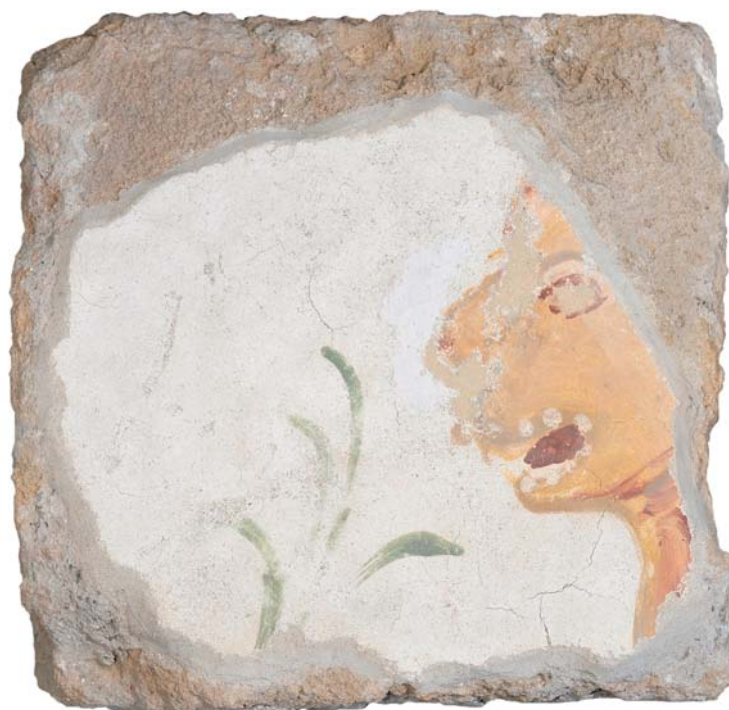
Cat. 119

Condition: corners slightly rounded; otherwise in good condition.*Mortar/plaster*

Condition: minor losses and abrasions, especially on the muzzle; a large loss in the eye; slightly powdery; surface grime.*Treatment*

Disinfection; consolidation of plaster edges; reattachment of plaster to stone support; application of mortar bands; removal of surface grime; consolidation of powdery paint layer.

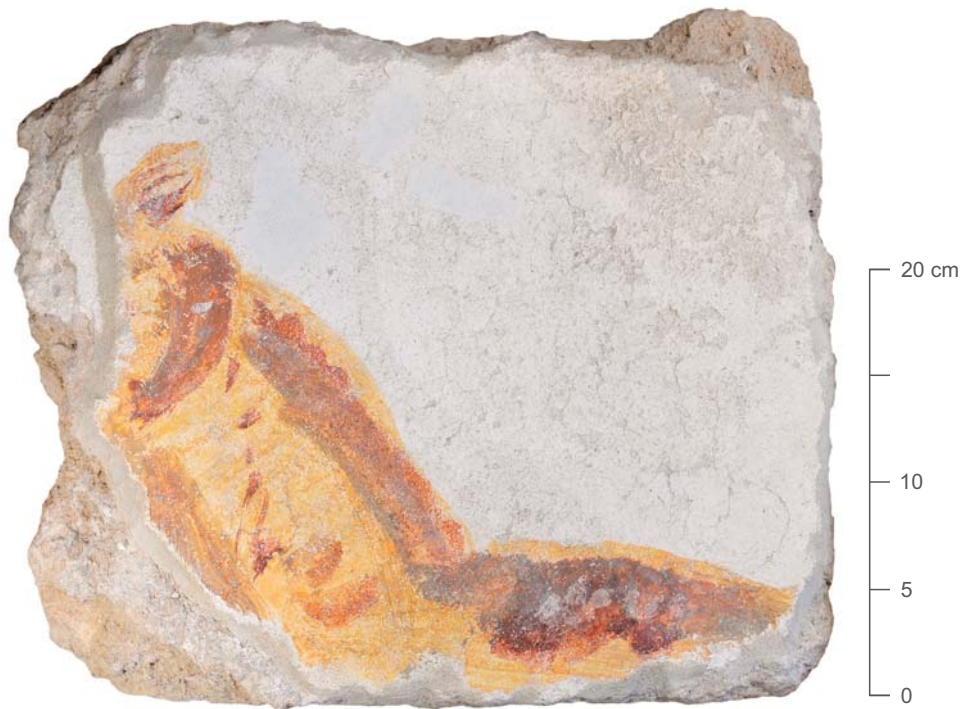
Cat. 120	<i>Representation</i>	
<i>Inv. No.</i> JY79WP	Unidentified animal looking left; small rounded ear and relatively long neck	
<i>Fig. 3-3I</i>	<i>Provenance</i> Residential district	<i>Discovery / transport to Beiteddine</i> 2000s / 2012
<i>Stone</i>	33 × 40 (face) × 15 cm; well-dressed ashlar; compact stone. <i>Condition:</i> good overall; minor chipping.	
<i>Mortar/plaster</i>	Type 2 mortar underneath the plaster along the left edge; Type 1 mortar on the bottom side of the ashlar. Plaster 5–8 mm thick. <i>Condition:</i> poor adhesion along the edges; abrasions, losses, and cracks; granular disintegration of plaster.	
<i>Paint layer</i>	Base color of the pelage rendered with relatively thin paint; anatomical details applied wet-into-wet with disordered brushstrokes and somewhat random, mixed colors. <i>Condition:</i> numerous losses, scuffs, and abrasions; reddish-brown parts sensitive and powdery; surface grime.

<i>Treatment</i>	Disinfection; consolidation of plaster edges; reattachment of plaster to stone support; application of mortar bands; removal of surface grime; consolidation of powdery paint layer; infilling losses of plaster; inpainting.
