LATE ANTIQUE WALL PAINTINGS FROM PORPHYREON IN THE SIDON HINTERLAND

Julia M. BURDAJEWICZ

PEETERS
LEUVEN – PARIS – BRISTOL, CT.
2022

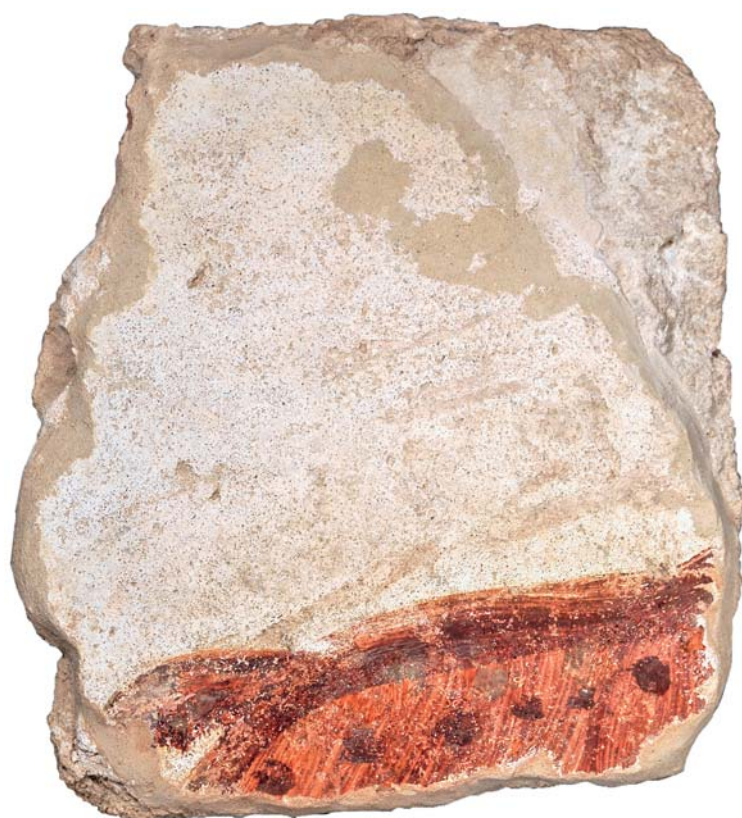
Cat. 121Inv. No.
97116*Representation*

Provenance
Basilica*Discovery / transport to Beiteddine*
1987 / about 1987*Stone*30 × 28 (face) × 9 cm; moderately dressed ashlar.
Condition: right side broken, possibly old damage; corners rounded; back side trimmed.*Mortar/plaster*Type 2 mortar underneath the plaster; likely in two layers on the right side of the ashlar; potsherd noted between mortar and plaster. Plaster 5–7 mm thick, even.
Condition: relatively good; some minor losses and scuffs; granular disintegration of plaster.*Paint layer*Applied in no more than two layers; base color pulled with wide brush and semi-transparent paint; darker contours and spots on the pelage rendered with thick, opaque paint.
Condition: minor losses and abrasions scattered all over; remains of slightly yellowed varnish; surface grime; hard, mortar-like deposits firmly adhering to the surface.*Treatment*

Disinfection; consolidation of plaster edges; application of mortar bands; removal of surface grime; removal of varnish; infilling losses of plaster; inpainting.

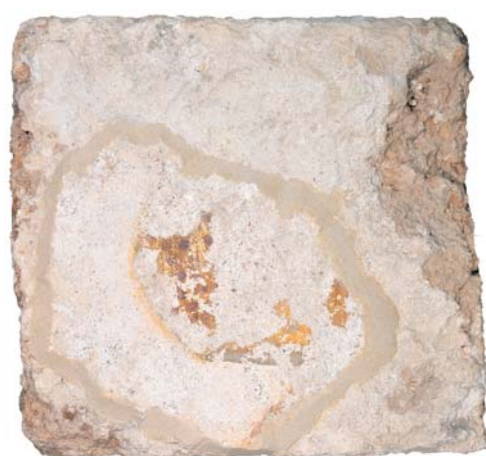
After treatment (2017) Cat. 126

Cat. 126	<i>Representation</i>	
<i>Inv. No.</i> 97090	Round yellow shape with multiple small, reddish-brown spots reminiscent of the pelage of a cheetah	
<i>Sample</i> Jy004		
[Fig. 3-4]	<i>Provenance</i> Basilica	<i>Discovery / transport to Beiteddine</i> 1987 / about 1987
<i>Stone</i>	36 × 38 (face) × 18 cm; nearly square, well-dressed ashlar. <i>Condition:</i> good overall; loss along the right edge.	
<i>Mortar/plaster</i>	Type 2 mortar underneath the plaster; Type 1 mortar on the sides of the ashlar. Plaster about 8 mm thick. <i>Condition:</i> broad abrasions; granular disintegration of plaster.	
<i>Paint layer</i>	Buildup difficult to assess due to the condition of the painting; possibly layered structure. <i>Condition:</i> poor due to plaster deterioration; extensive abrasions and losses; some remains of slightly yellowed varnish; surface grime.	
<i>Treatment</i>	Disinfection; consolidation of plaster edges and abraded areas; application of mortar bands; removal of surface grime; removal of varnish.

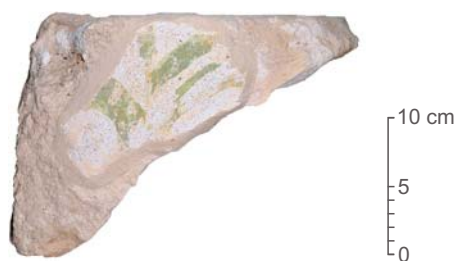
After treatment (2017)

Cat. 129	<i>Representation</i> Green generic plant	
<i>Inv. No.</i> 97142		
	<i>Provenance</i> Basilica	<i>Discovery / transport to Beiteddine</i> 1987 / about 1987
<i>Stone</i>	13 × 25 (face) × 18 cm; wedge-shaped, dressed element. <i>Condition:</i> good overall; deep cut made with an angle grinder on the top side, yet the element was not fully trimmed.	
<i>Mortar/plaster</i>	Type 2 mortar underneath the plaster and on the sides of the stone. Plaster 5–10 mm thick. <i>Condition:</i> minor, shallow losses; granular disintegration of plaster.	
<i>Paint layer</i>	Leaves are rendered with thick green paint applied in one layer. <i>Condition:</i> minor losses and abrasions; yellowed varnish; surface grime.	
<i>Treatment</i>	Disinfection; consolidation of plaster edges; application of mortar bands; removal of surface grime; removal of varnish.

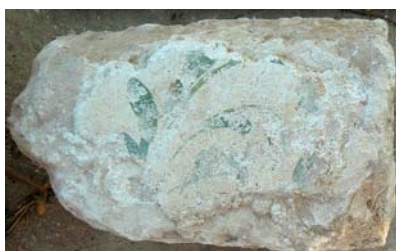
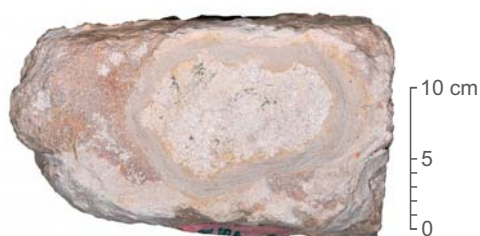
After discovery (2010); right, after treatment (2017)

Cat. 130	<i>Representation</i> Green generic plant	
<i>Inv. No.</i> JY104WP		
	<i>Provenance</i> Residential district	<i>Discovery / transport to Beiteddine</i> 2000s / 2016
<i>Stone</i>	15 × 27 (face) × 15 cm; roughly dressed, small ashlar. <i>Condition:</i> good.	
<i>Mortar/plaster</i>	Type 2 mortar underneath the plaster and on the sides of the ashlar. Plaster 6–8 mm thick. <i>Condition:</i> relatively well-preserved at the time of discovery, but almost entirely disintegrated by the time of the transport to Beiteddine; severely abraded; granular disintegration of plaster.	
<i>Paint layer</i>	Buildup difficult to assess due to the condition of the painting; most likely applied in one layer. <i>Condition:</i> painting practically gone.	
<i>Treatment</i>	Disinfection; consolidation of plaster edges and abraded areas; application of mortar bands; dusting; preventive consolidation of remains of paint layer.

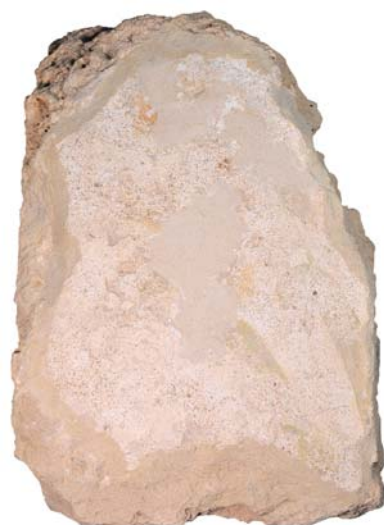
After treatment (2017) and tracing

Cat. 131	<i>Representation</i> Green generic plant	
<i>Inv. No.</i> 98492		
	<i>Provenance</i> Basilica	<i>Discovery / transport to Beiteddine</i> 1987 / about 1987
<i>Stone</i>	34 × 24 (face) × 6 cm; fragment of an ashlar. <i>Condition:</i> upper right corner missing, fresh break; large loss at the bottom edge; back side trimmed.	
<i>Mortar/plaster</i>	Type 2 mortar along the perimeter of the ashlar face. Plaster about 8 mm thick, even. <i>Condition:</i> broad and shallow losses and abrasions; some cracks along the edges; granular disintegration of plaster.	
<i>Paint layer</i>	Buildup difficult to assess due to the condition of the painting; most likely applied in one layer. <i>Condition:</i> severely abraded and faint; surface grime.	
<i>Treatment</i>	Disinfection; consolidation of plaster edges and abraded areas; application of mortar bands; removal of surface grime; preventive consolidation of paint layer.

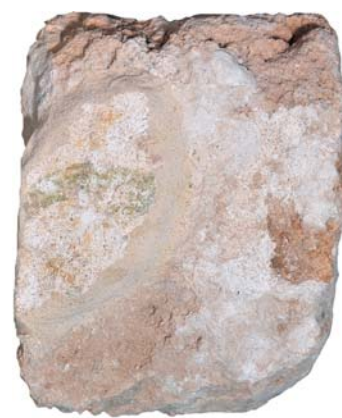
After treatment (2017) Cat. 132

Cat. 132	<i>Representation</i> Green leaf	
<i>Inv. No.</i> 97137		
	<i>Provenance</i> Basilica	<i>Discovery / transport to Beiteddine</i> 1987 / about 1987
<i>Stone</i>	20 × 16 (face) × 20 cm; small ashlar. <i>Condition:</i> good condition; minor chipping on the edges.	
<i>Mortar/plaster</i>	Type 2 mortar underneath the plaster and on the sides of the ashlar. Plaster 7–9 mm thick; present on two sides. <i>Condition:</i> cracks and surface abrasions; granular disintegration of plaster.	
<i>Paint layer</i>	Green paint applied in one layer. <i>Condition:</i> severely abraded and faded; possible remains of yellowed varnish; surface grime.	
<i>Treatment</i>	Disinfection; consolidation of plaster edges and abraded areas; application of mortar bands; removal of surface grime; preventive consolidation of paint layer.

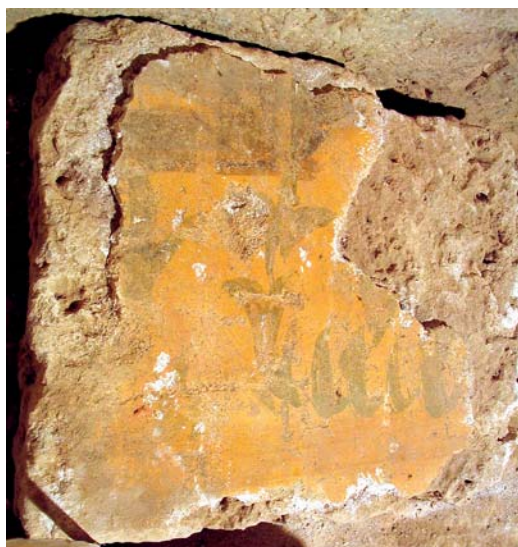
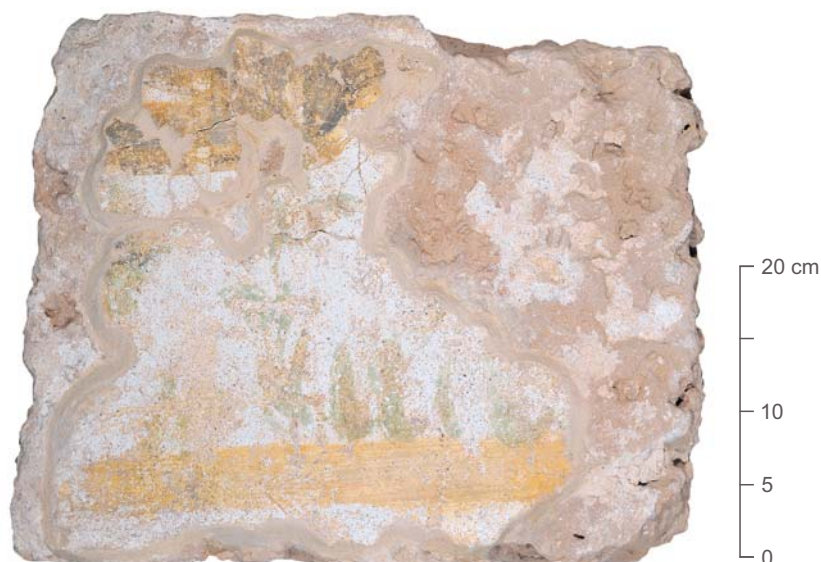
After treatment (2017); above, in storage at Beiteddine Museum (2004)

Cat. 137	<i>Representation</i>	
<i>Inv. No.</i> 98487	Green plants growing from a yellow strip of ground; hind leg(?) of a brown, reclining animal above it	
<i>Figs 4-15, 4-25</i>	<i>Provenance</i> Basilica	<i>Discovery / transport to Beiteddine</i> 1987 / about 1987
<i>Stone</i>	38 × 46 (face) × 8 cm; ashlar; very porous stone with pumice-like structure. <i>Condition:</i> back side trimmed; otherwise in good condition.	
<i>Mortar/plaster</i>	Type 2 mortar remains in the large cavities in the stone. Plaster 3–10 mm thick. <i>Condition:</i> upper part of the extant plaster disintegrated in storage; some of the fragments were collected upon moving the blocks to the current storage room; surface losses; granular disintegration of plaster.	
<i>Paint layer</i>	Buildup difficult to assess due to the condition of the painting; layered buildup possible in the area of the presumed animal. <i>Condition:</i> numerous abrasions and losses; thick, yellowed varnish; surface grime.

<i>Treatment</i>	Disinfection; consolidation of plaster edges; reintegration of broken plaster fragments; application of mortar bands; removal of surface grime; removal of varnish; preventive consolidation of paint layer.

Fig. 4-15. Artificial coatings; circled area blown-up in a microphotograph on the right (*Cat. 137* – microphoto taken at the edge of cleaning test area; *Cat. 172* – thick, delaminating varnish)

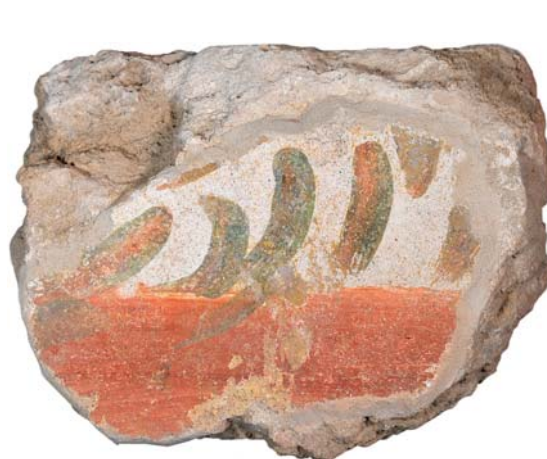
After treatment (2018) Cat. 140

Cat. 140	<i>Representation</i>	
	Green leaves growing from a red strip of ground (or a trunk if turned sideways)	
Inv. No. 98565		
	<i>Provenance</i> Basilica	<i>Discovery / transport to Beiteddine</i> 1987 / about 1987
<i>Stone</i>	19 × 23 (face) × 6 cm; fragment of an ashlar(?). <i>Condition:</i> broken on two sides; corners rounded; back side trimmed.	
<i>Mortar/plaster</i>	Type 2 mortar remains along the upper edge of the plaster. Plaster about 5 mm thick, even. <i>Condition:</i> a few abrasions; granular disintegration of plaster.	
<i>Paint layer</i>	Red ground rendered with a thick, even layer of opaque paint; green leaves on top; green paint on the leaves apparently mixed with the color of the ground. <i>Condition:</i> losses and abrasions; yellowed varnish; surface grime.	
<i>Treatment</i>	Disinfection; consolidation of plaster edges; application of mortar bands; removal of surface grime; removal of varnish; infilling losses of plaster; inpainting.

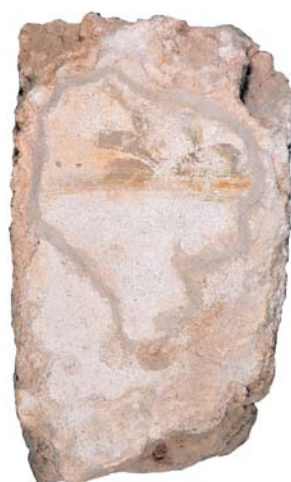
After treatment (2017) and tracing Cat. 141

Cat. 141	<i>Representation</i>	
	Clump of vegetation growing from a strip of ground	
Inv. No. 98488		
	<i>Provenance</i> Basilica	<i>Discovery / transport to Beiteddine</i> 1987 / about 1987
<i>Stone</i>	37 × 21 (face) × 40 cm; dressed ashlar, used as a header. <i>Condition:</i> some losses to the corners; otherwise in good condition.	
<i>Mortar/plaster</i>	Type 2 mortar on the face and on all sides of the ashlar. Plaster about 5 mm thick. <i>Condition:</i> generally good; granular disintegration of plaster.	
<i>Paint layer</i>	Applied wet-into-wet; several colors mixed together rather carelessly. <i>Condition:</i> abraded and faded; remains of slightly yellowed varnish; surface grime.	
<i>Treatment</i>	Disinfection; consolidation of plaster edges; application of mortar bands; removal of surface grime; removal of varnish; preventive consolidation of paint layer.

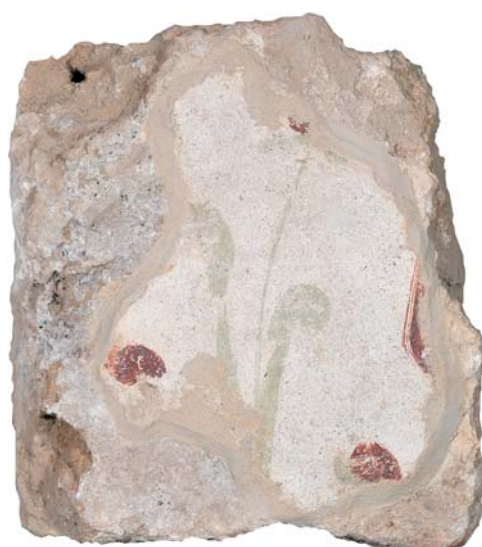
Cat. 148	<i>Representation</i> Plant with long, green leaves and red flowers	
<i>Inv. No.</i> 98552		
	<i>Provenance</i> Basilica	<i>Discovery / transport to Beiteddine</i> 1987 / about 1987
<i>Stone</i>	35 × 30 (face) × 17 cm; well-dressed ashlar. <i>Condition:</i> upper right and left corners missing, fresh breaks; back side trimmed.	
<i>Mortar/plaster</i>	Type 2 mortar remains on the face of the ashlar, locally underneath the plaster; Type 1 mortar in one of the cavities of the stone. Plaster 5–8 mm thick. <i>Condition:</i> adhesion slightly weakened along the edges; small losses and abrasions; granular disintegration of plaster.	
<i>Paint layer</i>	Applied in one layer; green leaves rendered thinly, red flowers thickly. <i>Condition:</i> some abrasions; red parts powdery; surface grime.	
<i>Treatment</i>	Disinfection; consolidation of plaster edges; application of mortar bands; removal of surface grime; consolidation of powdery paint layer.

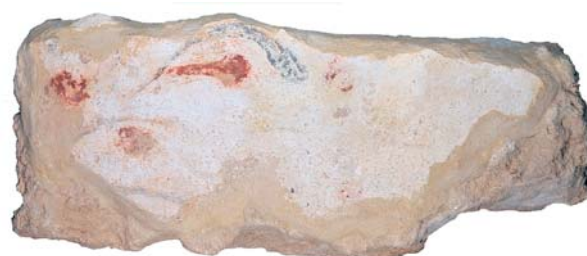
Cat. 149	<i>Representation</i> Plant with red elongated flowers and long, narrow, dark green leaves	
<i>Inv. No.</i> 97146		
<i>Fig. 4-28</i>	<i>Provenance</i> Basilica	<i>Discovery / transport to Beiteddine</i> 1987 / about 1987
<i>Stone</i>	18 × 27 (face) × 18 cm; small, roughly dressed ashlar. <i>Condition:</i> good.	
<i>Mortar/plaster</i>	Type 2 mortar on the sides of the ashlar. Plaster 5–10 mm thick; directly on stone. <i>Condition:</i> minor losses and abrasions; granular disintegration of plaster; otherwise in good condition.	
<i>Paint layer</i>	Probably applied in one layer. <i>Condition:</i> severely abraded; red parts powdery; surface grime.	
<i>Treatment</i>	Disinfection; consolidation of plaster edges; application of mortar bands; removal of surface grime; consolidation of powdery paint layer.

Fig. 4-28. Surface cleaning: left top and bottom, removal of surface grime using cotton swabs dipped in distilled water (*Cat. 100* and *Cat. 149*); top right, removal of an ink stain from *Cat. 52*; bottom right, removal of wax from *Cat. 92*

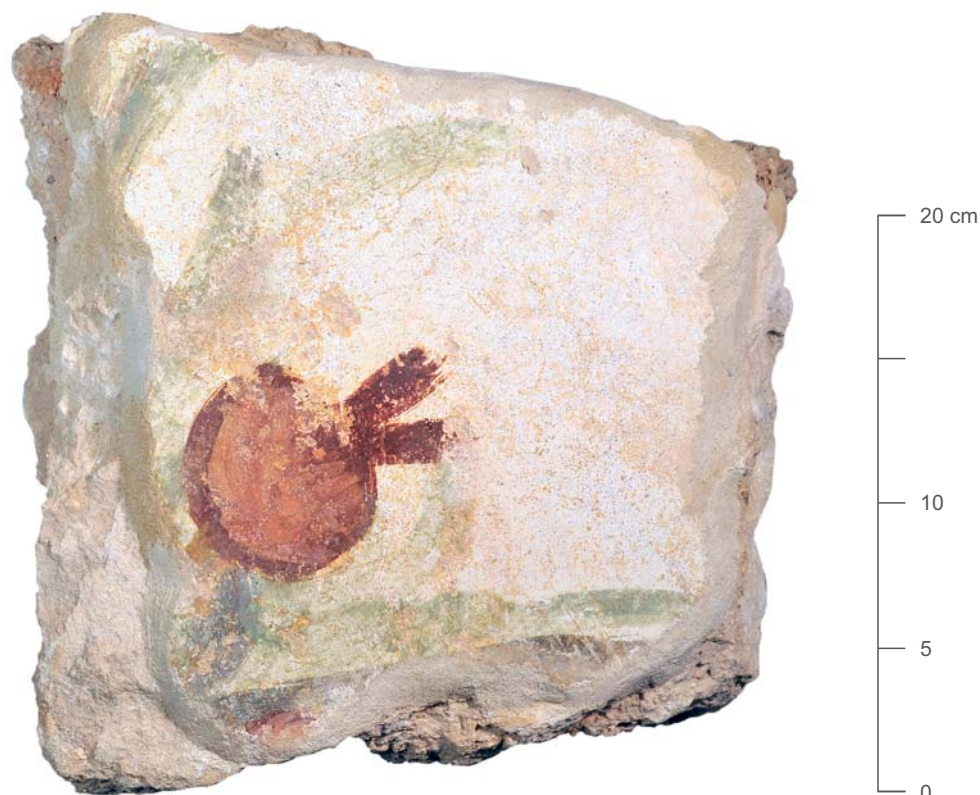
Cat. 153	<i>Representation</i> Pomegranate in foliage	
<i>Inv. No.</i> 97110		
<i>Fig. 3-1</i>	<i>Provenance</i> Basilica	<i>Discovery / transport to Beiteddine</i> 1987 / about 1987
<i>Stone</i>	25 × 25 (face) × 12 cm; fragment of an ashlar; conglomerate of large bioclasts. <i>Condition:</i> top side broken, fresh break; back side trimmed.	
<i>Mortar/plaster</i>	Type 2 mortar locally underneath the plaster. Plaster 6–8 mm thick. <i>Condition:</i> adhesion slightly weakened along the edges; surface abrasion and some minor losses; granular disintegration of plaster.	
<i>Paint layer</i>	Leaves rendered in semi-translucent paint, applied in thin superimposed layers; fruit rendered with thick, opaque red color; pink highlights on top. <i>Condition:</i> abraded and thin; yellowed varnish; red parts powdery after removal of varnish; surface grime.	
<i>Treatment</i>	Disinfection; consolidation of plaster edges; application of mortar bands; removal of surface grime; removal of varnish; consolidation of powdery paint layer; infilling losses of plaster; inpainting.

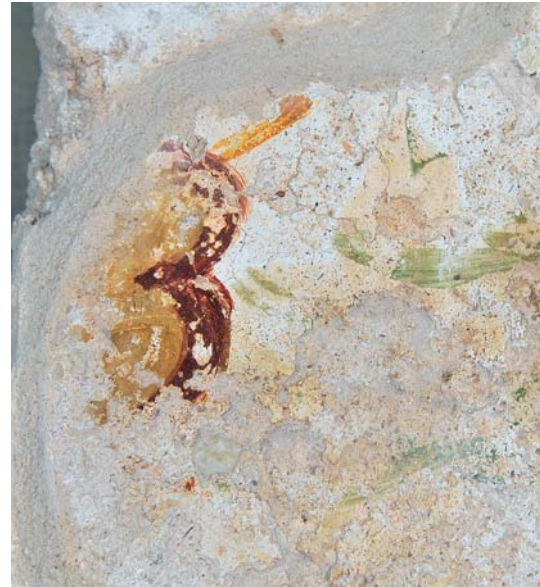
After treatment (2017); right, close-up of a pear(?)

Cat. 160 <i>Inv. No.</i> 97101	<i>Representation</i> Two bulbous fruit, most likely pears, in foliage	
	<i>Provenance</i> Basilica	<i>Discovery / transport to Beiteddine</i> 1987 / about 1987
<i>Stone</i>	33 × 28 (face) × 25 cm; roughly dressed ashlar. <i>Condition:</i> bottom right corner missing, fresh break; otherwise in good condition.	
<i>Mortar/plaster</i>	Type 2 mortar along the perimeter of the ashlar face and on its sides. Plaster 6–8 mm thick. <i>Condition:</i> numerous surface losses, pits, and abrasions; granular disintegration of plaster.	
<i>Paint layer</i>	Buildup difficult to assess due to the condition of the painting. <i>Condition:</i> poor due to plaster deterioration; surface grime.	
<i>Treatment</i>	Disinfection; consolidation of plaster edges and abraded areas; application of mortar bands; removal of surface grime.

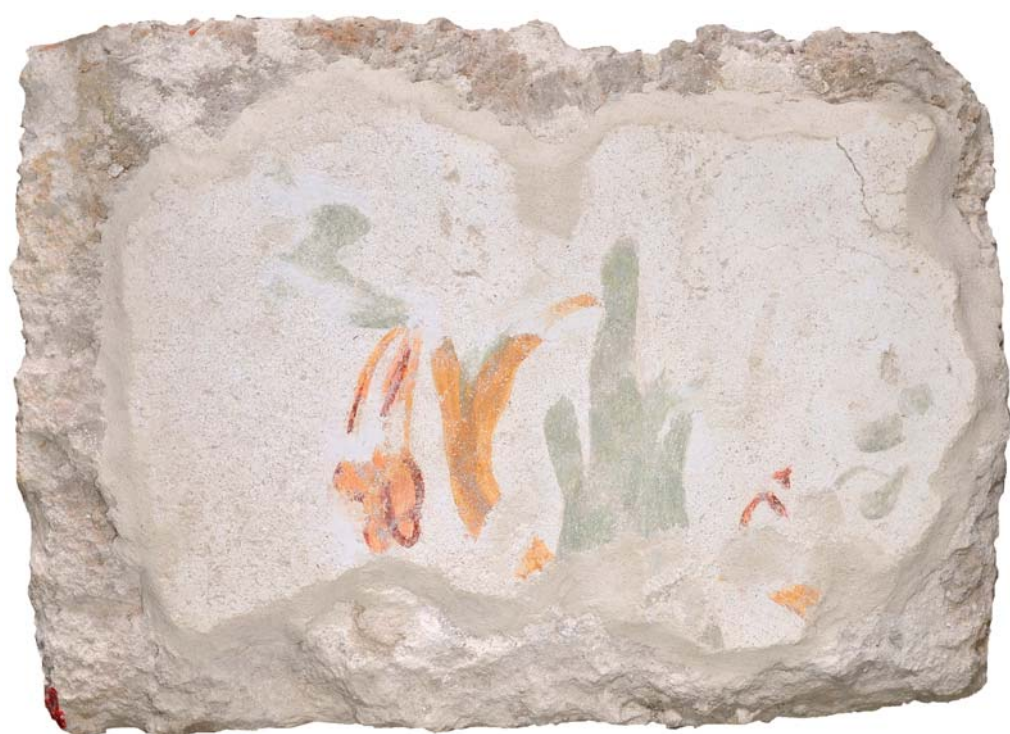
Cat. 164

After treatment (2019)

Condition: better condition of the painting upon discovery; losses and abrasions seem to have occurred in storage; red and pink parts slightly powdery; streaks of glossy, transparent varnish; surface grime.*Treatment*

Disinfection; consolidation of plaster edges; application of mortar bands; removal of surface grime; removal of varnish; consolidation of powdery paint layer; infilling losses of plaster; inpainting.

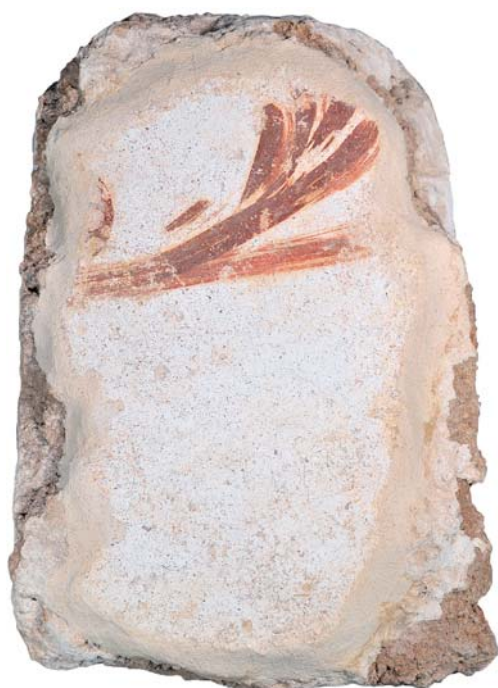
After treatment (2017) Cat. 166

**Cat. 166***Representation*
Fragment of a wreath(?)*Inv. No.*
JY4WP13*Provenance*
Residential district*Discovery / transport to Beiteddine*
1975 and again in 2000s / 2016*Stone*
28 × 20 (face) × 40 cm; roughly dressed ashlar, used as a header.
Condition: good.*Mortar/plaster*
Type 2 mortar underneath the plaster and on the sides of the ashlar. Plaster 8–10 mm thick, even.
Condition: good save for minor abrasions and granular disintegration of plaster.*Paint layer*
Thick, monochrome, applied in one layer.
Condition: good overall, slightly powdery; remains of glossy, slightly yellowed varnish; dusty.*Treatment*
Disinfection; consolidation of plaster edges; application of mortar bands; dusting; removal of varnish; consolidation of powdery paint layer.**Cat. 167***Representation*
Simple vegetal motif*Inv. No.*
JY10WP13*Provenance*
Residential district*Discovery / transport to Beiteddine*
2000s / 2016*Stone*

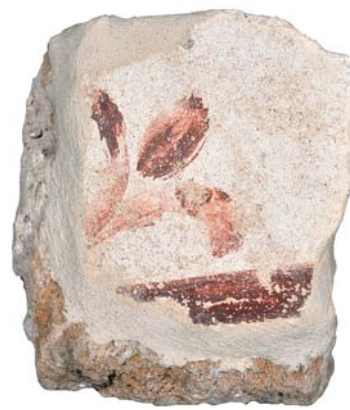
After treatment (2017) Cat. 167

16 × 13 (face) × 23 cm; small ashlar.
Condition: good.*Mortar/plaster*
Type 1 mortar on all sides of the ashlar. Plaster 6–12 mm thick.
Condition: good save for minor abrasions and granular disintegration of plaster.*Paint layer*
Monochrome; bottom strip of color rendered with thick opaque paint; leaves rendered in a fluent, watercolor-like manner.
Condition: somewhat abraded and powdery; surface grime.*Treatment*
Disinfection; consolidation of plaster edges; application of mortar bands; removal of surface grime; consolidation of powdery paint layer.

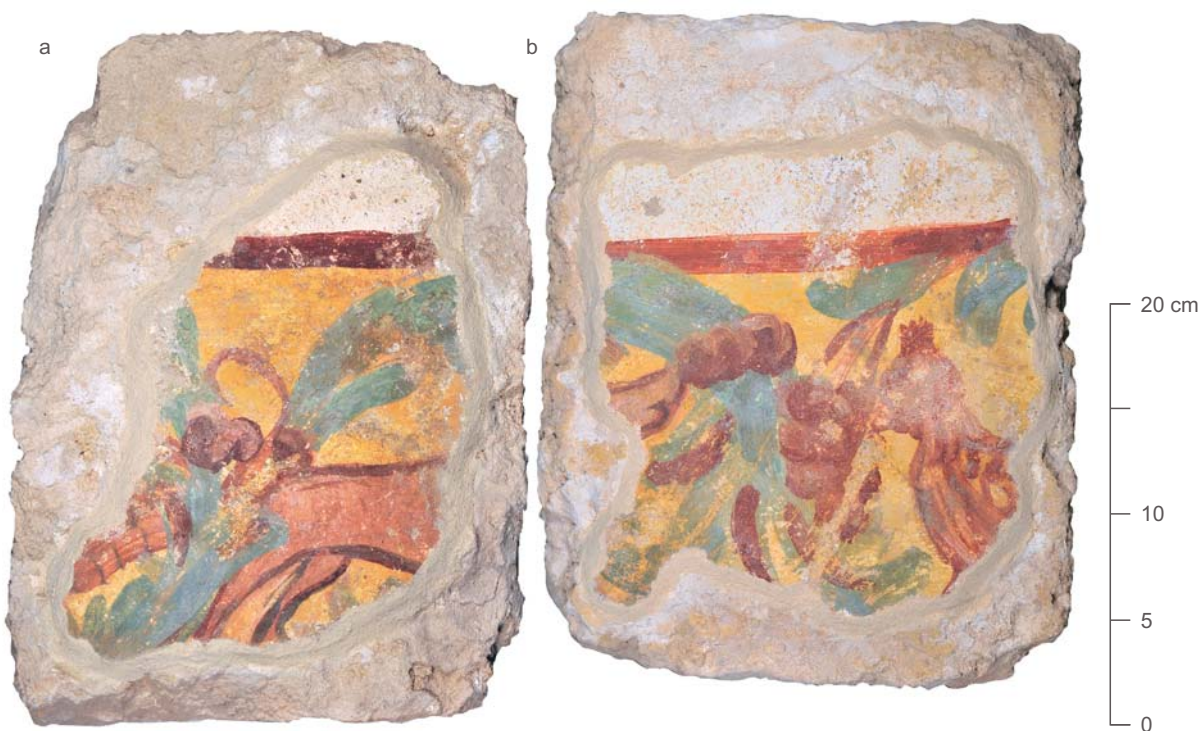
After treatment (2017)

Disinfection; consolidation of plaster edges; application of mortar bands; removal of surface grime; removal of varnish.

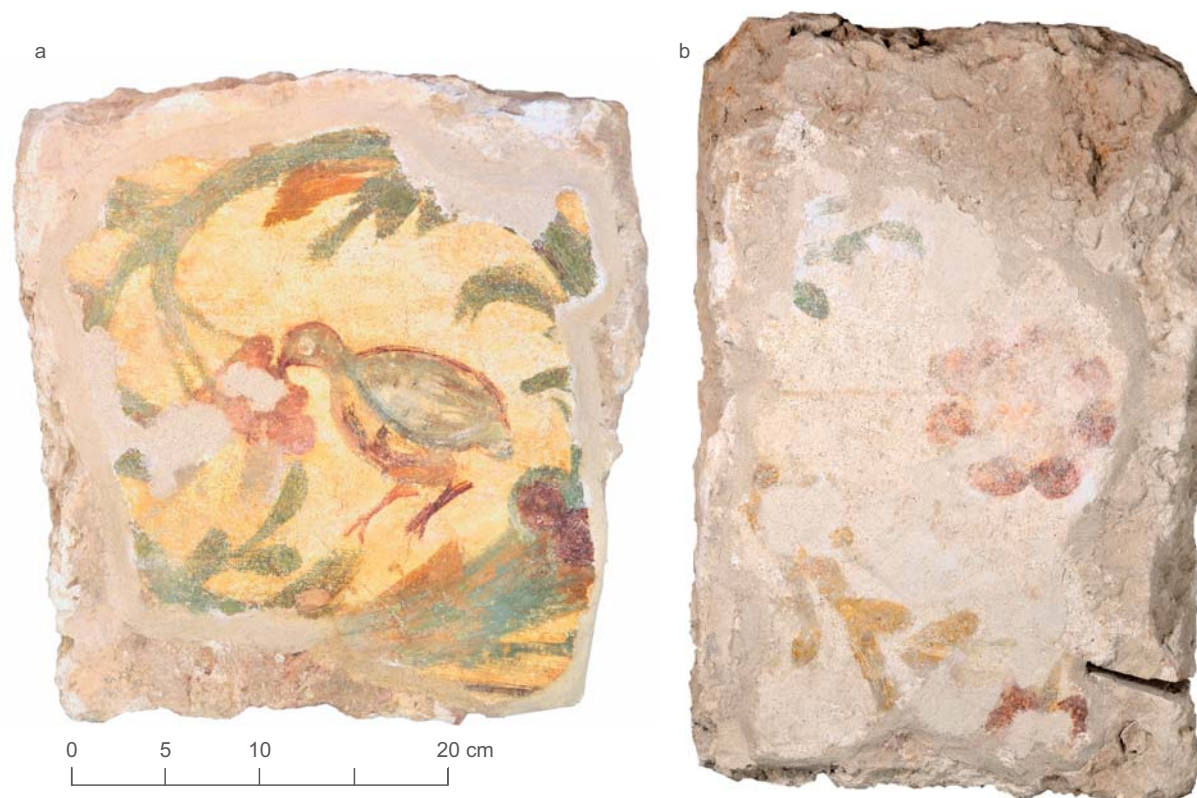
Cat. 171

After treatment (2018)

*Stone**a* – 34 × 33 (face) × 9 cm; face of a voussoir; it can be matched with fragment *b*, which constituted its intrados.*b* – 40 × 27 (face) × 9 cm; visibly concave intrados surface of a voussoir; it can be matched with fragment *a*, which constituted its face.*Condition: a, b* – back side trimmed, cut diagonally along its bottom edge; *b* – deep cut at the lower right edge.*Mortar/plaster**a* – Type 2 mortar underneath the top edge of plaster. *b* – Type 2 mortar remains along the perimeter of the element's face. *a, b* – Plaster 5–6 mm thick; mostly directly on stone.*Condition: a* – some shallow losses, especially at the bottom edge of the plaster; *b* – numerous shallow losses and abrasions; *a, b* – granular disintegration of the plaster.*Paint layer**a* – layered buildup comprising up to four layers of paint; particular layers are relatively thin; the thickest paint was used to render the acanthus leaves and fruit; bird rendered with schematic yet skillful strokes.*b* – buildup difficult to assess due to the condition of the painting.*Condition: a* – losses and abrasions scattered all over; yellowed varnish; red elements powdery after removal of varnish; surface grime.*b* – poorly preserved; severely abraded and faded; matt yellowed varnish; surface grime.*Treatment**a, b* – disinfection; consolidation of plaster edges and abraded areas; application of mortar bands; removal of surface grime; removal of varnish; preventive consolidation of powdery paint layer; infilling losses of plaster; inpainting.

Disinfection; consolidation of plaster edges; application of mortar bands; removal of surface grime; removal of varnish; preventive consolidation of paint layer; infilling losses of plaster; inpainting.

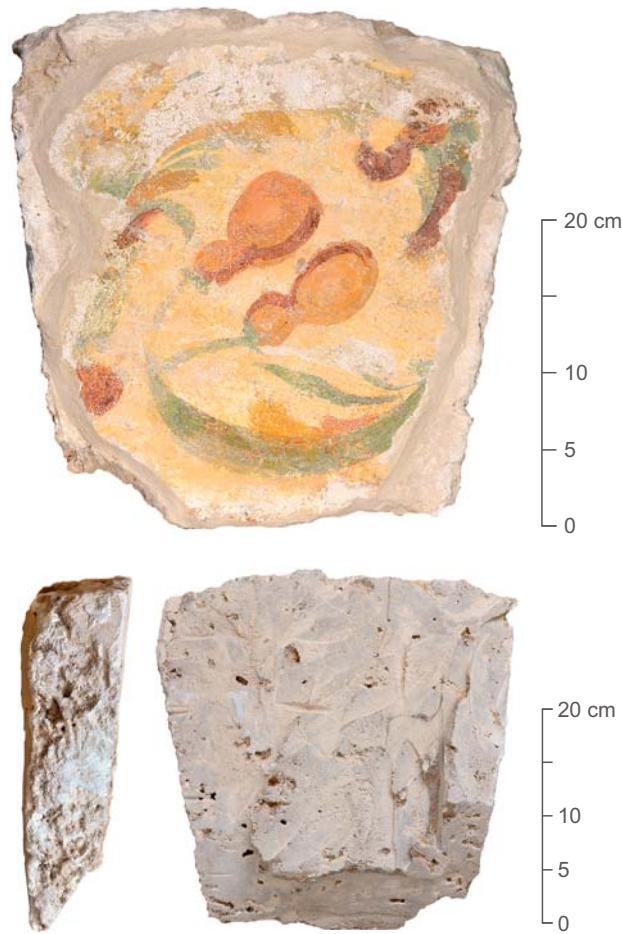
After treatment (2017); bottom, side view and back views of the stone, showing diagonally cut bottom edge

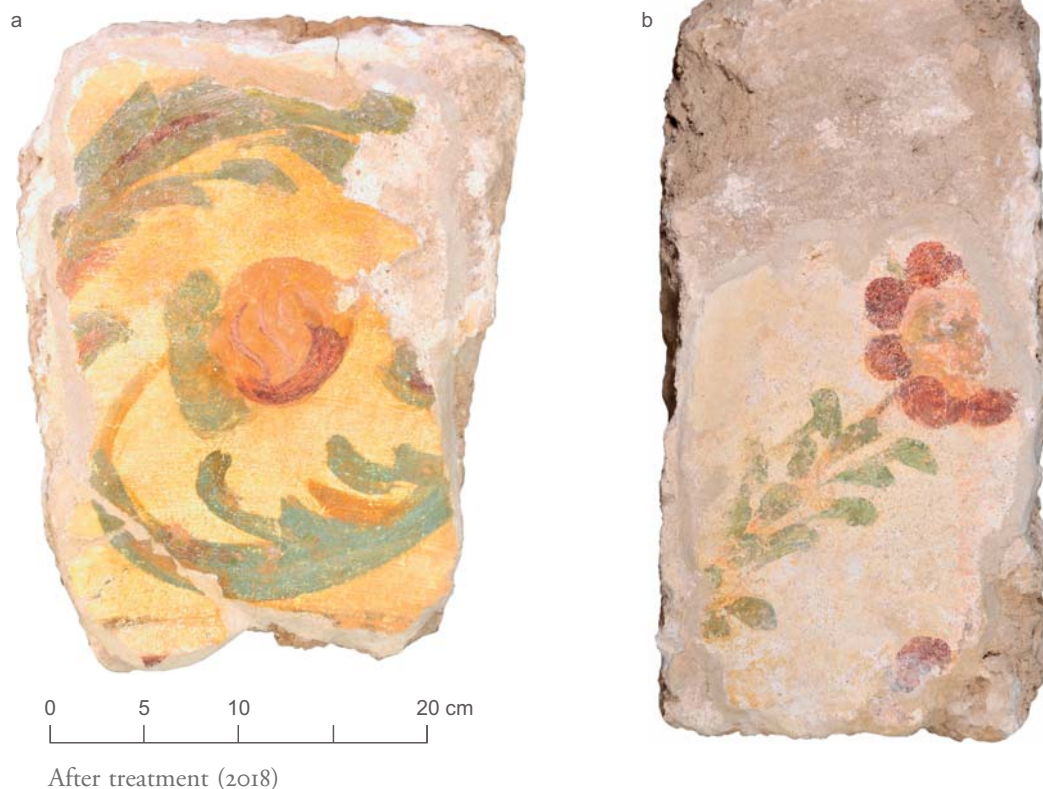
Cat. 175

*Stone**a* – 35 × 25 (face) × 12 cm; face of a voussoir.*b* – 42 × 22 (face) × 7 cm; visibly concave intrados surface of the same voussoir.*Condition: a, b* – back side trimmed; *a* – cut diagonally along its bottom edge; upper right corner missing, fresh break (a fragment of this corner was found in the storage room).*b* – cut diagonally along its bottom edge; lower right corner missing, fresh break.*Mortar/plaster**a* – Type 2 mortar along the perimeter of the element's face. Plaster 7–10 mm thick.*b* – Type 2 mortar in a strip along the perimeter of the element's face. Plaster 5–10 mm thick; directly on stone.*Condition: a* – severely abraded, especially in the upper right part; jagged edges and granular disintegration of plaster.*b* – jagged plaster edges; abraded and pitted surface; granular disintegration of plaster.*Paint layer**a* – layered buildup, comprising up to four layers of paint; the thickest paint renders acanthus leaves and fruit.*b* – buildup difficult to assess due to the condition of the painting; leaves rendered apparently with warm and cool tones of green.*Condition: a* – severe and broad abrasions of the paint, especially on the leaves; yellowed varnish locally turned opaque; red elements powdery after removal of varnish; surface grime.*b* – losses and abrasions; surface grime.*Treatment**a, b* – disinfection; consolidation of plaster edges and abraded areas; application of mortar bands; *a* – integration of broken stone fragment; removal of surface grime; removal of varnish; consolidation of powdery paint layer; infilling losses of plaster; inpainting. *b* – removal of surface grime; infilling losses of plaster; inpainting.

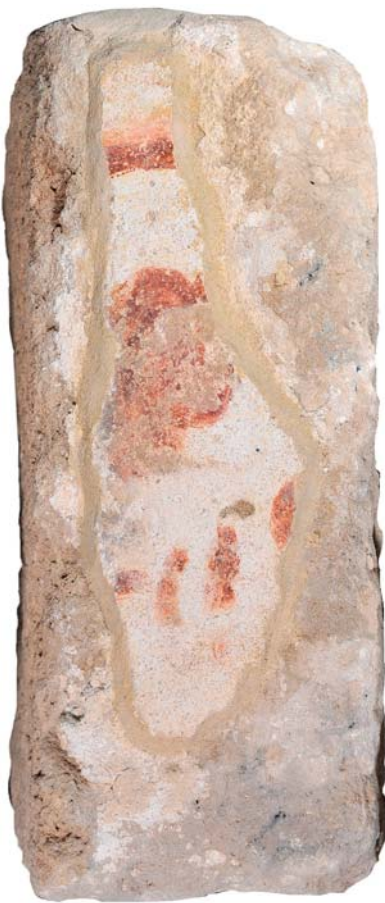
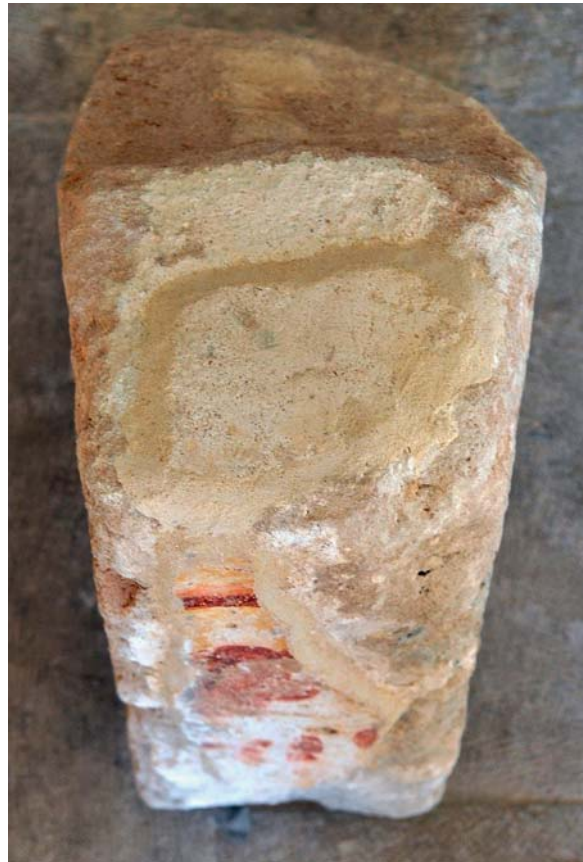
Cat. 177	<i>Representation</i>	
<i>Inv. No.</i>	Inhabited scroll on a white background; inside the scroll, a green bird (parakeet?)	
97144		
<i>Figs 3-II, 4-3I</i>	<i>Provenance</i>	<i>Discovery / transport to Beiteddine</i>
	Basilica	1987 / about 1987
<i>Stone</i>	32 × 17 (face) × 8 cm; face of a voussoir. <i>Condition:</i> back side trimmed; cut diagonally along its bottom edge; fresh-looking chipping on the front.	
<i>Mortar/plaster</i>	Type 2 mortar locally in the cavities of the stone. Plaster 7–8 mm thick. <i>Condition:</i> rough and abraded surface; granular disintegration of plaster.	
<i>Paint layer</i>	Varying thickness and paint handling; dark red stem of the scroll painted with thick, opaque paint; tendril rendered with a few strokes of watery paint; bird executed in two to three superimposed layers. <i>Condition:</i> abraded, especially in the part with the bird; yellowed varnish; red parts powdery after removal of varnish; surface grime.

After treatment (2018)

Angled view, showing the concavity in the intrados surface and the large loss on the back of the stone

<i>Treatment</i>	Disinfection; consolidation of plaster edges; application of mortar bands; removal of surface grime; removal of varnish; consolidation of powdery paint layer.

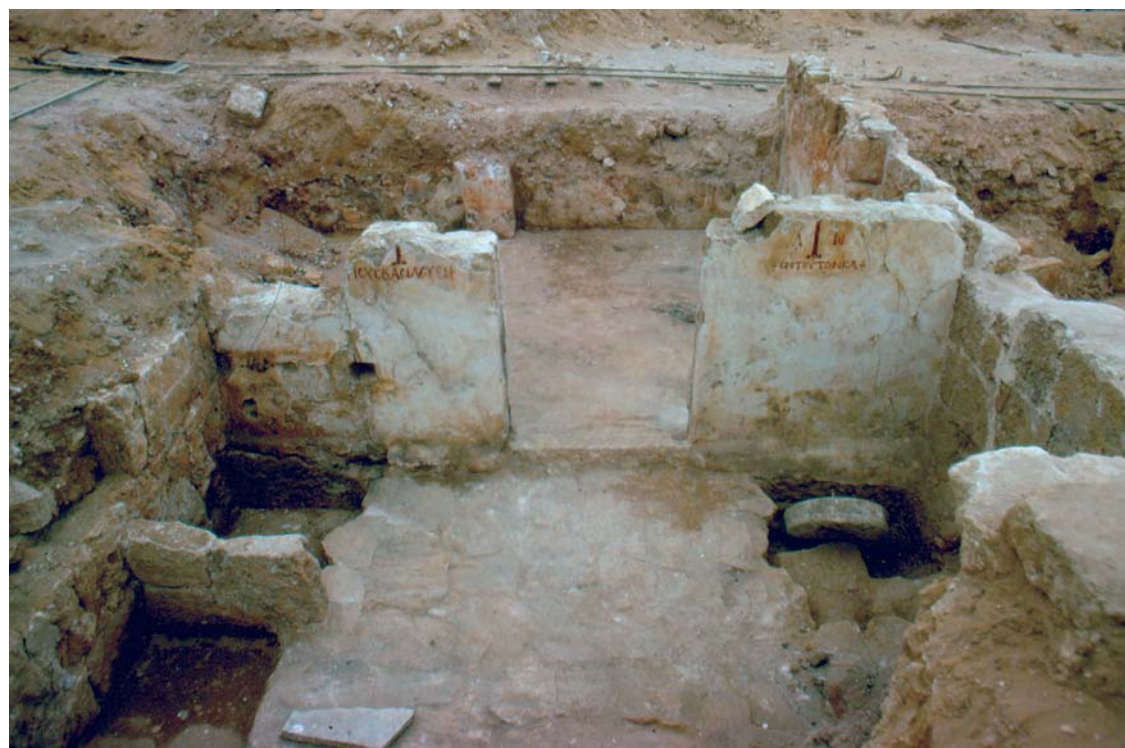
Passage from courtyard D11 into room D12: *Cat. 187* to the left of the doorway, *Cat. 188* to the right.
General view after exploration in 1975

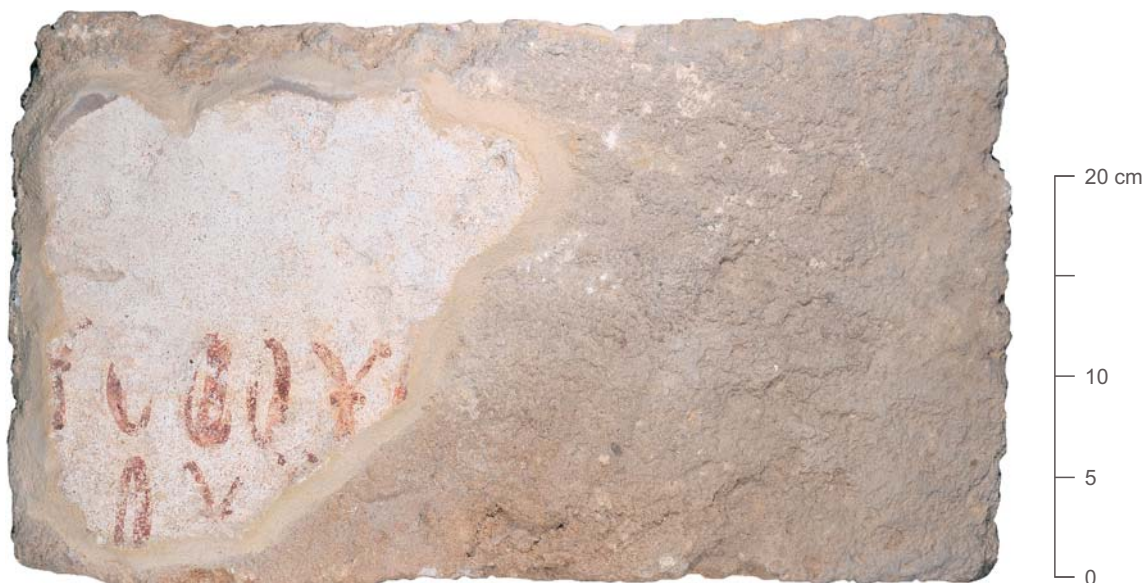
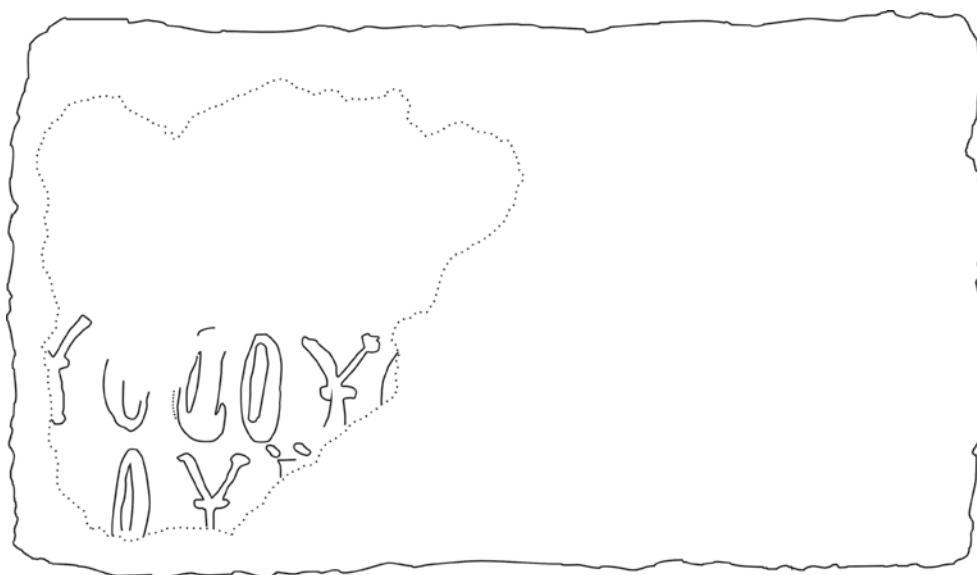
After discovery (1975)

After treatment (2017) and tracing

Cat. 201	<i>Representation</i>	
<i>Inv. No.</i>	Greek inscription	
JYI4WP12	Letter height 6 cm	
Chapter 5:	<i>Provenance</i>	<i>Discovery / transport to Beiteddine</i>
218	Residential district	2000s / 2012
<i>Stone</i>	31 × 50 (face) × 18 cm; well-dressed ashlar; compact stone. <i>Condition:</i> good.	
<i>Mortar/plaster</i>	Plaster 3–12 mm thick; directly on the stone. <i>Condition:</i> losses and abrasions; granular disintegration of plaster.	
<i>Paint layer</i>	Red paint applied in one layer. <i>Condition:</i> abraded and faded; powdery; surface grime.	
<i>Treatment</i>	Disinfection; consolidation of plaster edges; application of mortar bands; removal of surface grime; consolidation of powdery paint layer.

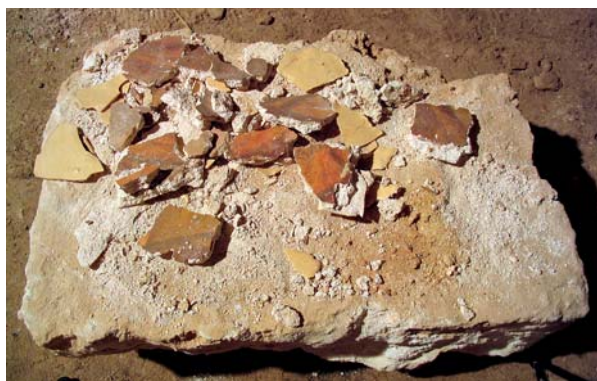
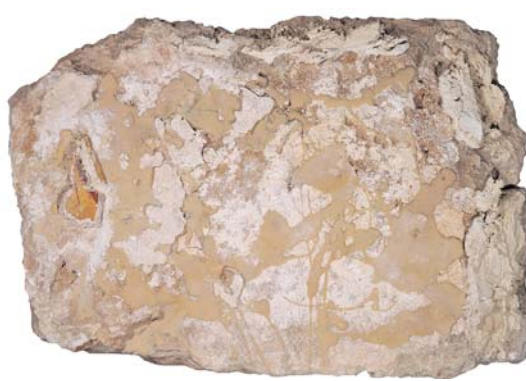
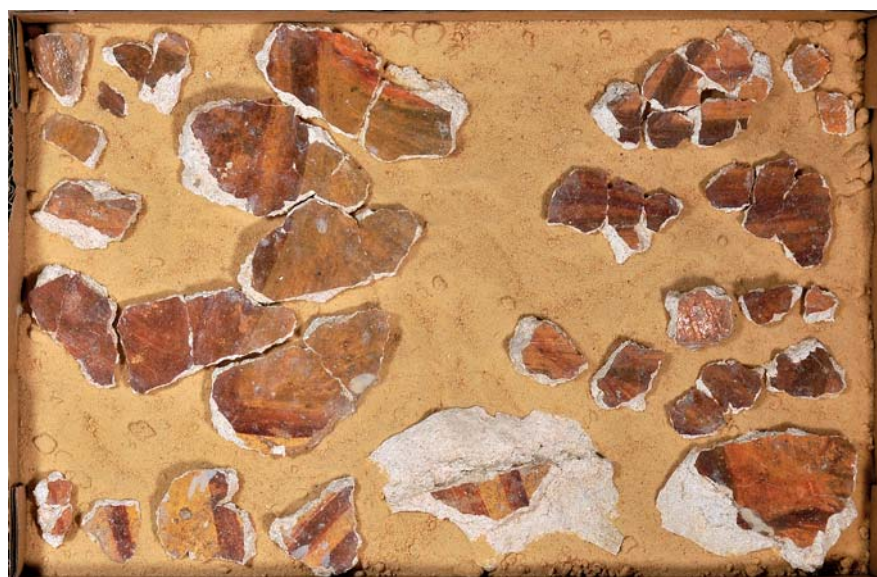
Reassembled plaster fragments (2018); epoxy(?) resin adhering to the back of the two large pieces in the lower right corner; top left, broken painted plaster in storage at the Beiteddine Palace (2004); top right, the face of the ashlar with a fragment of painted plaster and splashes of epoxy(?) resin (2018)

Cat. 213	<i>Representation</i> Unidentified	
<i>Inv. No.</i> 98527		
<i>Figs 4-5, 4-8, 4-27</i>	<i>Provenance</i> Basilica	<i>Discovery / transport to Beiteddine</i> 1987 / about 1987
<i>Stone</i>	32 × 46 (face) × 7 cm; ashlar, once well-dressed. <i>Condition:</i> back side trimmed; missing corner; black fungi noted on the back prior to conservation.	
<i>Mortar/plaster</i>	Type 2 mortar remains along the perimeter of the ashlar face. Plaster 8–12 mm thick. <i>Condition:</i> in 2004, broken fragments of plaster were found lying on top of the ashlar face; some pieces found loose in the storeroom were reassembled, but their original setting could not be determined; epoxy(?) resin observed on the ashlar and on the back of loose plaster fragments most likely served to reattach the plaster to the stone; granular disintegration of plaster.	
<i>Paint layer</i>	Various colors applied wet-into-wet, rather thickly. <i>Condition:</i> thick layer of yellowed varnish on all of the fragments.

the surviving fragments of broken plaster are covered with the resin, which is now impossible to remove safely [*Fig. 4-5* right]. During the current conservation project, an attempt was made to reassemble the loose fragments and to reattach them to the ashlar. It proved impossible because too many of them have disintegrated over the years [see below, *Fig. 4-27*]. Finally, some of the paintings were protected with varnish, which has now yellowed and become almost completely insoluble over the course of the three decades that have passed since its application (see below, § 4.3).

<i>Treatment</i>	Disinfection; consolidation of plaster edges on the ashlar and loose fragments; reassembly of some fragments.

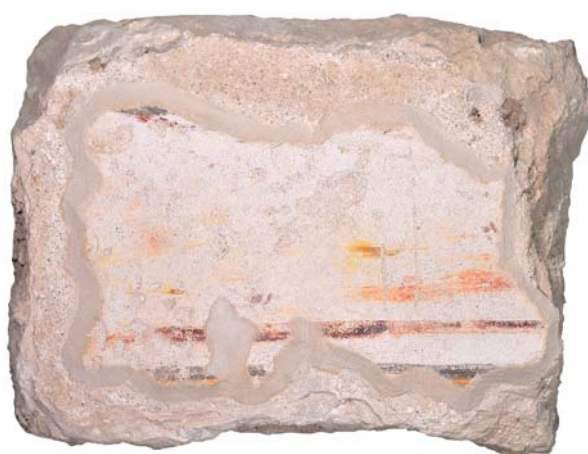
Cat. 214

After treatment (2017)

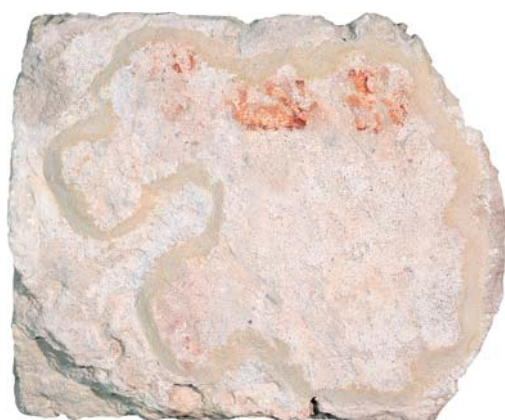
After treatment (2017) Cat. 218

Cat. 218	<i>Representation</i> Unidentified; reminiscent of a member of a jeweled cross	
<i>Inv. No.</i> 98503		
	<i>Provenance</i> Basilica	<i>Discovery / transport to Beiteddine</i> 1987 / about 1987
<i>Stone</i>	36 × 45 (face) × 20 cm; well-dressed ashlar; porous stone. <i>Condition:</i> two corners on the right missing, covered with mortar, indicating damage prior to use in construction.	
<i>Mortar/plaster</i>	Type 2 mortar remains along the perimeter of the ashlar face. Plaster 7–9 mm thick. <i>Condition:</i> surface poorly preserved; broad and deep abrasions; granular disintegration of plaster.	
<i>Paint layer</i>	Buildup difficult to assess; apparently several tones of red and pink with white round impastos on top. <i>Condition:</i> abraded; powdery; surface grime.	
<i>Treatment</i>	Disinfection; consolidation of plaster edges and abraded areas; application of mortar bands; removal of surface grime; consolidation of powdery paint layer.

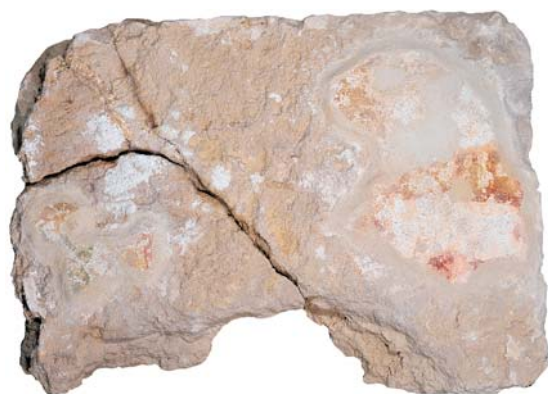
After treatment (2017) Cat. 219

Cat. 219	<i>Representation</i> Jeweled cross inside a medallion(?). Horizontal member of a cross on the right-hand side of the ashlar; fragment of a medallion(?) on the left	
<i>Inv. Nos</i> 98540 98571		
	<i>Provenance</i> Basilica	<i>Discovery / transport to Beiteddine</i> 1987 / about 1987
<i>Stone</i>	36 × 49 (face) × 9 cm; well-dressed ashlar; porous and crumbly stone. <i>Condition:</i> poor; broken into two large fragments (assigned separate inventory numbers) and several small ones; one fragment missing; easily disintegrating stone; back side trimmed.	
<i>Mortar/plaster</i>	Type 2 mortar on the ashlar face, along the edges. Plaster 6–9 mm thick. <i>Condition:</i> broad shallow losses and abrasions; granular disintegration of plaster.	
<i>Paint layer</i>	Buildup difficult to assess. <i>Condition:</i> abraded; powdery; surface grime.	
<i>Treatment</i>	Disinfection; consolidation of plaster edges and abraded areas; reassembling the small fragments of stone, but not the largest two, where the contact surface was too limited and too crumbly; application of mortar bands; removal of surface grime; consolidation of powdery paint layer.

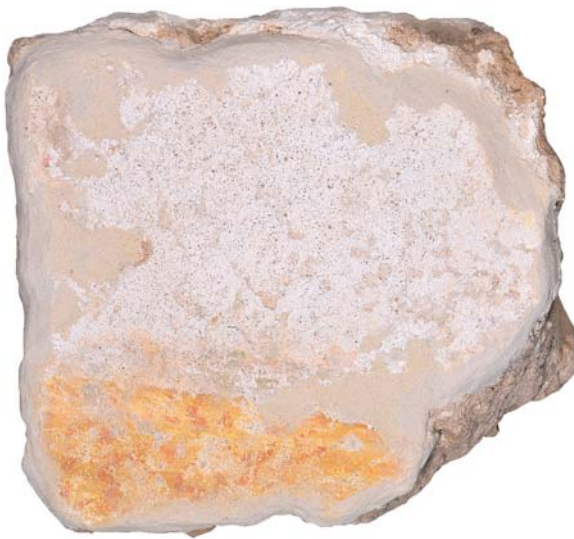
After treatment (2017) Cat. 220

**Cat. 220***Representation*
Unidentified*Inv. No.*
98536*Provenance*
Basilica*Discovery / transport to Beiteddine*
1987 / about 1987*Stone*27 × 29 (face) × 14 cm; roughly dressed ashlar.
Condition: bottom right corner missing.*Mortar/plaster*Type 2 mortar locally underneath the plaster. Plaster 5–7 mm thick.
Condition: poor surface condition; numerous losses, cracks, and indentations; granular disintegration of plaster.*Paint layer*Buildup difficult to assess.
Condition: abraded and faint; powdery; surface grime.*Treatment*

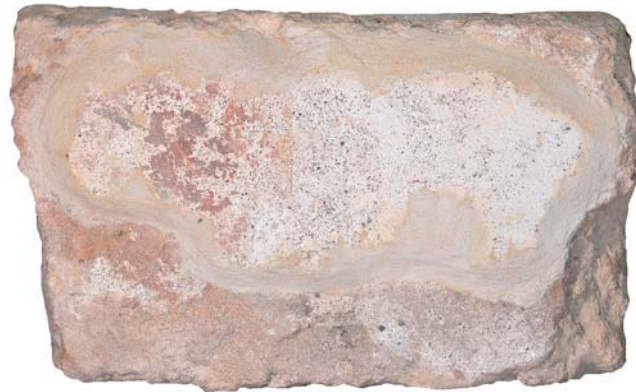
After treatment (2017) Cat. 221

Cat. 221*Representation*
Unidentified*Inv. No.*
98504*Provenance*
Basilica*Discovery / transport to Beiteddine*
1987 / about 1987*Stone*20 × 32 (face) × 14 cm; well-dressed ashlar; compact stone.
Condition: good.*Mortar/plaster*Plaster 7–9 mm thick; directly on stone.
Condition: broad surface abrasions; granular disintegration of plaster.*Paint layer*Applied thickly(?), several colors used.
Condition: severely abraded; powdery; surface grime.*Treatment*

Disinfection; consolidation of plaster edges and abraded areas; application of mortar bands; removal of surface grime; consolidation of powdery paint layer.

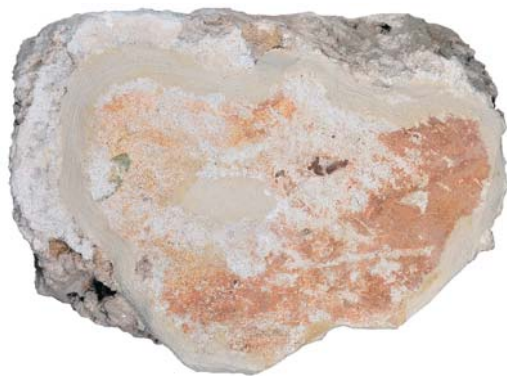
Cat. 224

Cat. 224Inv. No.
98523*Representation*
Unidentified*Provenance*
Basilica*Discovery / transport to Beiteddine*
1987 / about 1987*Stone*24 × 33 (face) × 17 cm; fragment of a roughly dressed ashlar; porous stone.
Condition: lower side broken, fresh break.*Mortar/plaster*Type 2 mortar at the edges of the ashlar face. Plaster 10–12 mm thick.
Condition: broad abrasions and some shallow losses; granular disintegration of plaster.*Paint layer*Pinkish-buff color applied very thickly; visible tonal transitions.
Condition: abraded, powdery; surface grime.*Treatment*

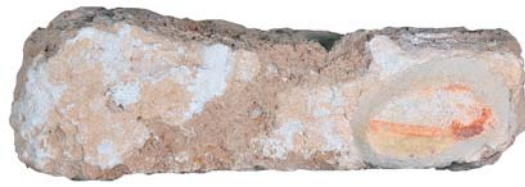
Cat. 225Inv. No.
98510*Representation*
Unidentified*Provenance*
Basilica*Discovery / transport to Beiteddine*
1987 / about 1987*Stone*9 × 28 (face) × 33 cm; well-dressed narrow ashlar; position in the wall structure most likely vertical.
Condition: good.*Mortar/plaster*Type 2 mortar on the ashlar face and sides. Plaster 8–10 mm thick.
Condition: good overall; granular disintegration of plaster.*Paint layer*Buildup difficult to assess.
Condition: faded; red elements powdery; surface grime.*Treatment*
