LATE ANTIQUE WALL PAINTINGS FROM PORPHYREON IN THE SIDON HINTERLAND

Julia M. BURDAJEWICZ

PEETERS
LEUVEN – PARIS – BRISTOL, CT.
2022

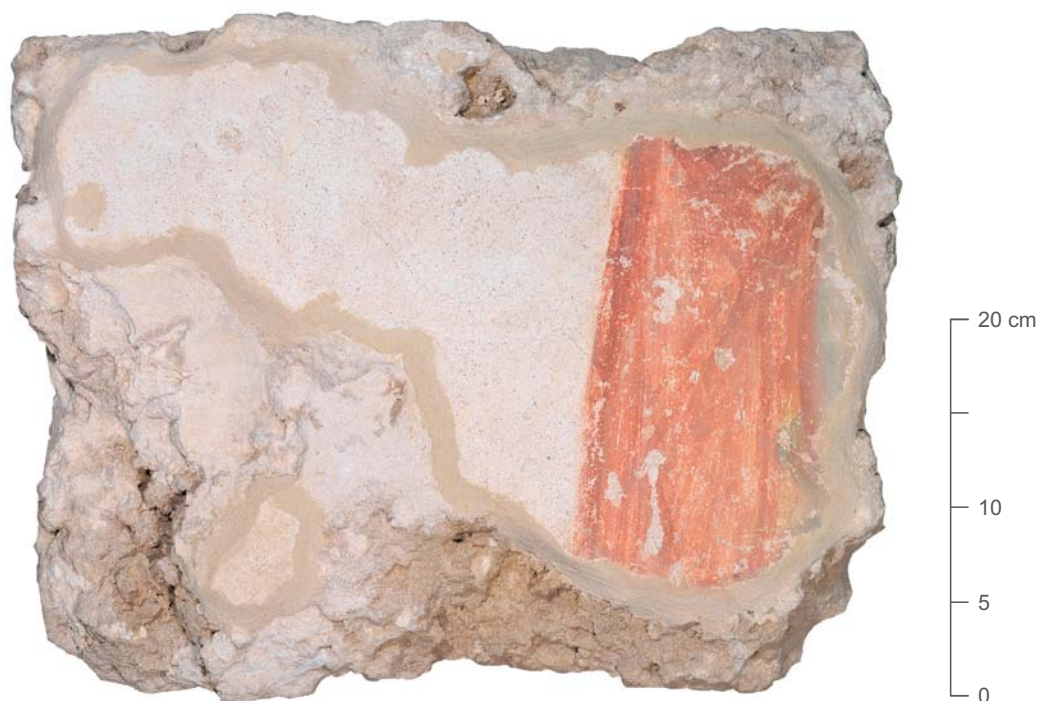
Cat. 226

Condition: good.*Mortar/plaster*

Condition: minor losses and abrasions; granular disintegration of plaster.*Paint layer*

Condition: minor losses; surface grime.*Treatment*

Disinfection; consolidation of plaster edges; application of mortar bands; removal of surface grime; preventive consolidation of paint layer.

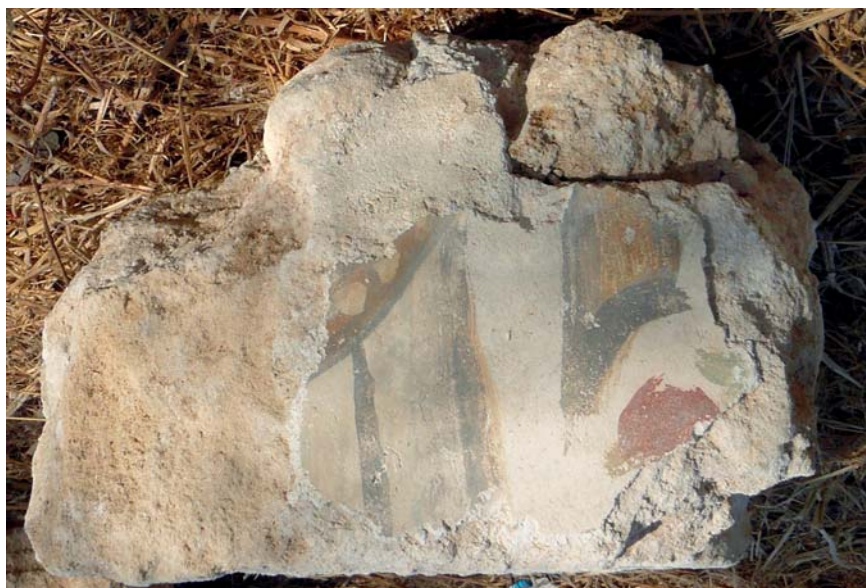
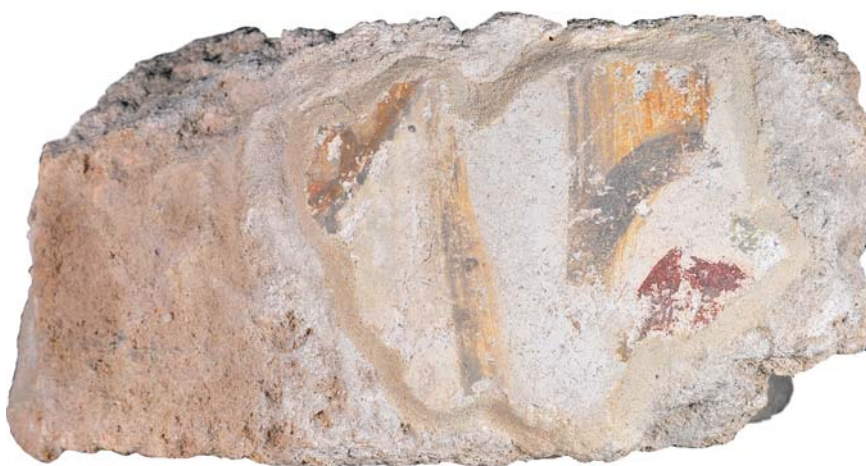
Cat. 229

After discovery (2010); bottom, after treatment (2017)

13 × 34 (face) × 39 cm; well-dressed, corbel-like element with projecting triangular profile as in *Cat. 31acd*.
Condition: projecting profile partly broken, fresh break; otherwise in good condition.

Type 2 mortar underneath the plaster and on the sides of the ashlar. Plaster 6 mm thick.
Condition: plaster partly disintegrated in storage; small losses and abrasions; granular disintegration of plaster.

Relatively thickly applied; probably wet-into-wet; palette of colors and paint handling similar to *Cat. 228*.
Condition: losses and abrasions; slightly powdery; surface grime.

Disinfection; consolidation of plaster edges; application of mortar bands; removal of surface grime; consolidation of powdery paint layer.

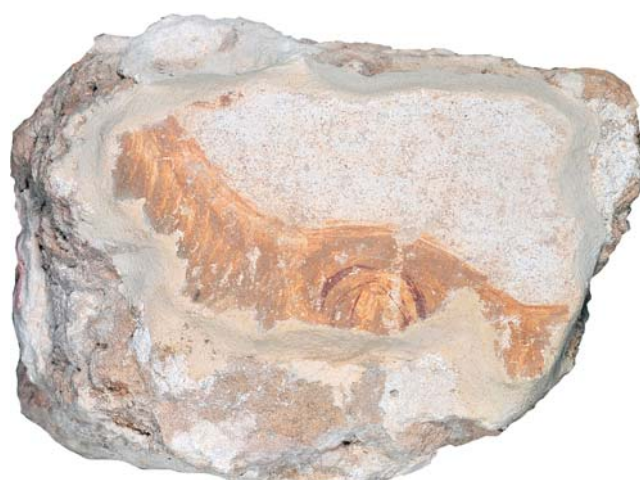
After treatment (2017) Cat. 232

Cat. 232	<i>Representation</i> Unidentified	
<i>Inv. No.</i> JY6WP14		
	<i>Provenance</i> Residential district	<i>Discovery / transport to Beiteddine</i> 2000s / 2016
<i>Stone</i>	21 × 29 (face) × 42 cm; roughly dressed stone. <i>Condition:</i> good.	
<i>Mortar/plaster</i>	Type 2 mortar locally underneath the plaster and in cavities on the sides of the stone. Plaster about 8 mm thick. <i>Condition:</i> jagged plaster edges; surface abrasions; granular disintegration of plaster.	
<i>Paint layer</i>	Applied rather thickly, wet-into-wet. <i>Condition:</i> minor losses and scuffs; powdery; surface grime.	
<i>Treatment</i>	Disinfection; consolidation of plaster edges and abraded areas; application of mortar bands; removal of surface grime; consolidation of powdery paint layer.

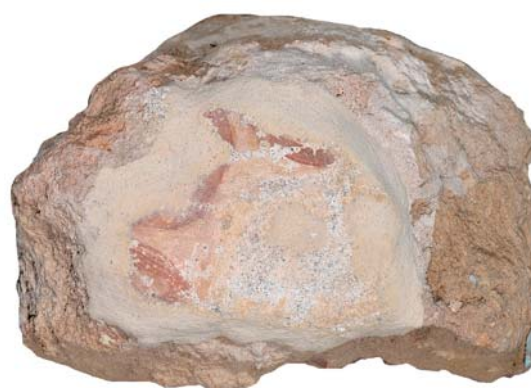
After treatment (2017) Cat. 233

Cat. 233	<i>Representation</i> Unidentified	
<i>Inv. No.</i> JY51WP		
	<i>Provenance</i> Residential district	<i>Discovery / transport to Beiteddine</i> 2000s / 2016
<i>Stone</i>	17 × 25 (face) × 25 cm; roughly dressed ashlar fragment. <i>Condition:</i> broken at the bottom, fresh break; edges rounded.	
<i>Mortar/plaster</i>	Type 1 mortar on one of the sides; Type 2 mortar on other sides and underneath the plaster. Plaster 6–9 mm thick. <i>Condition:</i> minor losses and abrasions; granular disintegration of plaster.	
<i>Paint layer</i>	Buildup difficult to assess. <i>Condition:</i> minor losses and abrasions; surface grime.	
<i>Treatment</i>	Disinfection; consolidation of plaster edges; application of mortar bands; removal of surface grime; preventive consolidation of paint layer.

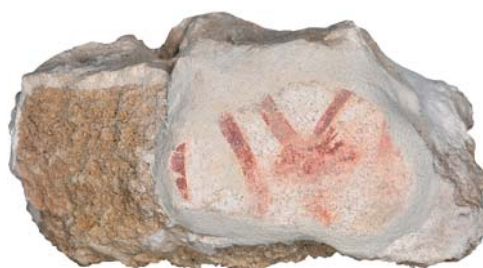
After treatment (2017) Cat. 240

Representation
Unidentified*Inv. No.*
—*Provenance*
Residential district*Discovery / transport to Beiteddine*
2000s / 2016*Stone*14 × 38 (face) × 19 cm; roughly dressed ashlar; porous stone, numerous cavities.
Condition: good; top side broken, covered with mortar, indicating damage prior to use in construction.*Mortar/plaster*Type 1 mortar on the sides of the stone; possibly some Type 2 mortar underneath the plaster. Plaster 8–10 mm thick.
Condition: a few minor losses; granular disintegration of plaster.*Paint layer*Red paint applied with single strokes, moderately thick.
Condition: partly abraded and powdery; surface grime.*Treatment*

Disinfection; consolidation of plaster edges; application of mortar bands; removal of surface grime; consolidation of powdery paint layer.

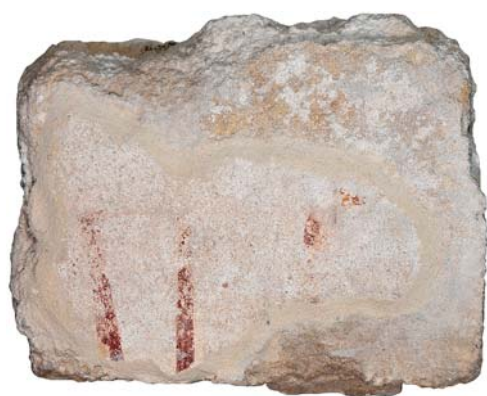
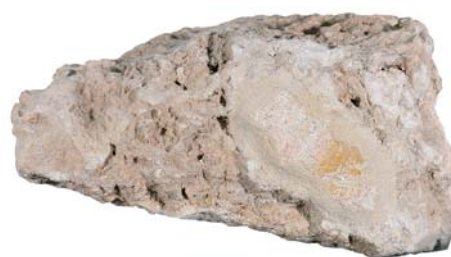
Inv. No.
985II*Provenance*
Basilica*Discovery / transport to Beiteddine*
1987 / about 1987*Stone*14 × 29 (face) × 36 cm; narrow, flat, roughly dressed ashlar, original position in the wall structure possibly vertical.
Condition: good overall.*Mortar/plaster*Type 2 mortar remains on the edges. Plaster 6–9 mm thick; directly on stone.
Condition: surface abrasions and losses; granular disintegration of plaster.*Paint layer*Buildup difficult to assess.
Condition: severely abraded save for the yellow ring, which was likely painted with thick paint; powdery; surface grime.*Treatment*

Disinfection; consolidation of plaster edges; application of mortar bands; removal of surface grime; consolidation of powdery paint layer.

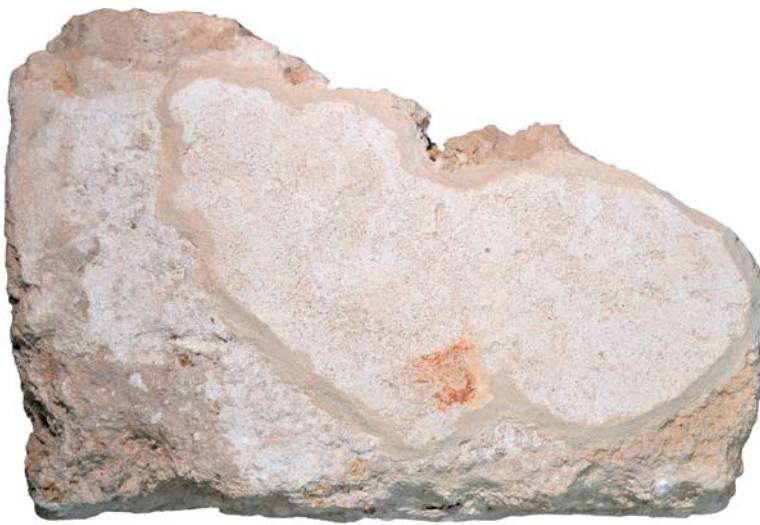
Cat. 250	<i>Representation</i> Unidentified	
<i>Inv. No.</i> 98555		
	<i>Provenance</i> Basilica	<i>Discovery / transport to Beiteddine</i> 1987 / about 1987
<i>Stone</i>	34 × 50 (face) × 22 cm; fragment of an ashlar. <i>Condition:</i> upper right corner missing, fresh break.	
<i>Mortar/plaster</i>	Type 2 mortar along the perimeter of the ashlar face and on the sides. Plaster 6–8 mm thick. <i>Condition:</i> losses and abrasions; granular disintegration of plaster.	
<i>Paint layer</i>	Too poorly preserved to assess buildup. <i>Condition:</i> abraded and powdery; surface grime.	
<i>Treatment</i>	Disinfection; consolidation of plaster edges and abraded areas; application of mortar bands; removal of surface grime; consolidation of powdery paint layer.

Disinfection; consolidation of plaster edges and abraded areas; application of mortar bands; removal of surface grime; preventive consolidation of the remaining paint layer.

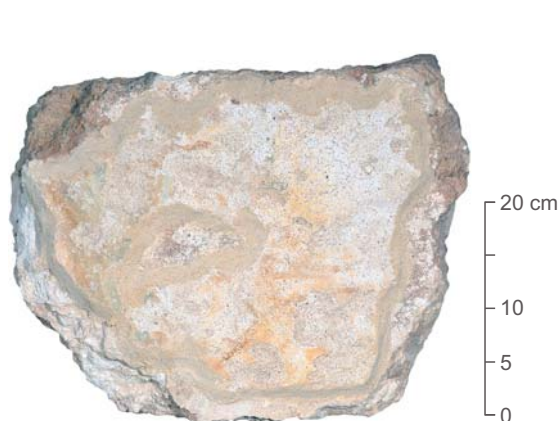
After treatment (2017) Cat. 252

Cat. 252	<i>Representation</i> Unidentified	
<i>Inv. No.</i> 97102		
<i>Samples</i> Jy014 [Fig 3-13] Jy015 [Fig 3-9]	<i>Provenance</i> Basilica	<i>Discovery / transport to Beiteddine</i> 1987 / about 1987
<i>Stone</i>	32 × 42 (face) × 16 cm; roughly dressed ashlar. <i>Condition:</i> fresh chip in the upper left corner; other losses at the corners covered with mortar, indicating damage prior to use in construction.	
<i>Mortar/plaster</i>	Type 2 mortar on the sides of the ashlar and partly underneath the plaster. Plaster 6–8 mm thick. <i>Condition:</i> broad and shallow losses and abrasions; granular disintegration of plaster.	
<i>Paint layer</i>	Remains of thinly applied yellow paint; green paint thick, with marked brushstrokes. <i>Condition:</i> abraded and powdery; surface grime.	
<i>Treatment</i>	Disinfection; consolidation of plaster edges and abraded areas; application of mortar bands; removal of surface grime; consolidation of powdery paint layer.

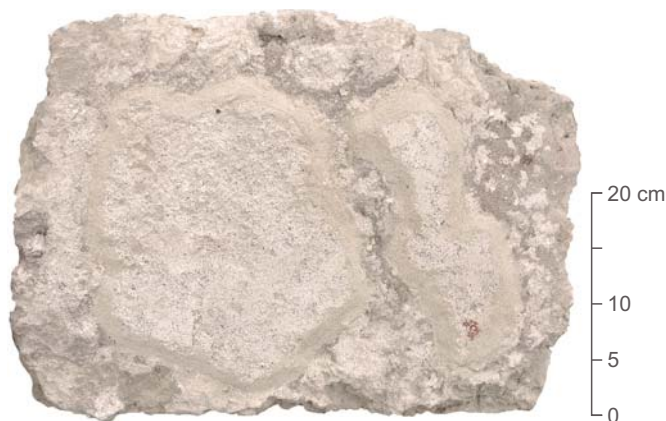
After treatment (2017) Cat. 253

Cat. 253	<i>Representation</i> Unidentified	
<i>Inv. No.</i> 97103		
	<i>Provenance</i> Basilica	<i>Discovery / transport to Beiteddine</i> 1987 / about 1987
<i>Stone</i>	37 × 50 (face) × 20 cm; roughly dressed ashlar. <i>Condition:</i> good; missing upper right corner covered with mortar, indicating damage prior to use in construction.	
<i>Mortar/plaster</i>	Type 2 mortar remains along the perimeter of the ashlar face. Plaster 5–9 mm thick; mostly directly on stone. <i>Condition:</i> severe surface deterioration; broad abrasions; granular disintegration of plaster.	
<i>Paint layer</i>	Too poorly preserved to assess buildup. <i>Condition:</i> surviving patch of paint powdery; surface grime.	
<i>Treatment</i>	Disinfection; consolidation of plaster edges and abraded areas; application of mortar bands; removal of surface grime; consolidation of powdery paint layer.

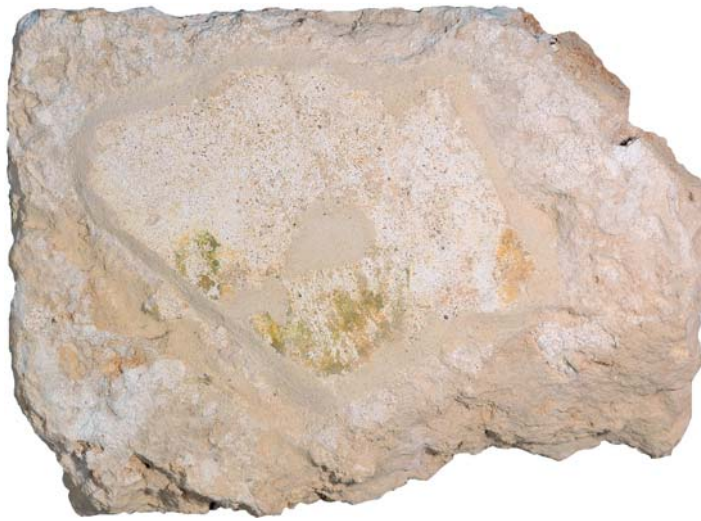
After treatment (2017) Cat. 254

Cat. 254	<i>Representation</i> Unidentified	
<i>Inv. No.</i> 97107		
	<i>Provenance</i> Basilica	<i>Discovery / transport to Beiteddine</i> 1987 / about 1987
<i>Stone</i>	29 × 38 (face) × 9 cm; well-dressed ashlar once. <i>Condition:</i> three corners missing; one of these found in the storeroom; fresh breaks; back side trimmed.	
<i>Mortar/plaster</i>	Type 2 mortar remains along the perimeter of the ashlar face. Plaster 6–12 mm thick; directly on stone. <i>Condition:</i> a few large losses; minor abrasions; granular disintegration of plaster.	
<i>Paint layer</i>	Too poorly preserved to assess buildup. <i>Condition:</i> abraded; slightly yellowed varnish; surface grime.	
<i>Treatment</i>	Disinfection; consolidation of plaster edges and abraded areas; integration of the broken corner; application of mortar bands; filling in the joint; removal of surface grime; removal of varnish; preventive consolidation of remaining paint layer.

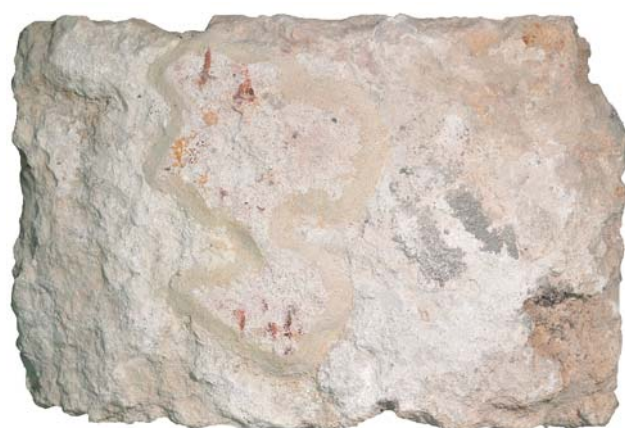
Cat. 256

*Stone*38 × 57 (face) × 16 cm; well-dressed ashlar.
Condition: good; minor chip losses along the edges.*Mortar/plaster*Type 2 mortar on all sides of the ashlar. Plaster 5–7 mm thick.
Condition: severely abraded surface; jagged plaster edges; granular disintegration of plaster.*Paint layer*Too poorly preserved to assess buildup.
Condition: abraded and powdery; surface grime.*Treatment*

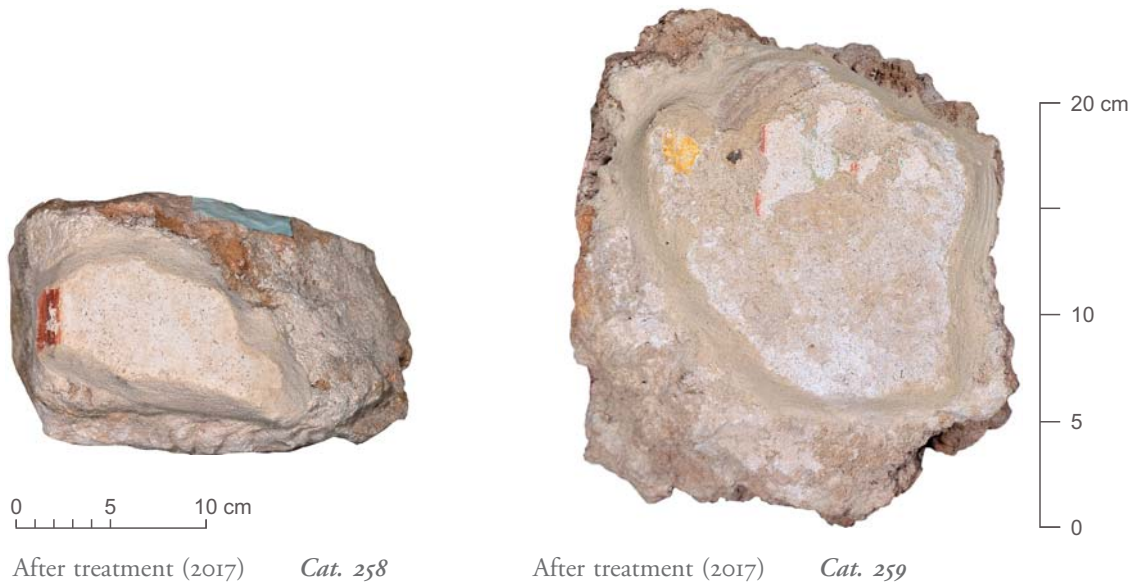
**Cat. 258**

11 × 20 (face) × 12 cm; fieldstone or fragment of a roughly dressed ashlar.
Condition: good.

Type 2 mortar underneath the plaster and on the sides. Plaster 5–12 mm thick; folded over the left edge.
Condition: plaster patch slightly larger upon discovery; granular disintegration of plaster.

Applied in a relatively thick layer.
Condition: surviving paint in good condition; slightly powdery; dusty.

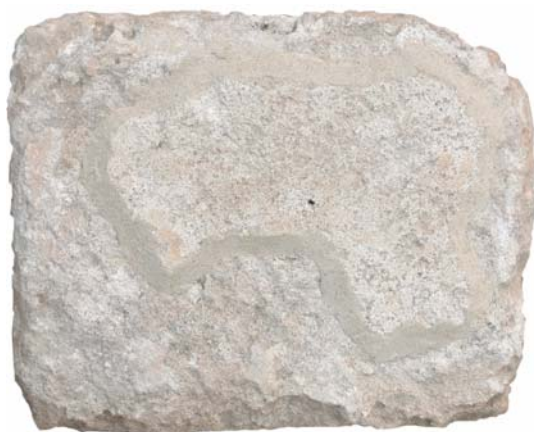
Cat. 268	<i>Representation</i> No paint layer preserved	
<i>Inv. No.</i> 98535		
	<i>Provenance</i> Basilica	<i>Discovery / transport to Beiteddine</i> 1987 / about 1987
<i>Stone</i>	21 × 28 (face) × 20 cm; well-dressed ashlar. <i>Condition:</i> good.	
<i>Mortar/plaster</i>	Type 2 mortar underneath the plaster and on the sides of the ashlar. Plaster 4–6 mm thick. <i>Condition:</i> surface abrasions; granular disintegration of plaster.	
<i>Treatment</i>	Disinfection; consolidation of plaster edges; application of mortar bands; dusting.

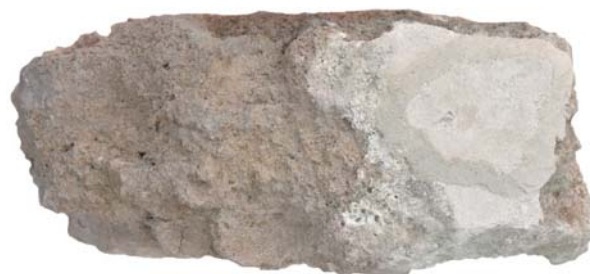
Cat. 269	<i>Representation</i> No paint layer preserved	
<i>Inv. No.</i> 98497		
	<i>Provenance</i> Basilica	<i>Discovery / transport to Beiteddine</i> 1987 / about 1987
<i>Stone</i>	14 × 32 (face) × 42 cm; roughly dressed ashlar; original position in the wall structure possibly vertical. <i>Condition:</i> chipping of the face; missing corner at the back.	
<i>Mortar/plaster</i>	Type 2 mortar remains underneath the plaster. Plaster 4–5 mm thick. <i>Condition:</i> granular disintegration of plaster.	
<i>Treatment</i>	Disinfection; consolidation of plaster edges; application of mortar bands; dusting.

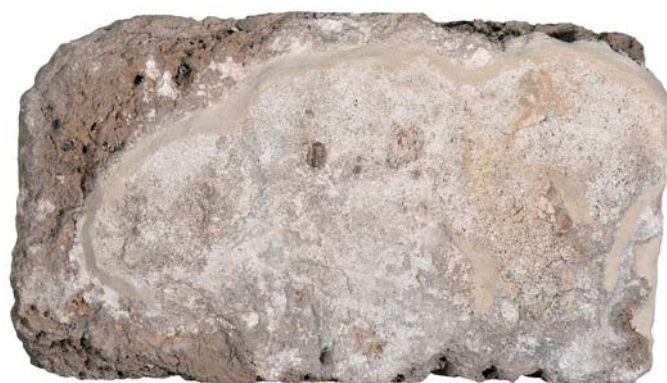
Cat. 272		<i>Representation</i>
<i>Inv. No.</i> JYI61WP		No paint layer preserved; remains of painted elements in a warm gray with dark contours still observed at the time of discovery
<i>Provenance</i> Residential district		<i>Discovery / transport to Beiteddine</i> 2000s / 2016
<i>Stone</i>	33 × 58 (face) × 15 cm; roughly dressed ashlar; porous stone. <i>Condition:</i> good; some chipping of the corners and edges.	
<i>Mortar/plaster</i>	Type 2 mortar on the sides of the ashlar. Plaster about 3 mm thick; folded over the right-hand edge, continuing on the side of the ashlar. <i>Condition:</i> severely abraded surface; broad losses; granular disintegration of plaster; discoloration of the plaster caused by black lichen.	
<i>Treatment</i>	Disinfection; consolidation of plaster edges and abraded areas; application of mortar bands; dusting.

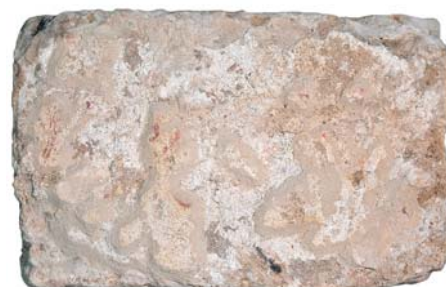
Cat. 273		<i>Representation</i>
<i>Inv. No.</i> —		No paint layer preserved
<i>Provenance</i> Residential district		<i>Discovery / transport to Beiteddine</i> 2000s / 2016
<i>Stone</i>	25 × 39 (face) × 17 cm; small, well-dressed ashlar. <i>Condition:</i> good.	
<i>Mortar/plaster</i>	Type 2 mortar on the sides. Plaster 6–8 mm thick; directly on stone. <i>Condition:</i> numerous losses; granular disintegration of plaster.	
<i>Treatment</i>	Disinfection; consolidation of plaster edges and abraded areas; application of mortar bands; dusting.

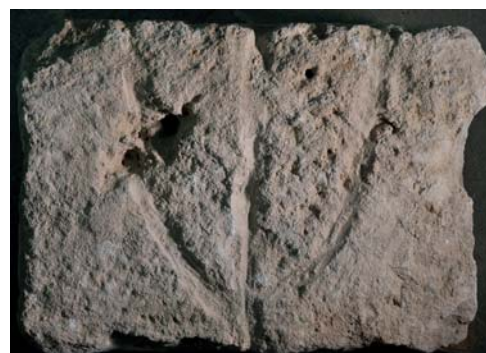
Cat. 280

Longer side of the ashlar with the trident-shaped groove, viewed in raking light; left, shorter side with remains of plaster
